In-flight fire and collision with terrain involving Beechcraft B58 Baron, VH-NPT

near East Kimberley Regional Airport, Kununurra, Western Australia on
16 April 2022

ATSB Transport Safety Report

AO-2022-026

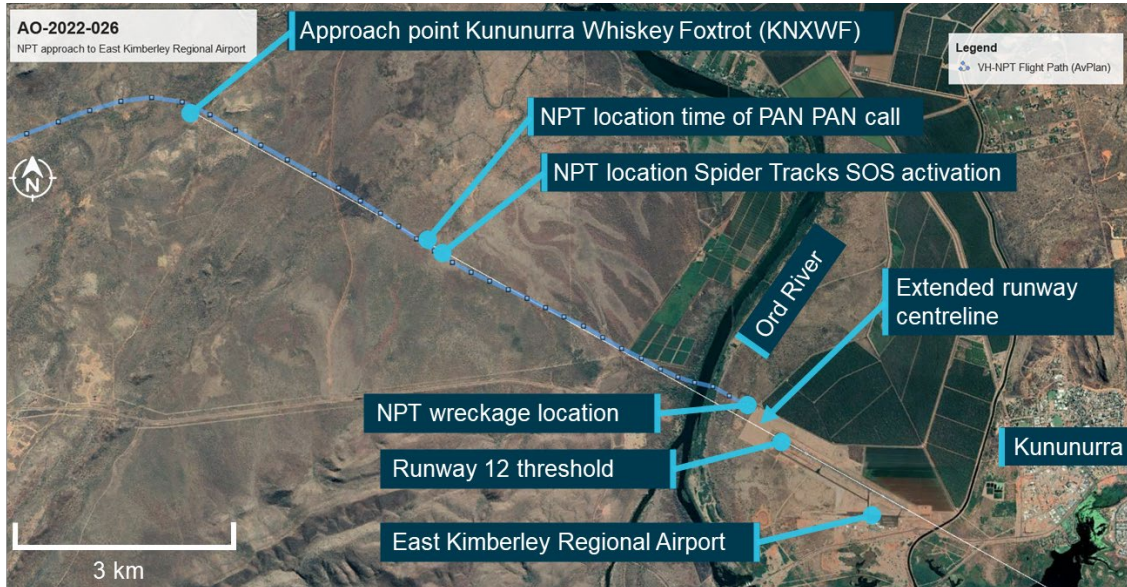
Figure 3: NPT approach to East Kimberley Regional Airport

The pilot then expended the entire contents of the aircraft's handheld portable fire extinguisher, while continuing the straight in approach to runway 12 (Figure 3). However, the fire almost

Recorded flight data indicated that, at 0837, the aircraft started diverging left of the extended runway centre line, crossing the Ord River at low level approximately 1.5 km from the threshold of runway 12. The aircraft subsequently collided with terrain, coming to rest inverted about 600 m beyond the river and about 800 m from the runway 12 threshold (Figure 3) and was consumed by a significant post-impact fire.

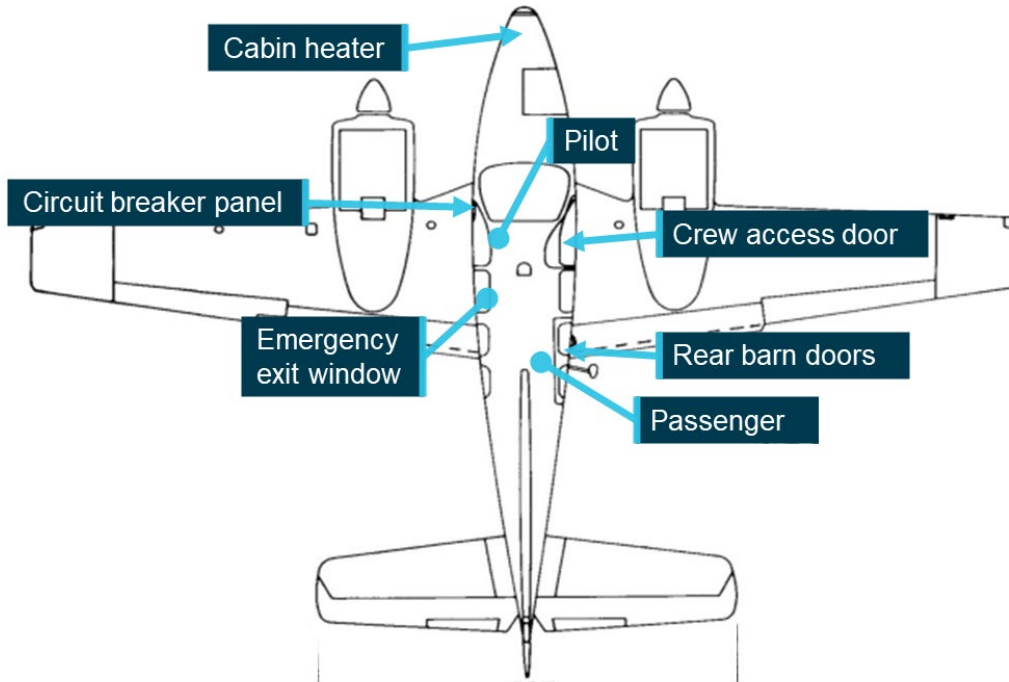
Figure 5: Aircraft schematic identifying location of key elements

The B58 is fitted with a fuel-burning cabin heater in the nose of the aircraft (Figure 5). Maintenance records indicated that the heater was infrequently used, and the pilot advised that the heater was not utilised during the accident flight. In the 12 months leading up to the most recent 100 hourly inspection the heater had been used for 102.5 of the aircraft's accumulated 1,077 hours, of which only 3.3 had been accrued in the last 6 months. The heater's hour count following the 100 hourly inspection was unable to be determined due to the post impact fire.

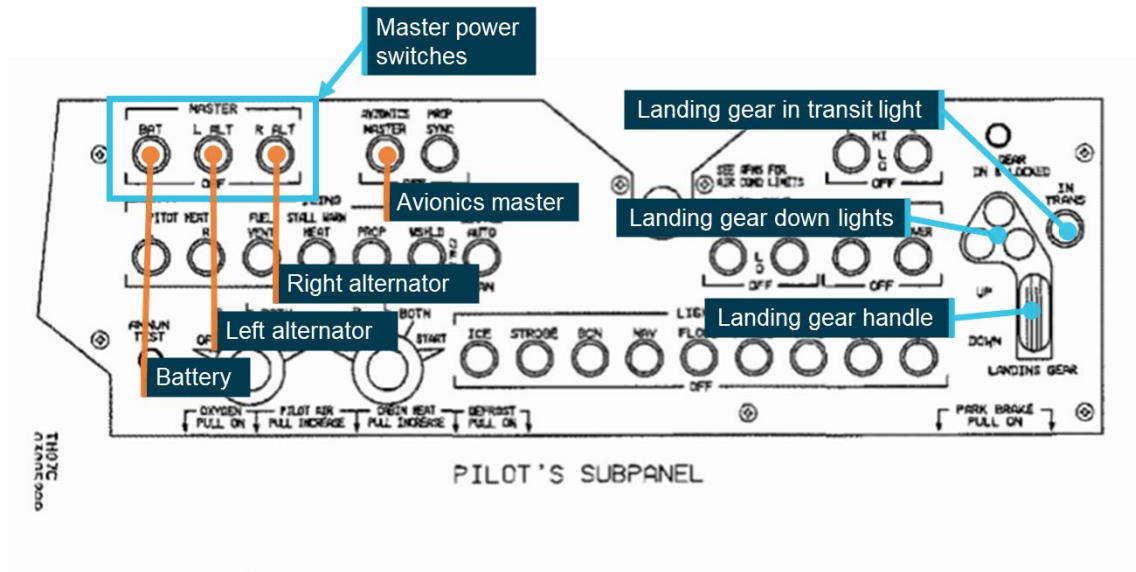
Figure 6: Schematic of the pilot’s subpanel showing master power and landing gear controls

Aircraft power was supplied by a single battery and an alternator fitted to each of the aircraft’s 2 engines. These power sources could be connected and disconnected individually using 3 separate switches on the pilot’s sub-panel labelled ‘MASTER’ (Figure 6). To protect the avionics from electrical damage when the master switches were being operated, a separate ‘AVIONICS MASTER’ switch (Figure 6) controlled power to these devices. The ‘AVIONICS MASTER’ was dependant on the ‘MASTER’ switches in the control hierarchy, meaning that if the ‘MASTER’ switches were off, the ‘AVIONICS MASTER’ was not able to be powered.

The heater is supplied with fuel via a direct line from the left-wing leading-edge fuel tank. The fuel line is attached to the tank at the wing root and traverses internally along the lower left fuselage. It passes through the aircraft cockpit below the pilot's circuit breaker panel (Figure 6). The line then enters the aircraft's nose-wheel bay and connects to the heater. The line fills with fuel as the tank is filled and will remain full of fuel at all normal flight attitudes. The line is secured at multiple locations with clamps to prevent damage from contact with the aircraft's structure.
