Collision with terrain involving Kubicek Balloons BB78Z, VH-RJR

15 km north-west of Moorabbin Airport, Victoria on 20 April 2022

ATSB Transport Safety Report

AO-2022-028

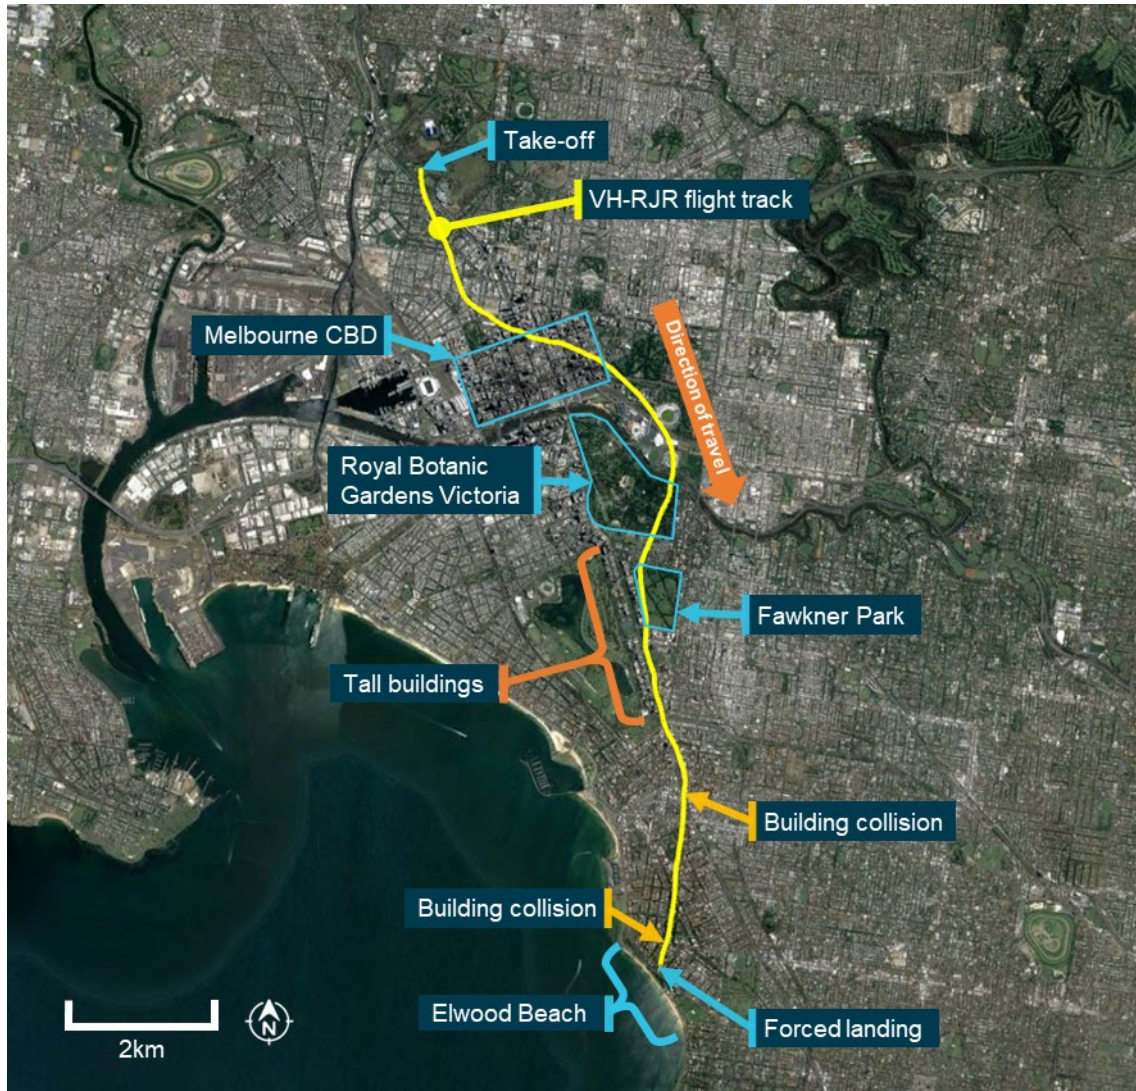
Figure 2: Balloon flight track

At about 0656, the pilot attempted a landing in Fawkner Park (Figure 2), but as the balloon descended over the Royal Botanic Gardens it tracked away from the larger central areas of the park. The pilot heated the envelope and ascended into north-westerly winds to attempt to track back towards the park's centre but was unsuccessful. The balloon then continued to track south-south-east along the western edge of the park adjacent to nearby buildings.

At about 0706, the pilot descended the balloon to track towards Elwood Beach and instructed the passengers to adopt the landing position. During the descent, the balloon's basket impacted a glass fence on top of a building. Shortly after, the pilot advised the passengers of a malfunction with the deflation system, for them to remain in the landing position, and the intent to land at Elwood Beach. The pilot continued to fly the balloon at low altitude towards Elwood Beach, which required almost continual operation of 1 or 2 of the balloon's 3 burners to maintain altitude, with precise altitude control not possible.

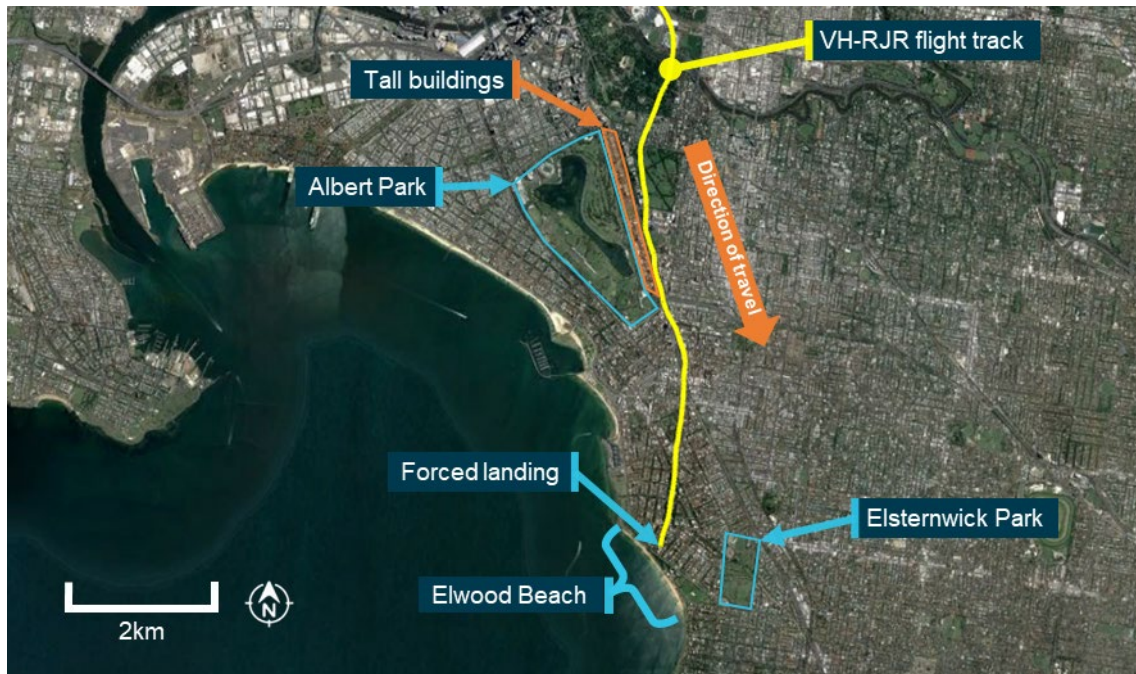
Figure 4: Balloon flight track with potential landing options

- After noticing the deflation system was not sealing correctly, the pilot maintained the balloon's altitude as low as possible because it was safer and provided more potential landing areas. The heat required to ascend would have increased the fuel burn, reducing the balloon's endurance. Moreover, later in the flight, keeping a lower altitude provided the shortest route to Elwood Beach – an area the pilot had previously landed a balloon. However, due to this low altitude with precise altitude control impossible, the pilot could not slow the balloon's descent fast enough to avoid colliding with the two buildings.

- Elsternwick Park was also an option, but based on the prevailing winds would have required an ascent, increasing the fuel used. Therefore, the pilot attempted to land at Elwood Beach.

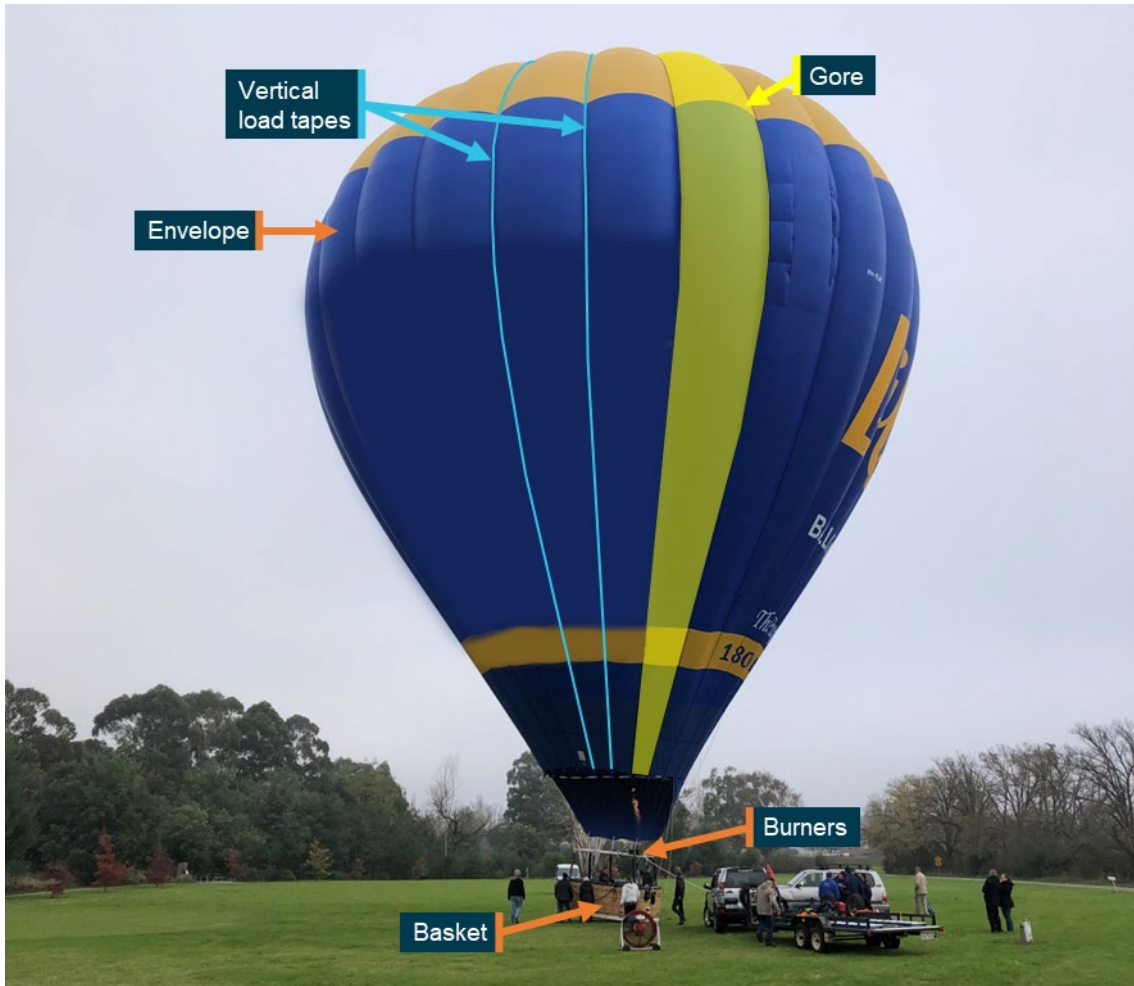
Figure 5: VH-RJR

The BB78Z is a 275,000 cubic feet hot-air balloon produced by Kubicek Balloons, a balloon manufacturer based in Czechia. The incident balloon (VH-RJR) was manufactured in 2021 (Figure 5) and included a T-partitioned basket with 2 passenger compartments fitted with rope handles, and a triple burner system. The envelope has vertical load tapes which transfer the internal envelope forces to carry the basket, and 24 gores (vertical fabric panel sections between vertical load tapes).

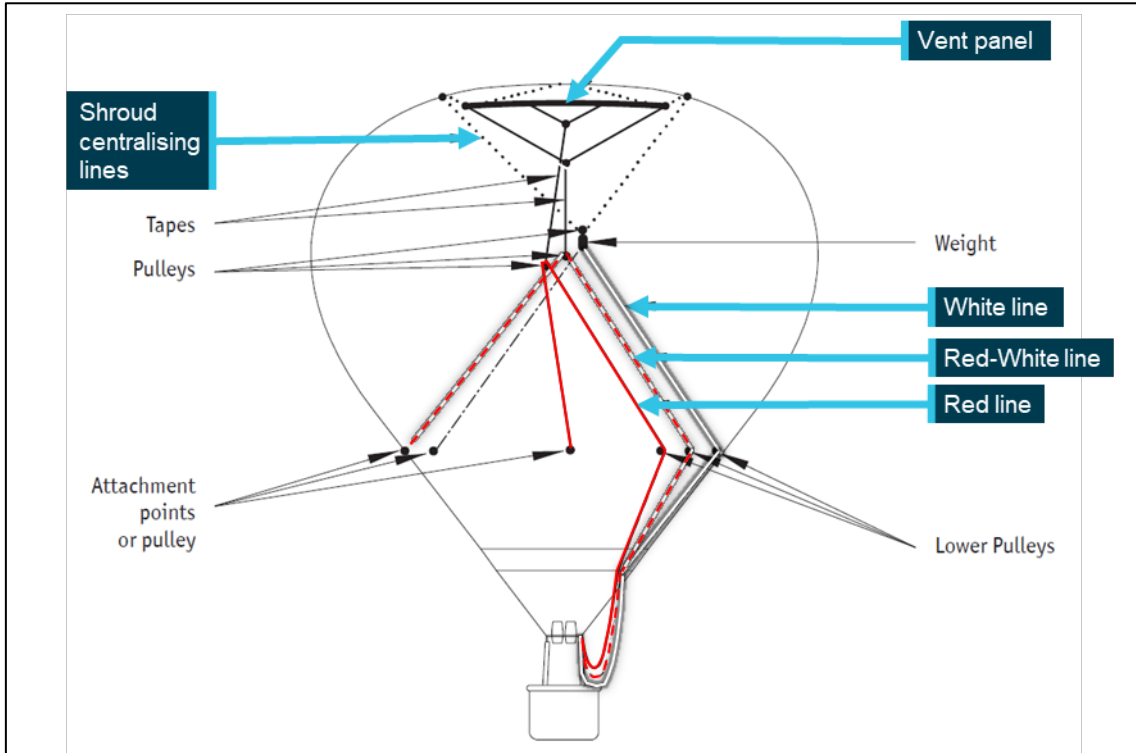
Figure 6: VH-RJR deflation system

The balloon had a modified deflation system with longer spacing between the vertical load tapes at the vent aperture edge compared to the standard deflation system design. This spacing allowed normal envelope pressure to push the vent panel upwards through the vent aperture, allowing air to leak uncontrolled out of the envelope. This deflation system issue was only evident at elevated envelope temperatures, normally reached during flight when the pressure on the vent panel was higher.

The balloon was equipped with a Kubicek 3-line deflation system (Figure 6). In-flight venting was achieved by pulling on the red-white line (parachute vent line) which in turn pulled the vent panel (Figure 7) at the top of the balloon for a controlled release of air through the vent aperture. Releasing the parachute vent line allowed the vent panel to close, being pushed upwards by the pressure of the heated air within the envelope.

The parachute vent line was used to descend the balloon, such as when approaching to land. For final landing, when the balloon was close to the ground, the fast deflation line (red line) was pulled so that the centre of the vent panel was pulled down into the balloon for rapid deflation. A white line was connected to the shroud centralising lines to stretch the vent panel over the vent aperture for proper sealing and to also reset the vent panel after the red line was pulled. A weight was attached to the white line to assist with sealing.
