Flight below minimum altitude occurrences

40 km south of Cairns Airport, Queensland on 24 and 26 October 2022

ATSB Transport Safety Report

AO-2022-051

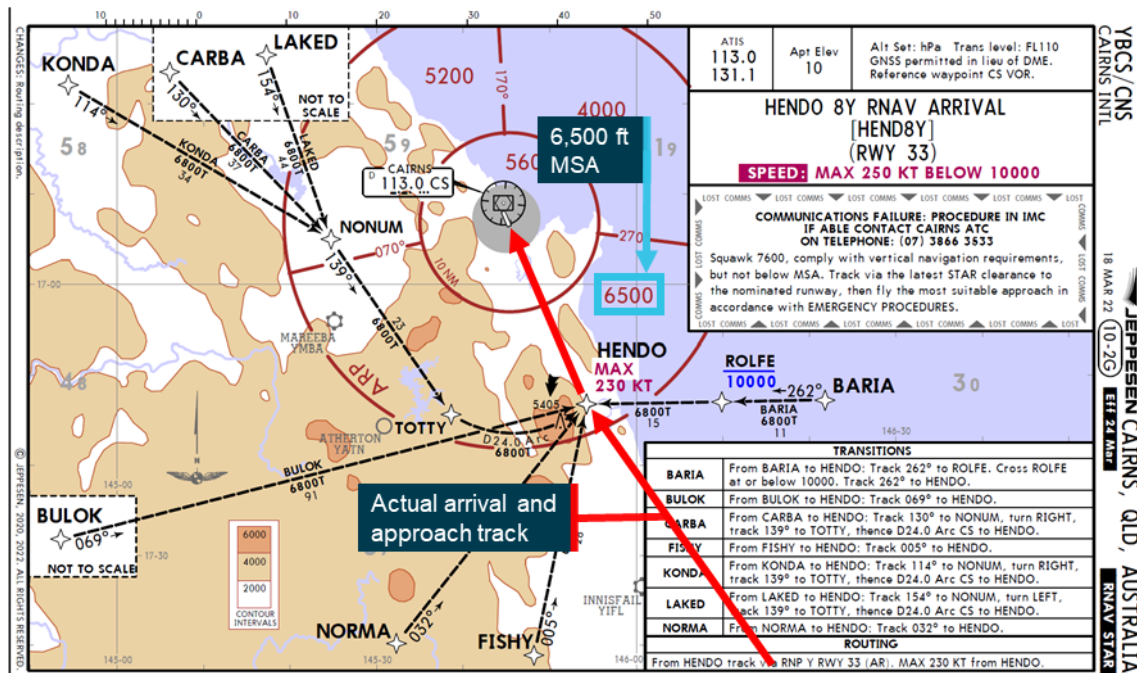
Figure 1: Jeppesen HENDO 8Y standard arrival – VH-VUT

At 1945 local time, the aircraft was cruising in darkness at flight level (FL)³ 380 about 215 NM to the south of Cairns. At that time, air traffic control (ATC) provided the crew with clearance to conduct the Cairns HENDO 8Y standard arrival via the BARIA waypoint⁴ transition (Figure 1).

The flight crew entered the HENDO 8Y arrival into the flight management computer (FMC) and selected the BARIA transition. The HENDO 8Y arrival progressed into the required navigation performance (RNP) Y instrument approach for runway 33 at Cairns Airport. While clearance for the approach had not been provided at that time, the crew anticipated the clearance and loaded the approach into the FMC. The HENDO waypoint was located within the 6,500 ft minimum sector altitude (MSA)⁵ segment to the south of Cairns and from HENDO, the minimum altitude for commencing the RNP Y approach was 6,800 ft above mean sea level (AMSL).

At 2011:38, about 7 NM prior to crossing HENDO, the aircraft descended below 6,800 ft (Figure 3) and 9 seconds later descended below the 6,500 ft MSA. Six seconds later, at 2011:53, ATC observed that the aircraft had descended below 6,800 ft and contacted the crew to confirm the aircraft's altitude. The captain then reselected 6,800 ft and manually arrested the descent. ATC then issued a low altitude alert to the crew and advised them to climb immediately. Three seconds later, at 2012:07, the aircraft stopped descending at about 6,048 ft and then commenced a climb. At 2012:28, the aircraft climbed back above 6,800 ft. No ground proximity warning system alerts were generated during the incident.

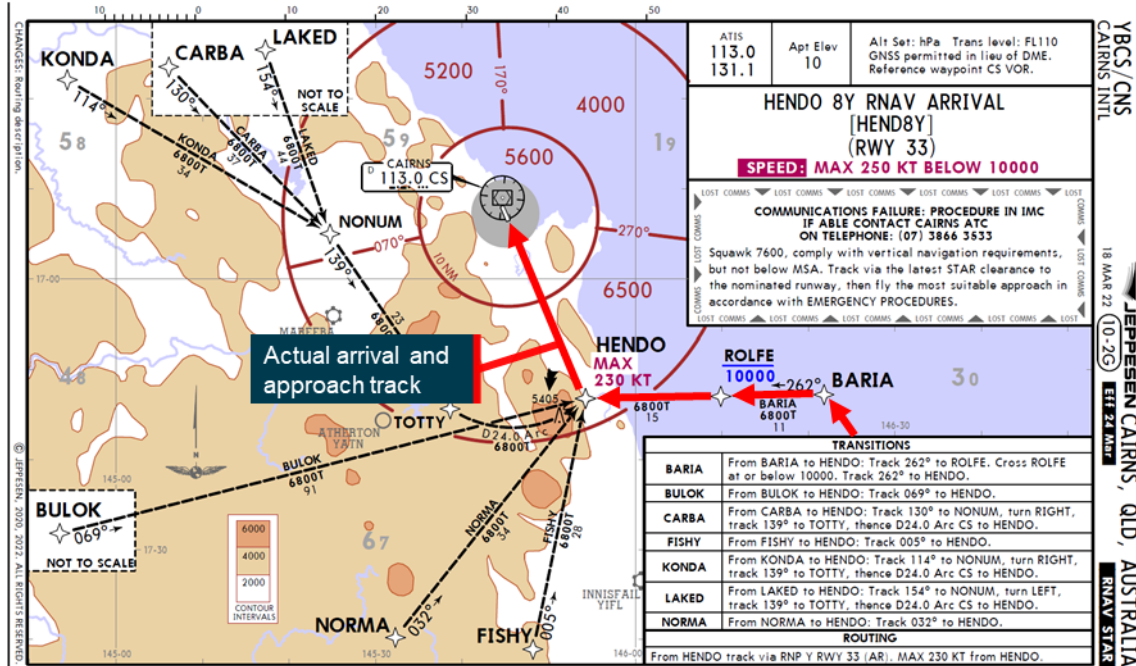
Figure 4: Jeppesen HENDO 8Y standard arrival – VH-VZA

At 0739, in daylight, while the aircraft was in cruise at FL 380 about 225 NM to the south of Cairns, ATC provided the crew with clearance to conduct the Cairns HENDO 8Y arrival via the BARIA waypoint transition (Figure 4).

The flight crew entered the HENDO 8Y arrival into the FMC and selected the BARIA transition. While clearance for the RNP Y runway 33 approach had not been provided at that time, the crew anticipated the clearance and loaded the approach. The crew believed that they had only been cleared for the BARIA arrival transition and had not yet received clearance for the HENDO approach transition, and therefore did not select that transition. As the selection had not been made, the FMC did not load the instrument approach segment from the IAF to the IF and presented a discontinuity between the waypoint HENDO and the IF waypoint CS540 (see the section titled *Flight management computer*).

The aircraft passed HENDO at 0811:56 at an altitude of 6,129 ft (Figure 5). The crew recognised that the aircraft had descended early and selected the altitude hold (ALT HLD) autopilot function to stop further descent. Eleven seconds after the aircraft crossed HENDO, ATC contacted the crew to verify that the aircraft had passed HENDO at the correct altitude. ATC then confirmed with the crew that the flight was operating in visual conditions and provided clearance for a visual approach.

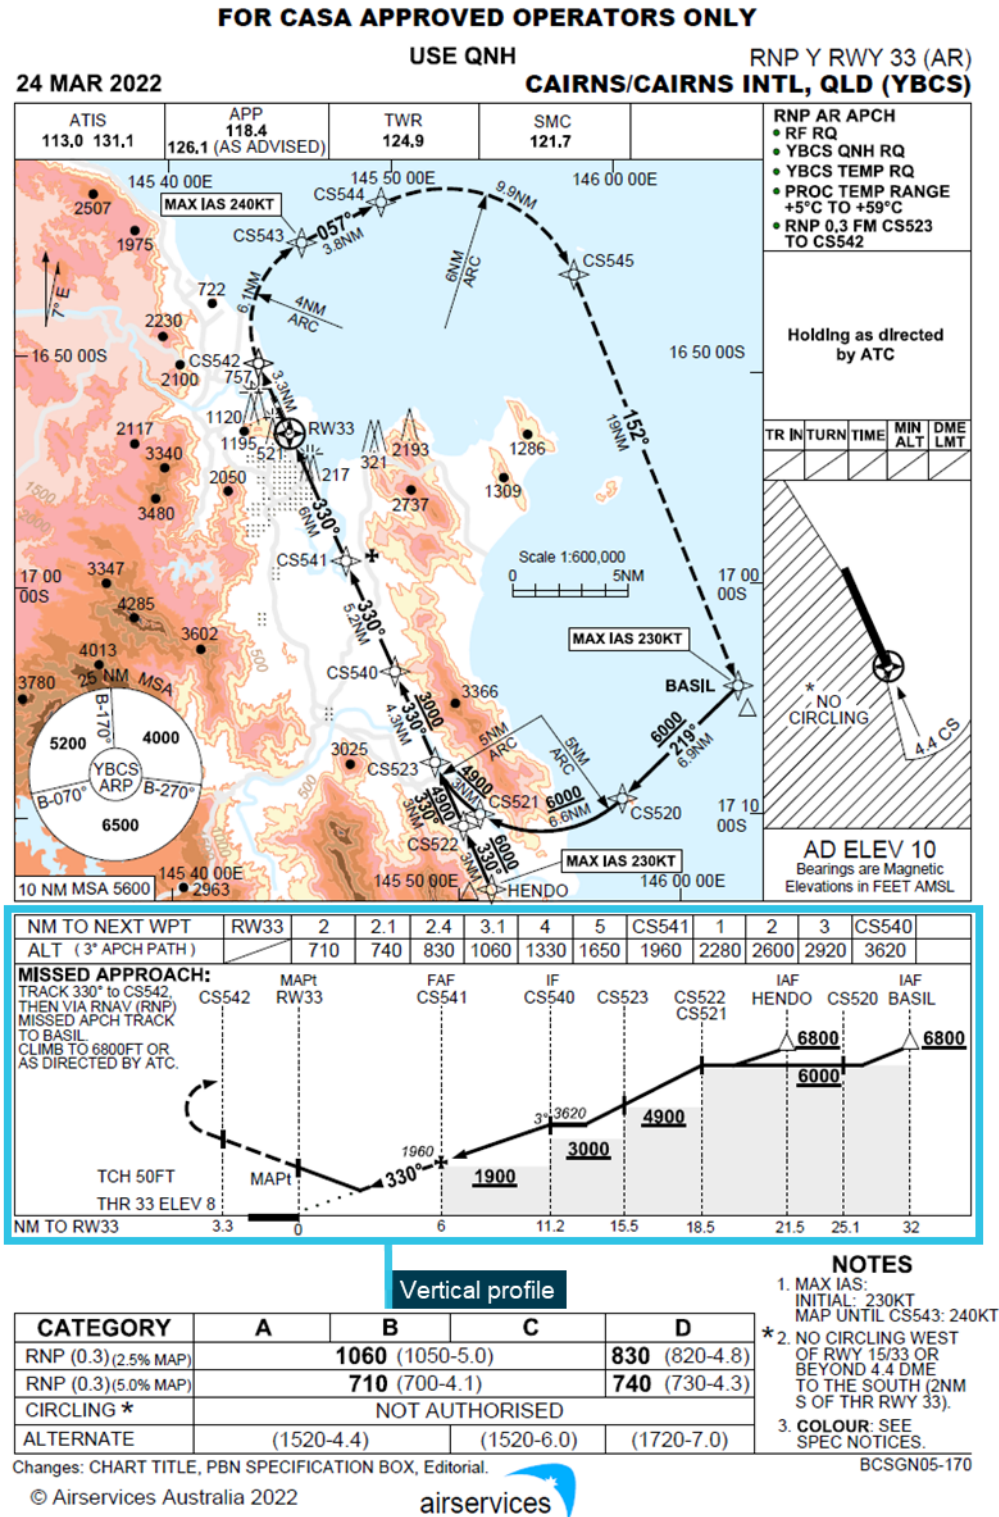
Figure 6: Airservices Cairns RNP Y runway 33 approach chart

The Airservices Australia chart vertical profile presentation included the full approach including the waypoints CS521, CS522 and HENDO (Figure 6).
