# Close proximity involving Boeing 737, VH-VZO and Airbus A330, VH-EBJ

Sydney Airport, New South Wales, on 5 August 2019

**ATSB Transport Safety Report**

AO-2019-041

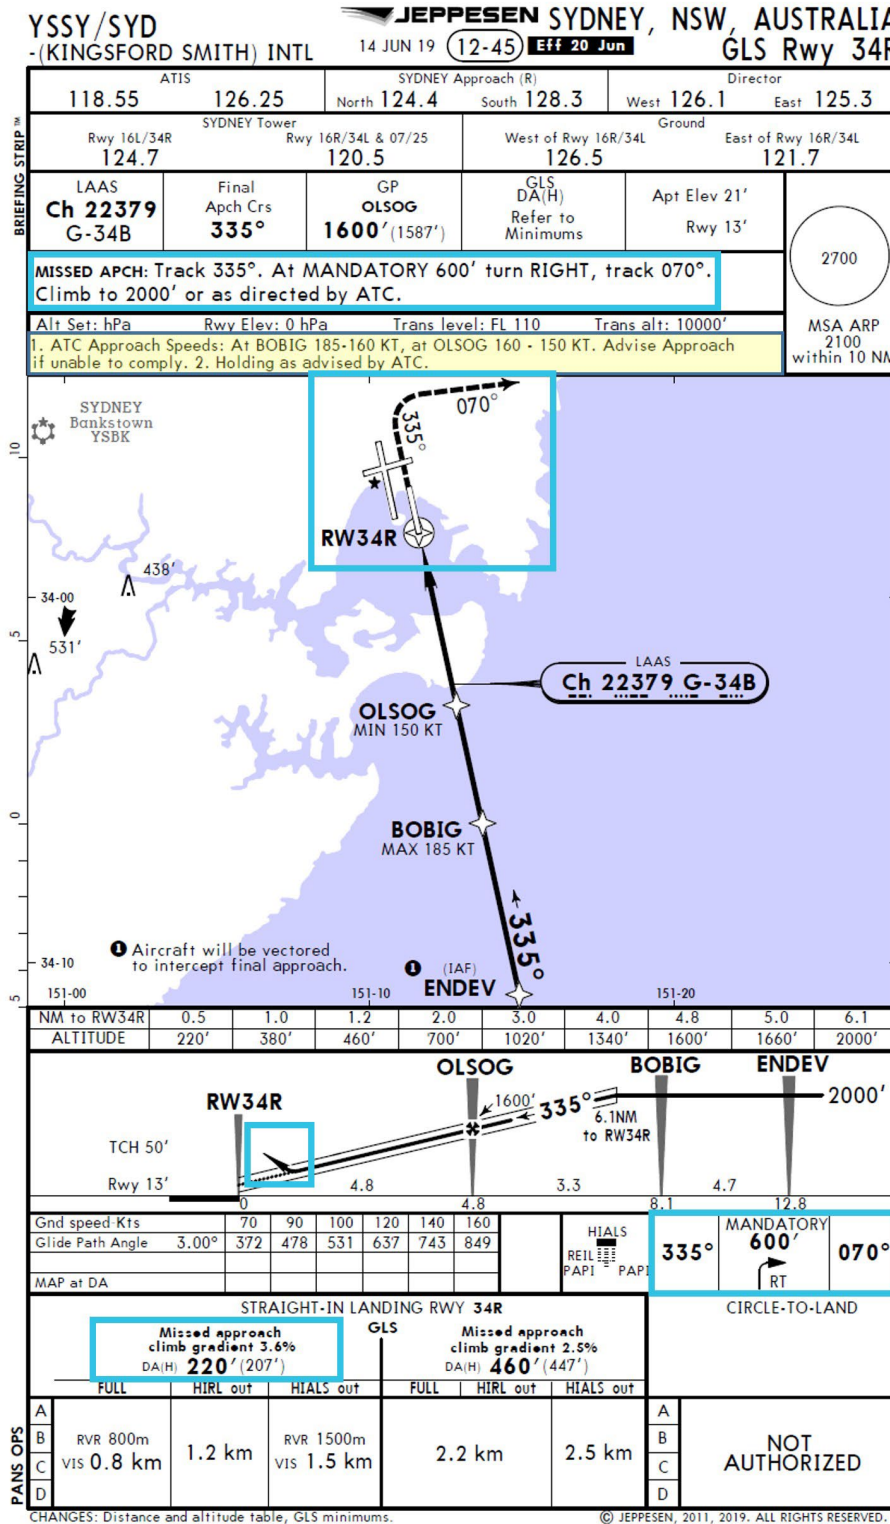
Figure 2: Sydney GLS runway 34R approach chart with missed approach requirements defined by blue boxes and approach speed requirements highlighted in yellow

For a missed approach during this IVA, the crew were required to follow the instructions on the runway 34R approach chart (Figure 2). If a missed approach was initiated at or after the missed approach point, at about 0.5 NM from the runway (corresponding to the approach path intersecting with the decision altitude<sup>7</sup> of 220 ft), flight crews were to maintain the approach track (335°) until a mandatory right turn at 600 ft onto a heading of 070°. <sup>8</sup> The specified level-off altitude was 2,000 ft or as directed by ATC. If the missed approach was initiated before the missed approach point, flight crews were expected to maintain the approach track until reaching the missed approach point, then follow the procedure.

In this case, the missed approach procedure for the GLS runway 34R approach (used by the 737 crew) required flight crew to maintain runway track (335°) and at 600 ft turn right, track 070° and climb to 2,000 ft (Figure 2).

The Jeppesen and Airservices instrument approach charts depicted the missed approach path for runway 34R tracking straight ahead until well north of the departure end of runway 34R before the right turn (Figure 2). Missed approaches initiated before or at the missed approach point will reach the mandatory 600 ft right turn well before the turn depicted on the chart.

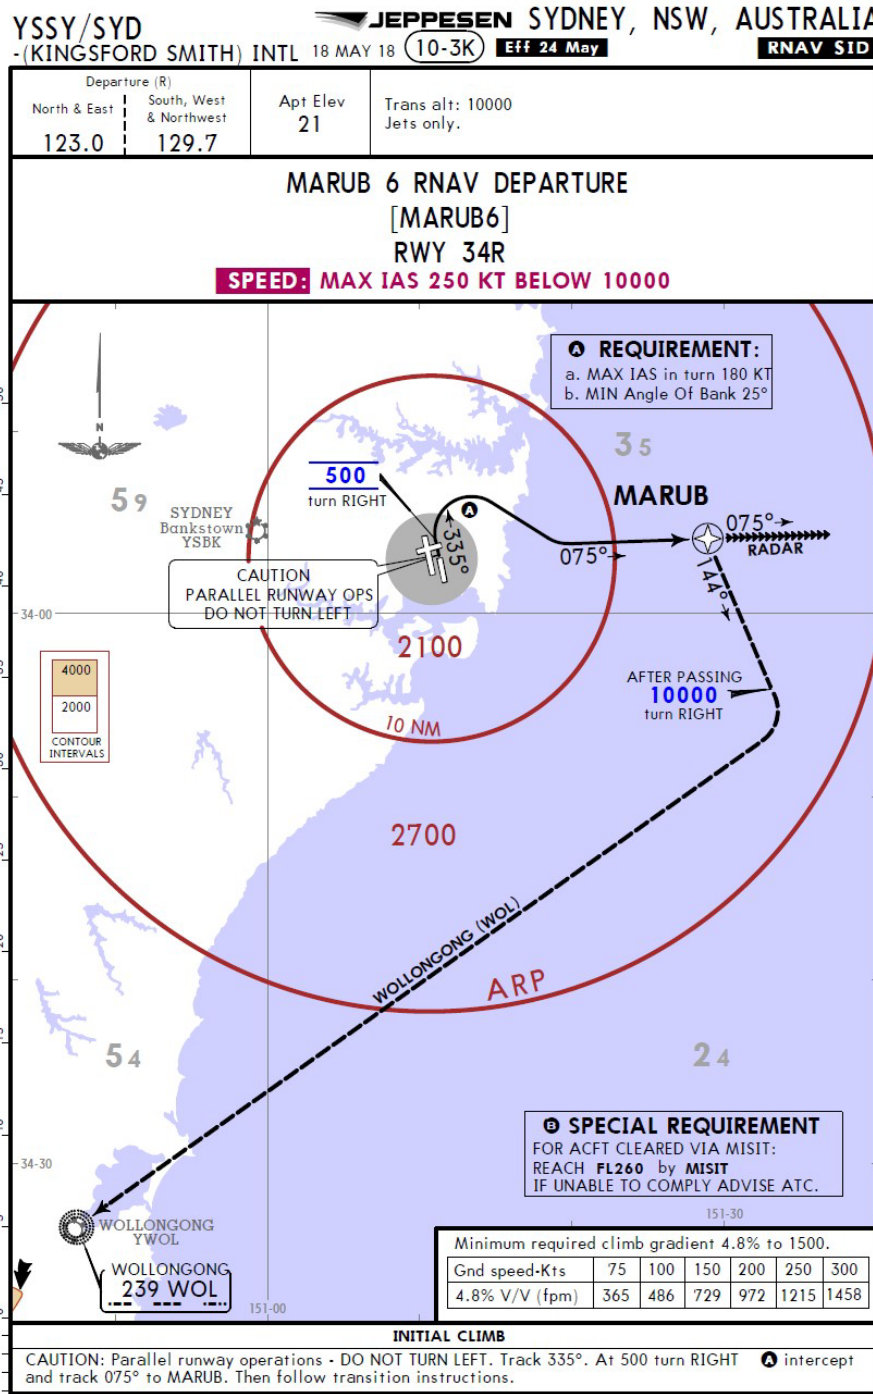
Figure 3: Sydney SID MARUB SIX RNAV departure plate

The A330 crew was cleared to depart via the MARUB SIX RNAV departure (Figure 3). This was a commonly-used standard instrument departure (SID) for jet aircraft taking off from runway 34R and tracking south. On reaching 500 ft, flight crews were required to make a right turn onto a south-easterly heading to intercept an easterly track (075°) from the airport to waypoint MARUB.<sup>10</sup> From there, aircraft were turned right onto a southerly track and a further right turn after passing 10,000 ft.

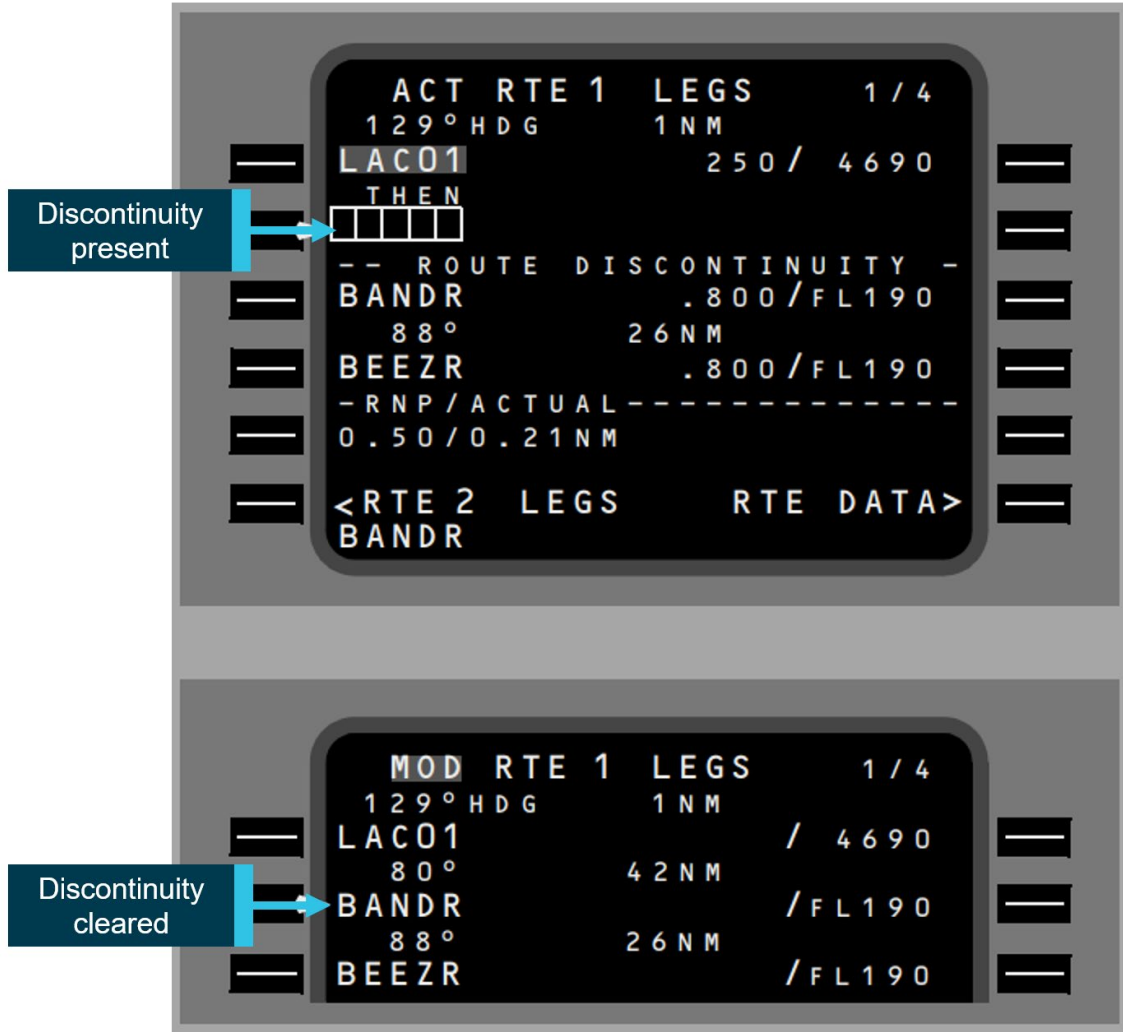
**Figure 12: Example flight management computer route legs page with discontinuity present (top) or cleared (bottom).**

A route discontinuity was displayed on the central display unit (CDU) with an alert message and associated message indications (Figure 12). A flight crew could resolve the discontinuity by entering an adjoining waypoint in the CDU. There was no requirement to do this.

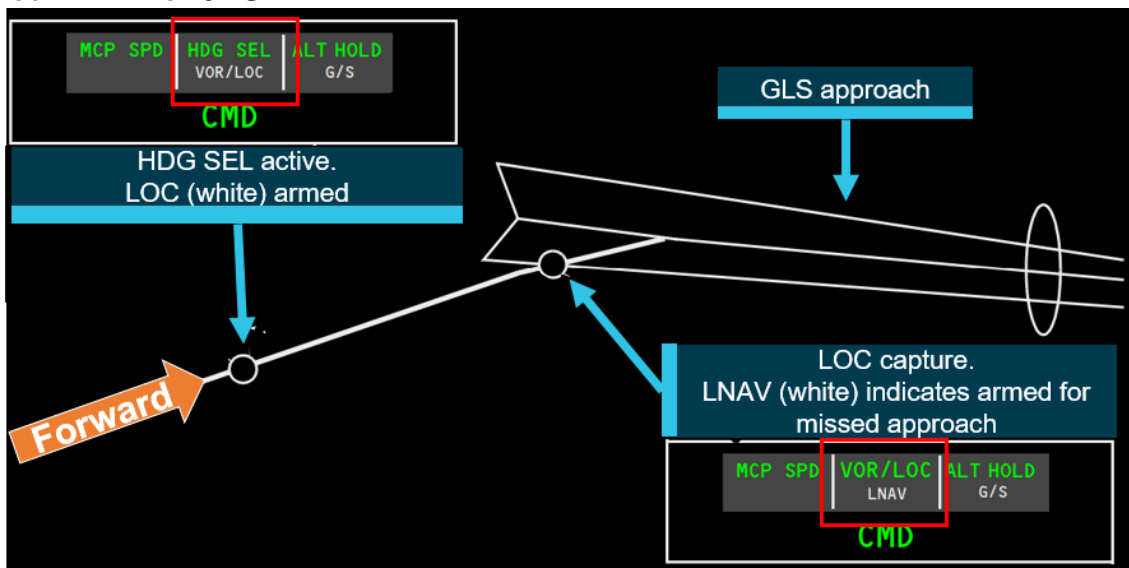
**Figure 13: 737 indications on ground-based augmentation system landing system (GLS) approach displaying when LNAV becomes armed**

When conducting an instrument approach, following localiser (LOC) capture the roll (lateral) mode window will display LNAV in white (armed), providing the engagement criteria in flight is met. This visual display is the only indication to pilots that LNAV guidance will be available during a missed approach (Figure 13).
