# Steering failure and contact with navigational beacon involving *CMA CGM Puccini*

Port of Melbourne, Victoria on 25 May 2023

**ATSB Transport Safety Report**

MO-2023-002

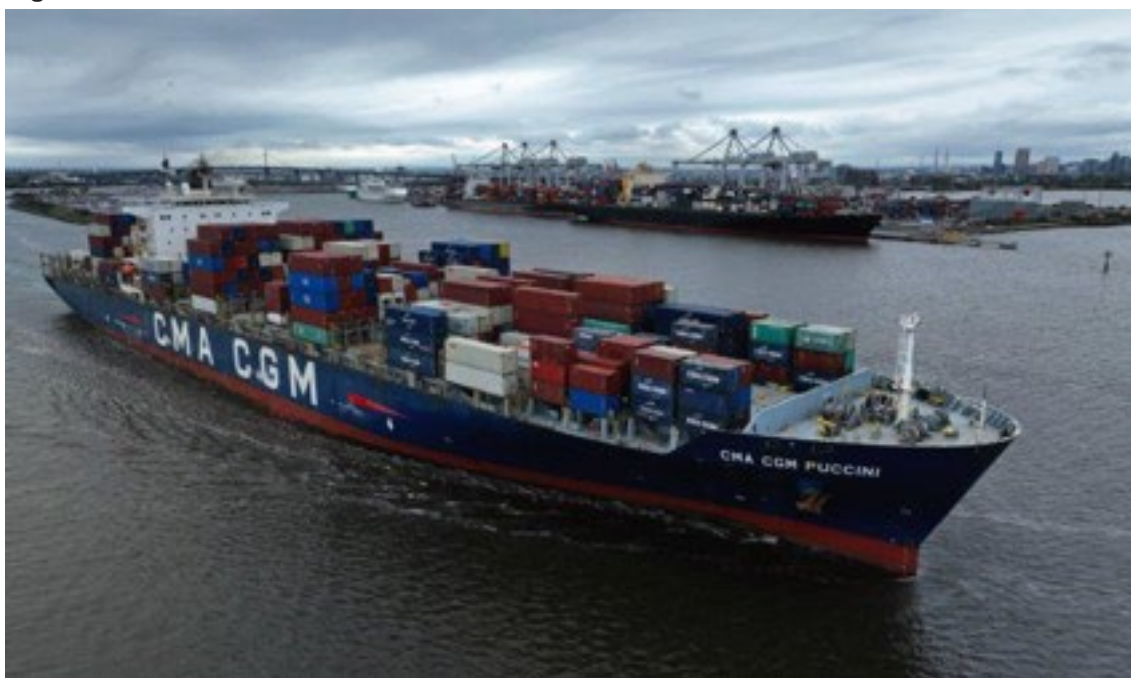
**Figure 1: *CMA CGM Puccini***

At 0900<sup>1</sup> on 23 May 2023, a pilot boarded the 277.3 m, fully cellular container ship *CMA CGM Puccini* (Figure 1) for pilotage into the Port of Melbourne. Pre-pilotage checks included a test of machinery and equipment, including the steering gear. The ship was safely berthed at Swanson Dock at 1330 and cargo operations commenced soon thereafter.

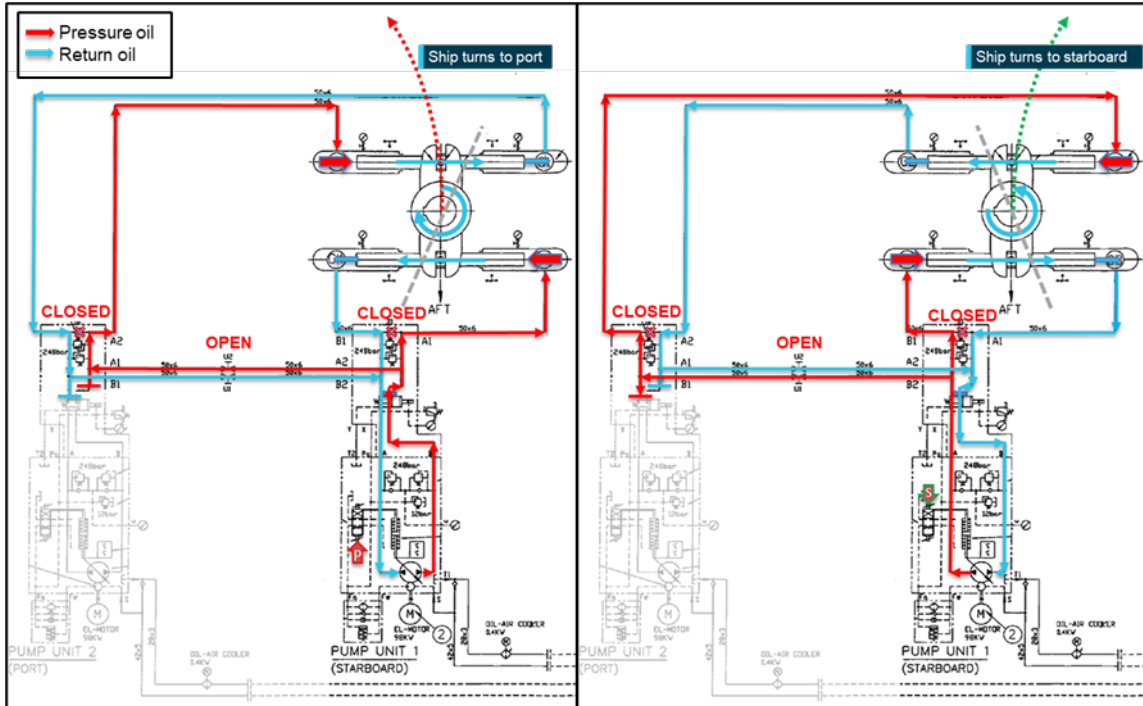
Figure 5: Single pump, 4-cylinder, normal operation of steering, to port and starboard

During normal operation either one, or both, pumps were running, supplying all 4 cylinders. Isolation valves (U1 and U2) were open, pump by-pass valves (B1 and B2) were closed (Figure 5).

Single pump (#1) operation shown; diagram is similar for pump 2. Isolation valves (U1, U2) open, pump by-pass valves (B1, B2) closed. Signal is received into the proportional valve altering the flow rate and direction of oil at the pump. System response will be improved (faster) with second pump operating in parallel.

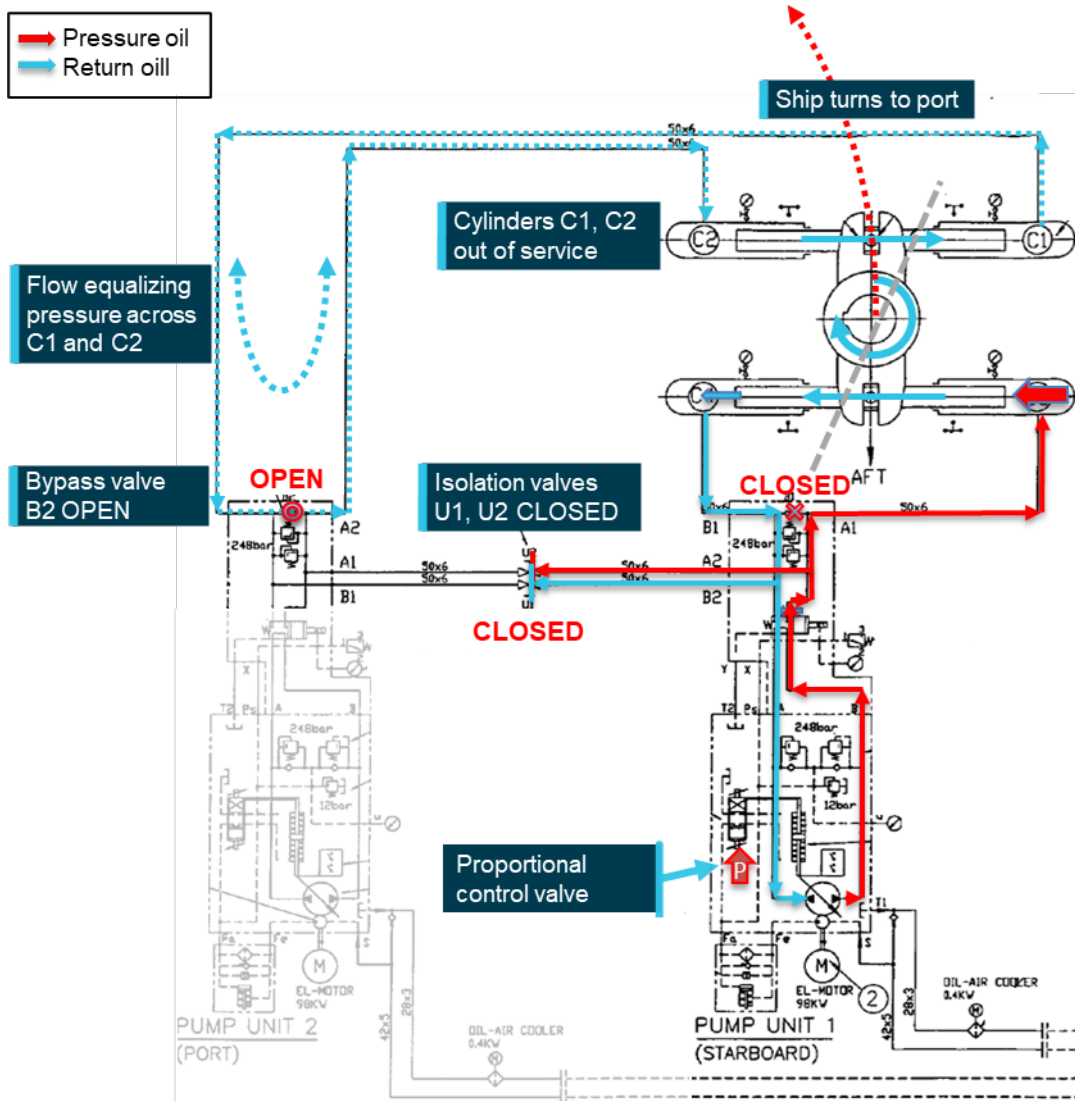
Figure 6: Port rudder using pump 1 with hydraulic system 2 (pump 2, cylinders C1 and C2) isolated

It was possible to separate the 2 hydraulic circuits and operate on one circuit (and pump) alone. In this case, the isolation valves were to be closed and the by-pass valve on the non-running pump was to be opened (Figure 6). This mode of operation was referred to in the shipboard procedures in relation to operation of the steering gear with an oil leak in one of the circuits.

Hydraulic system 2 out of service, isolation valves (U1, U2) closed, pump 2 isolated, pump 2 by-pass valve (B2) open to allow oil flow between cylinders C1 and C2 and prevent hydraulic locking.  
Source: CMA CGM, annotated by ATSB
