Engine failure involving de Havilland Canada DHC-2 Beaver, VH-AAX

Moruya Airport, New South Wales, on 4 April 2022

ATSB Transport Safety Report

AO-2022-025

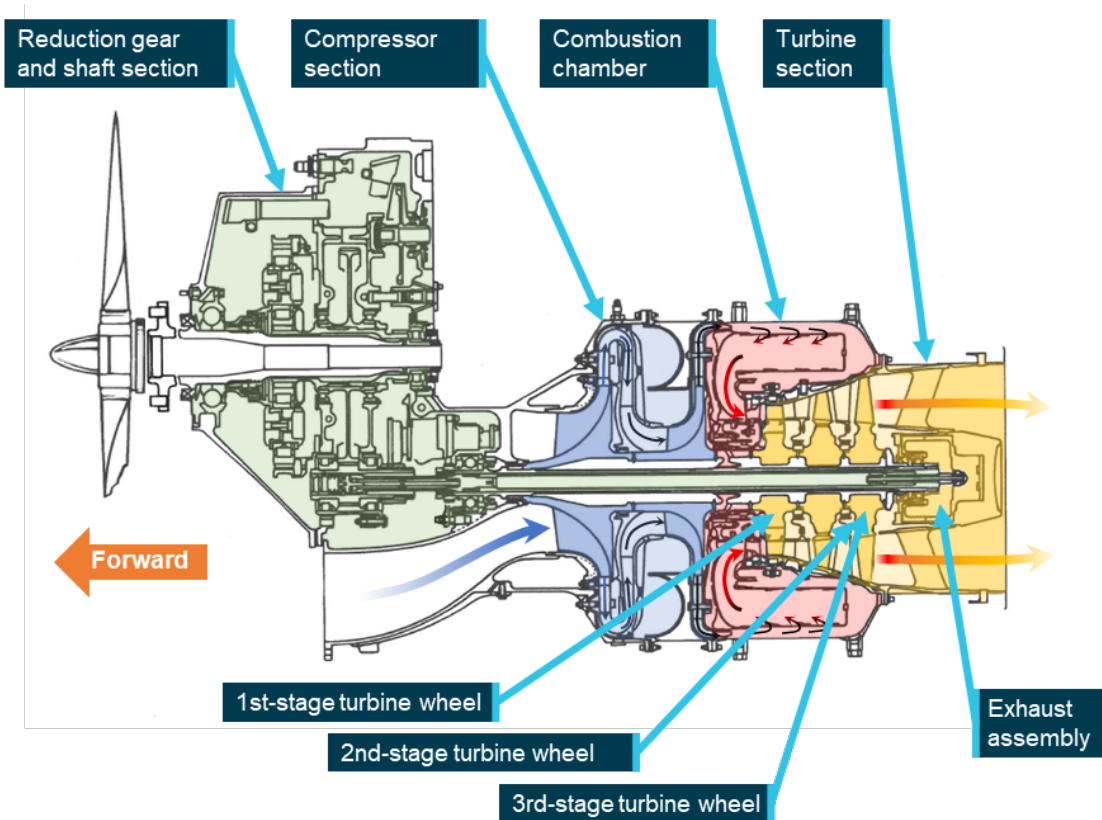
Figure 4: Schematic of Honeywell TPE331-2-201A Engine

The engine fitted to VH-AAX was a Honeywell International Inc (formerly AlliedSignal, Garrett, and AiResearch) model number TPE331-2-201A, turbo-propeller engine (Figure 4), serial number P90018C. It consisted of:

The turbine section contained the 1st, 2nd and 3rd-stage turbine wheels. The exhaust assembly was considered part of the turbine section.

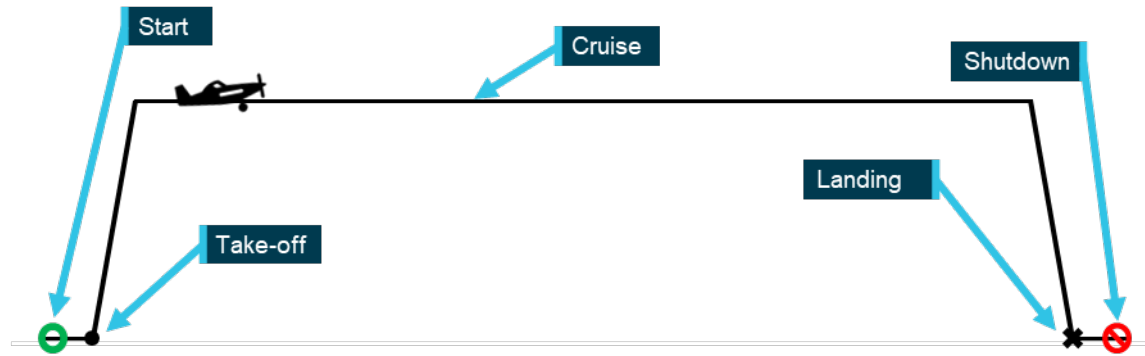
Figure 8: Example of a passenger transport flight corresponding to a single engine cycle

The previously established cycle counting and life limits for life-limited parts used in Honeywell TPE331 turboprop engines were based on a cycle that consisted of an engine start, aircraft take-off, cruise, landing, and engine shutdown (Figure 8). This is typical of a passenger transport flight. Applying this, an engine component such as a turbine wheel, would accrue a single cycle for each engine start/shutdown, irrespective of how many landings occurred.

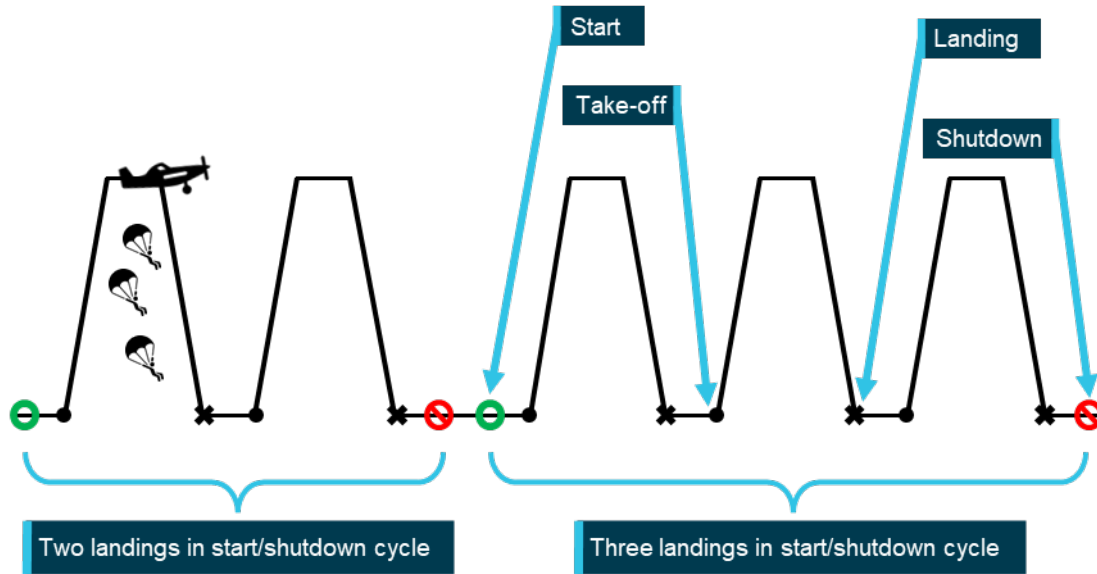
Figure 9: Example of a special-use operation requiring an equivalent cycle calculation

The AD required implementation of a new flight cycle counting method, which involved tracking ‘equivalent cycles’ for turbine wheels in aircraft undertaking special-use operations (Figure 9). An equivalent cycle incorporated a damage fraction factor for each additional landing that occurred with no engine shutdown followed by a take-off. This was in addition to the cycle for one landing associated with the start/shutdown as shown in Figure 8. Total equivalent cycles were the sum of equivalent cycles for all operational flights.
