# Misaligned take-off involving Piper PA-31, VH-XMM

Essendon Fields Airport, Victoria on 21 July 2023

## **ATSB Transport Safety Report**

AO-2023-035

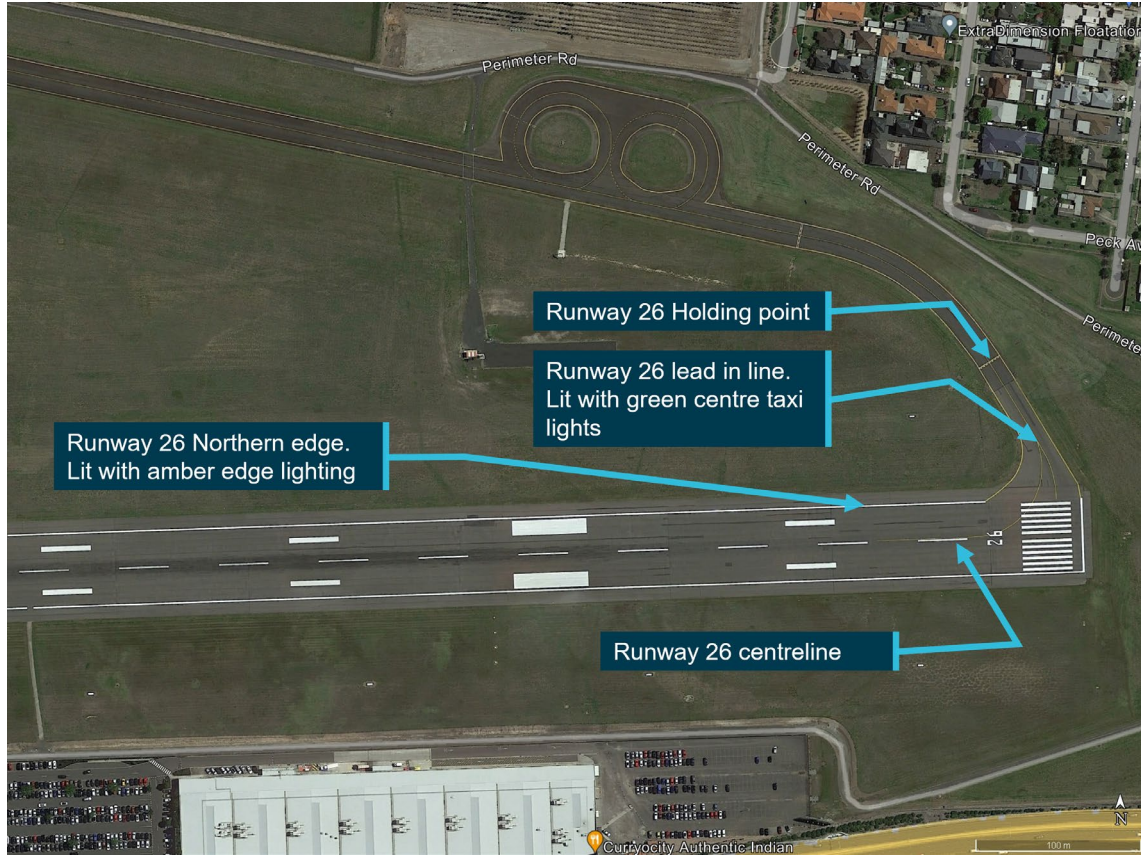
Figure 4: Runway 26 lights and markings

The airport is equipped with green taxiway centreline lighting and runway 26 has a lit lead in taxi line with painted yellow markings. The runway edge lighting provided for runway 26 includes medium and high intensity lighting at 58 metre intervals along the runway edge (Figure 4).

The aerodrome inspection carried out on the evening prior to the incident, did not note any defects or damage to the airport lighting system.
