Engine room fire on board *MPV Everest*

Southern Ocean on 5 April 2021

ATSB Transport Safety Report

MO-2021-003

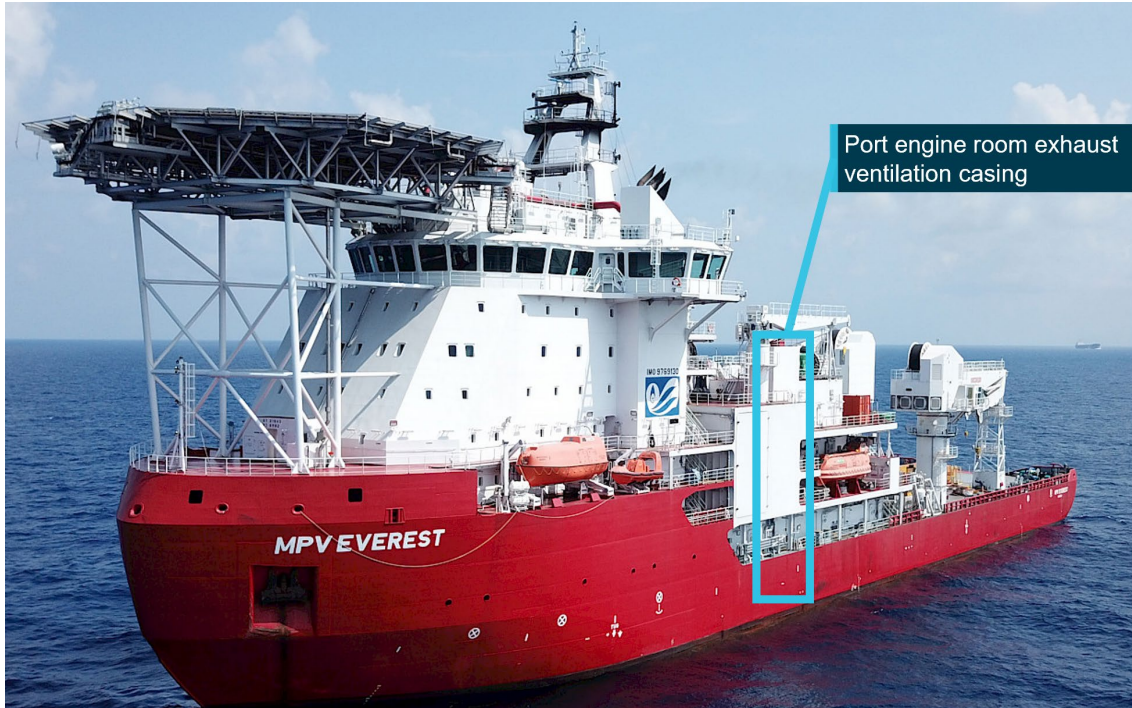
Figure 3: MPV Everest – Port engine room exhaust ventilation casing

Meanwhile, the ship's master and doctor were in the master's office, located one deck below the navigation bridge (bridge), which overlooked the main and upper accommodation decks aft. At about 1058, they saw large flames erupting from the open louvres in the port engine room's exhaust ventilation casing located one deck above the upper accommodation deck, aft of the accommodation superstructure (Figure 3). At about the same time, AAD staff conducting seabird observations on the bridge also sighted flames aft of the bridge.

Note the location of the port engine room exhaust ventilation casing above deck.
 Source: Maritime Construction Services, annotated by the ATSB

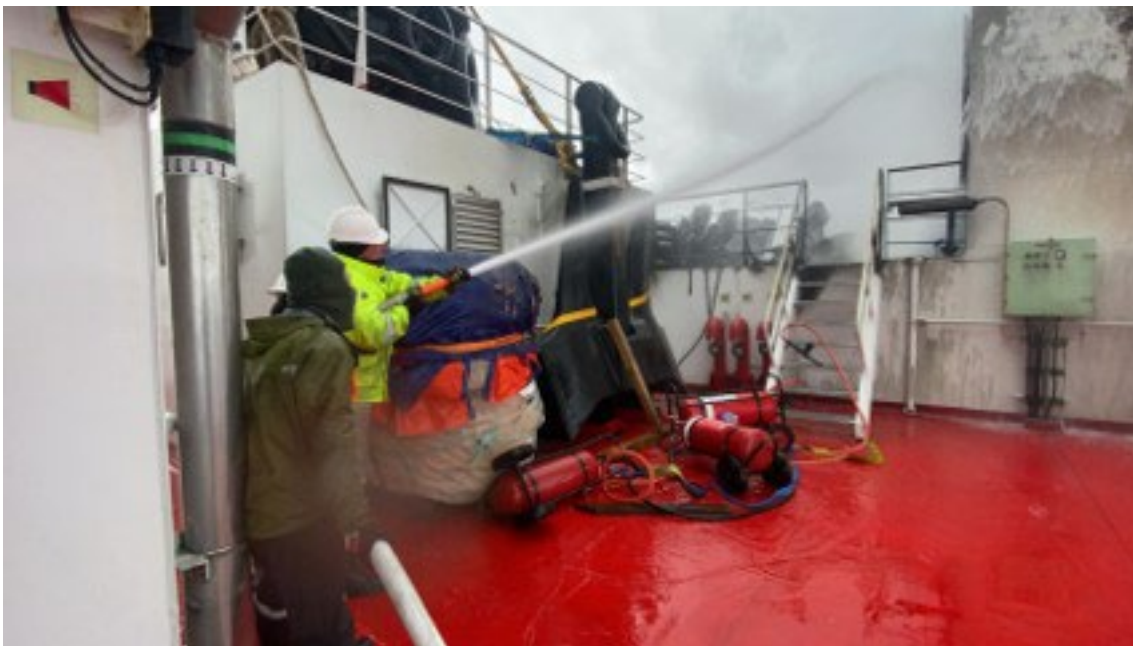
Figure 5: Boundary cooling and firefighting operations on deck

At about the same time, the chief engineer, who was concerned that water was not making it through to the water mist system's nozzles in the port engine room, asked the second engineer to check the system's pumps. The second engineer went to the water treatment room where the water mist system's pumps were located and found that while the pumps were running, the solenoid valves leading to the relevant zones in the port engine room remained shut. The second engineer manually opened the valves to the water mist nozzles for the port engine room and confirmed from the pressure gauges on the lines that water was now flowing through. On the bridge, the master made a PA announcement advising all crew that the fire was being fought with 'a water sprinkler system' and that boundary cooling was underway (Figure 5).

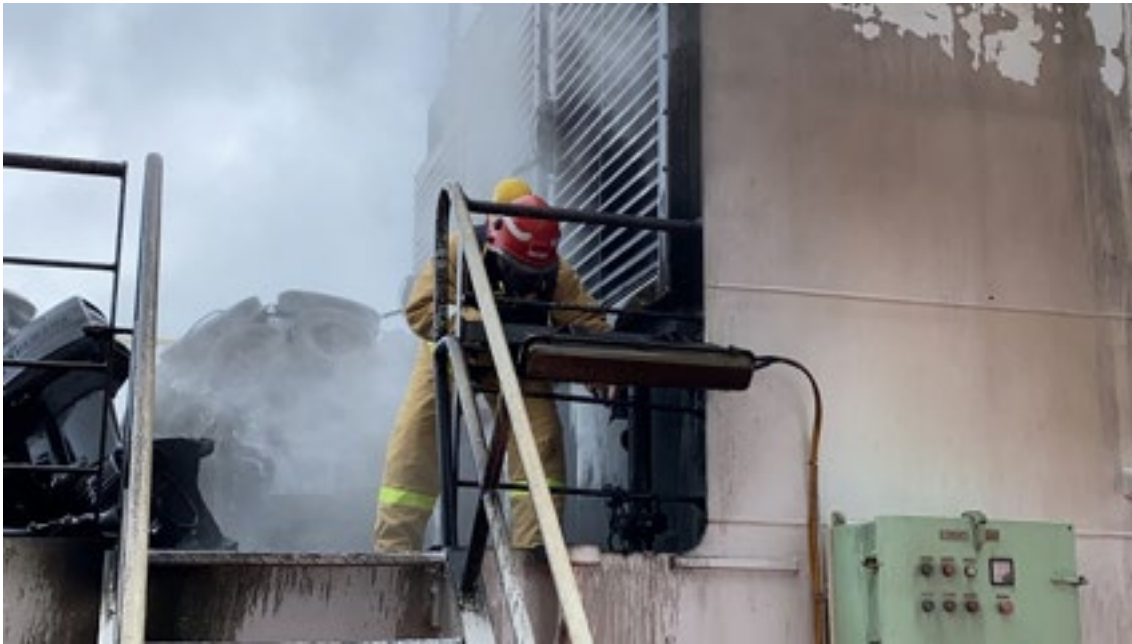
Figure 6: AAD volunteer firefighter checking ventilation louvres

At about 1227, the AAD watercraft operator volunteered to check the ventilation casing louvres were shut. The AAD volunteer firefighter donned a fireman outfit and SCBA set and found that the louvres remained partly open but could not be shut further as the louvres and their closing mechanism were distorted due to heat from the fire (Figure 6). The AAD firefighter also suggested using an AAD thermal camera to monitor the engine room externally and check for hot spots. The master agreed and notified the second engineer that the water mist system and boundary cooling was to be maintained for a further 20 minutes until the reducing temperatures stabilised.

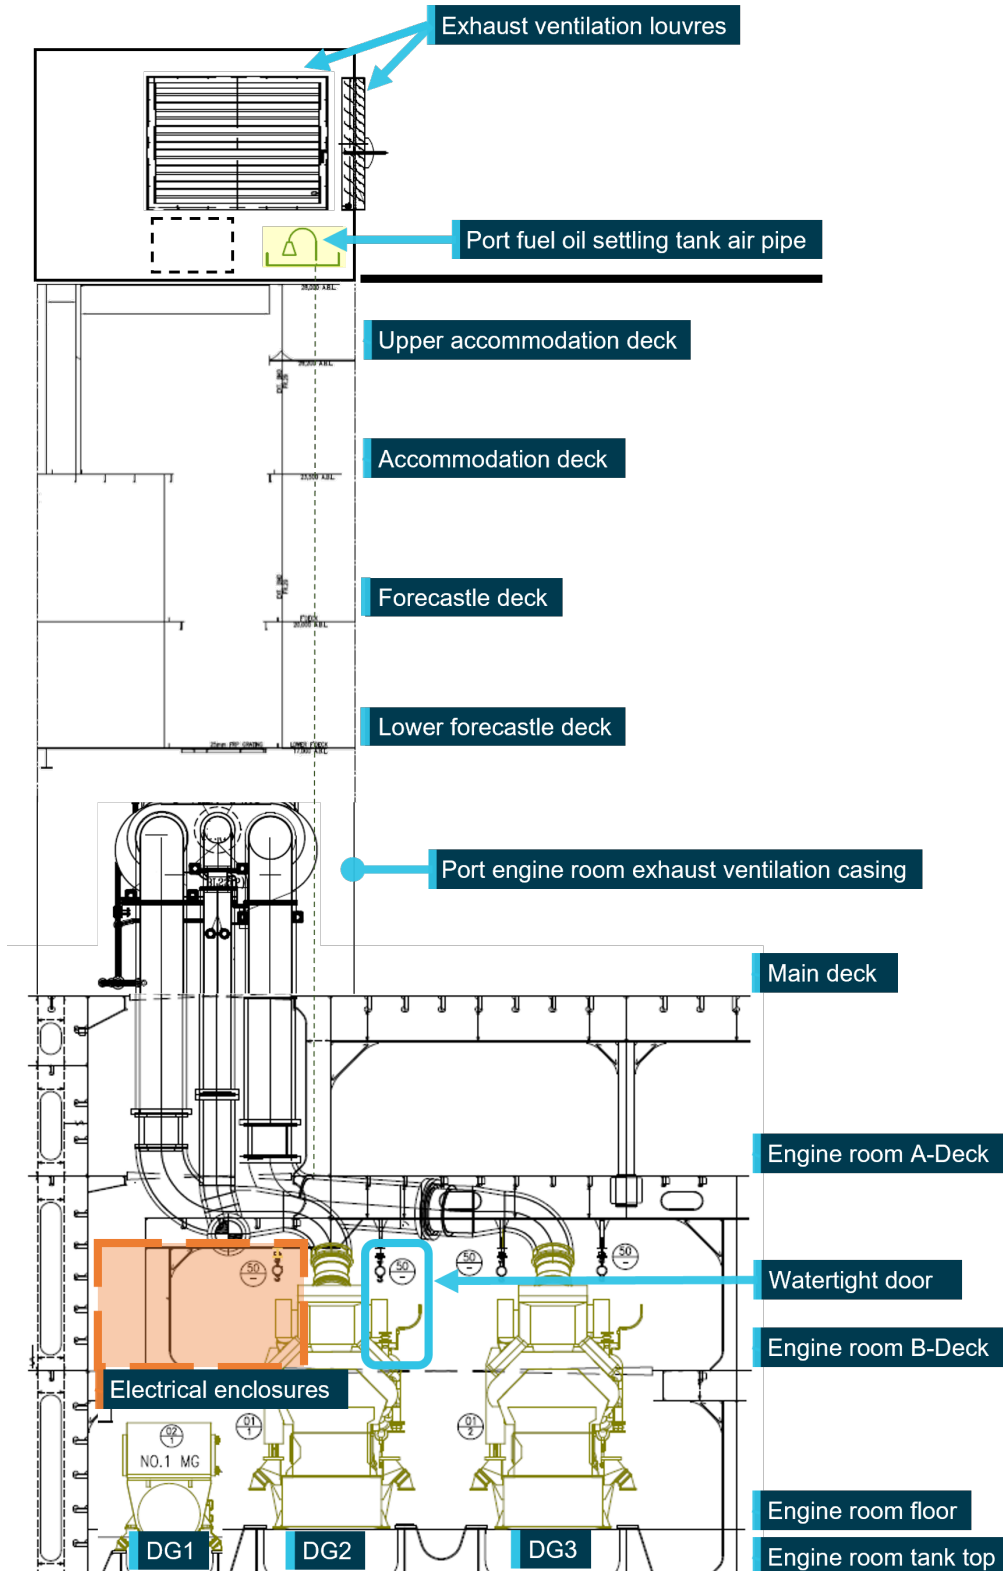
Figure 13: Port engine room and exhaust ventilation casing (looking forward)

At the port forward corner of B-Deck, almost directly above the MCC and PDB, was the opening of the port engine room’s exhaust ventilation casing. The casing extended vertically upwards from the deckhead to a deck just above the upper accommodation deck level (Figure 13). The

The port engine room was equipped with 2 supply fans which created a positive pressure in the space. The resulting airflow created a strong updraft through the exhaust ventilation casing which exited through the ventilation louvres of the casing above the upper accommodation deck. The exhaust trunkings of all 3 generators led forward to the port corner of B-Deck where they turned upwards and entered the exhaust ventilation casing. The trunkings continued up to just above the main deck level where they turned and exited the ventilation casing through its forward bulkhead to continue to the ship's funnels.

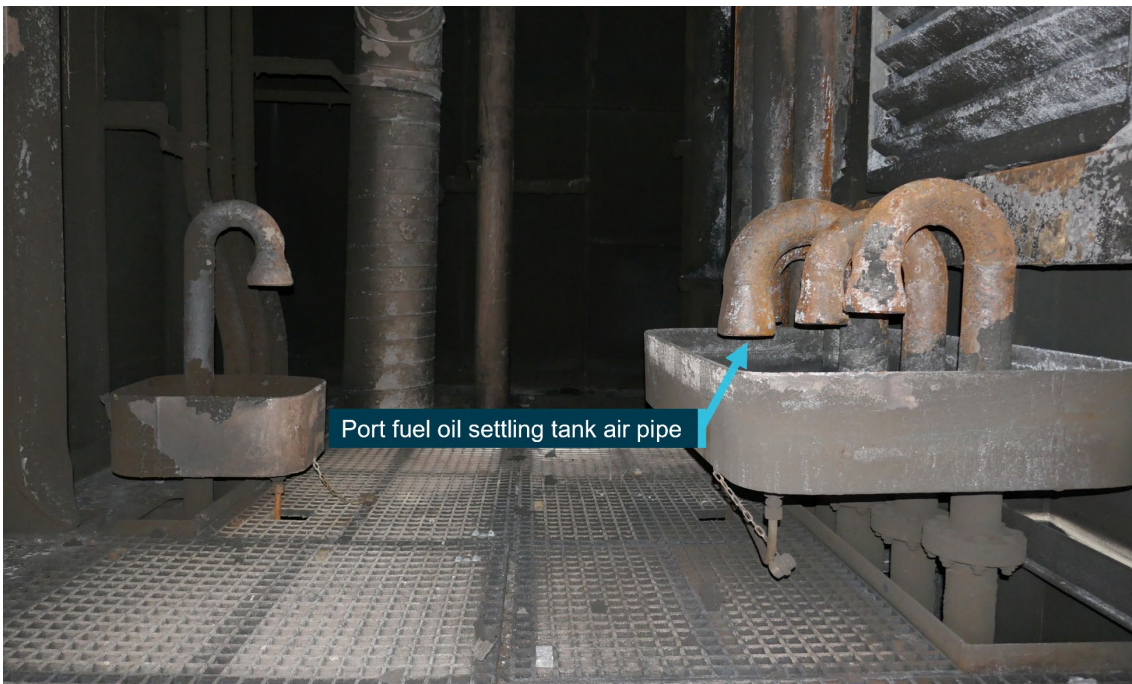
Figure 14: Arrangement of air pipes within port exhaust ventilation casing

The gooseneck ends of the settling tank, day tank and purifier vents were sited within a save-all with a capacity of about 150 L. The save-all had a small drainpipe that drained any accumulated fluid to the sludge tank. The boiler day tank vent was sited separately within a smaller save-all (Figure 14).

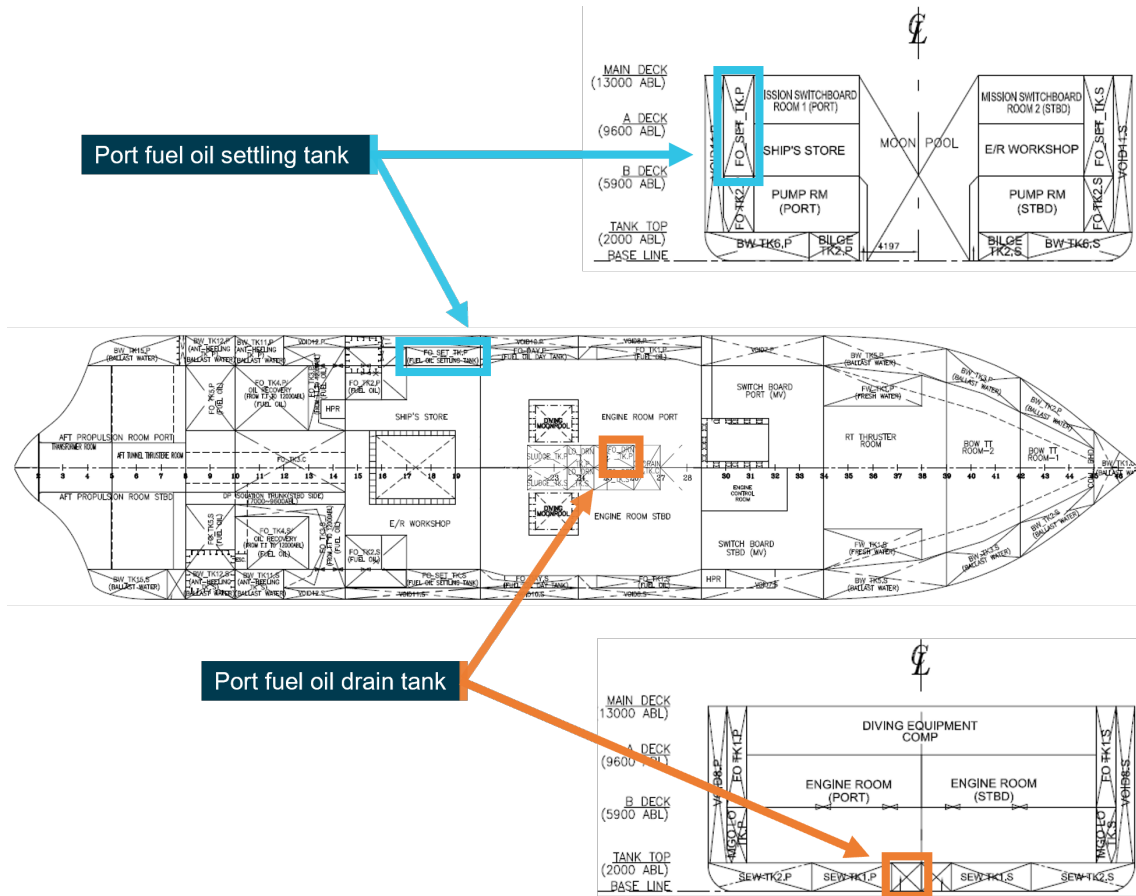
Figure 15: Relative locations of port settling tank and port drain tank

The port fuel oil settling tank (port settling tank) had a capacity of 122.7 m³ and was located in the port engine room extending from the main deck down to B-Deck and sited inboard of a void space on the port side (Figure 15).

The tank was fitted with level sensors and transmitters with high and low level alarms. The low level alarm sensor was set to activate when fuel levels in the tank reached 30% of tank volume and the high level alarm sensor level was set at 85% of tank volume. As a safety measure, when fuel levels in the tank reached 90% of tank volume, an outlet drained fuel via a non-return valve to the port fuel oil drain tank (Figure 16). The overflow line was also fitted with a sight-flow glass (located in the engine room store) on a vertical section of the port settling tank's overflow line. There was no flow alarm fitted to the overflow line, nor was one required.

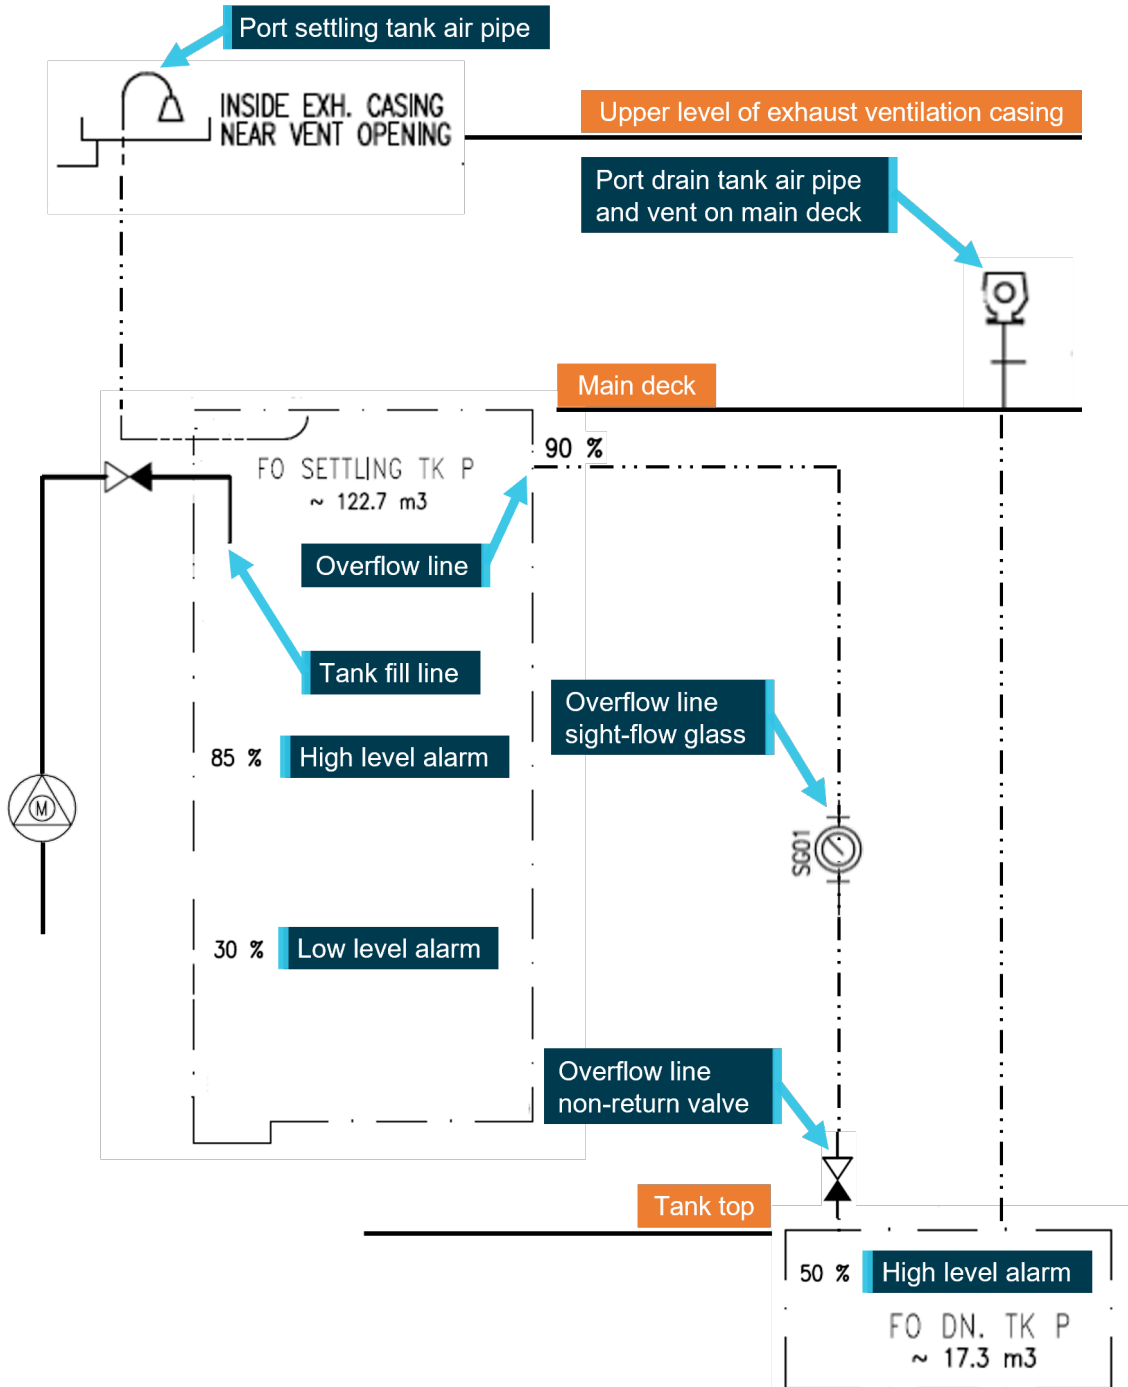
Figure 16: Port settling tank and drain tank schematic

overflowed through the goose neck vent into the port engine room's exhaust ventilation casing (see Figure 16 and Figure 17).

On board *MPV Everest*, the means to prevent overpressure in the port settling tank was the overflow pipe leading to the port drain tank which was fitted with a non-return valve (Figure 16). The port drain tank in turn was fitted with an air pipe which led to the open main deck. The design of the overflow system also complied with other classification society rules relating to the capacity of the drain tank, tank level alarms and installation of a sight-flow glass in the overflow line.

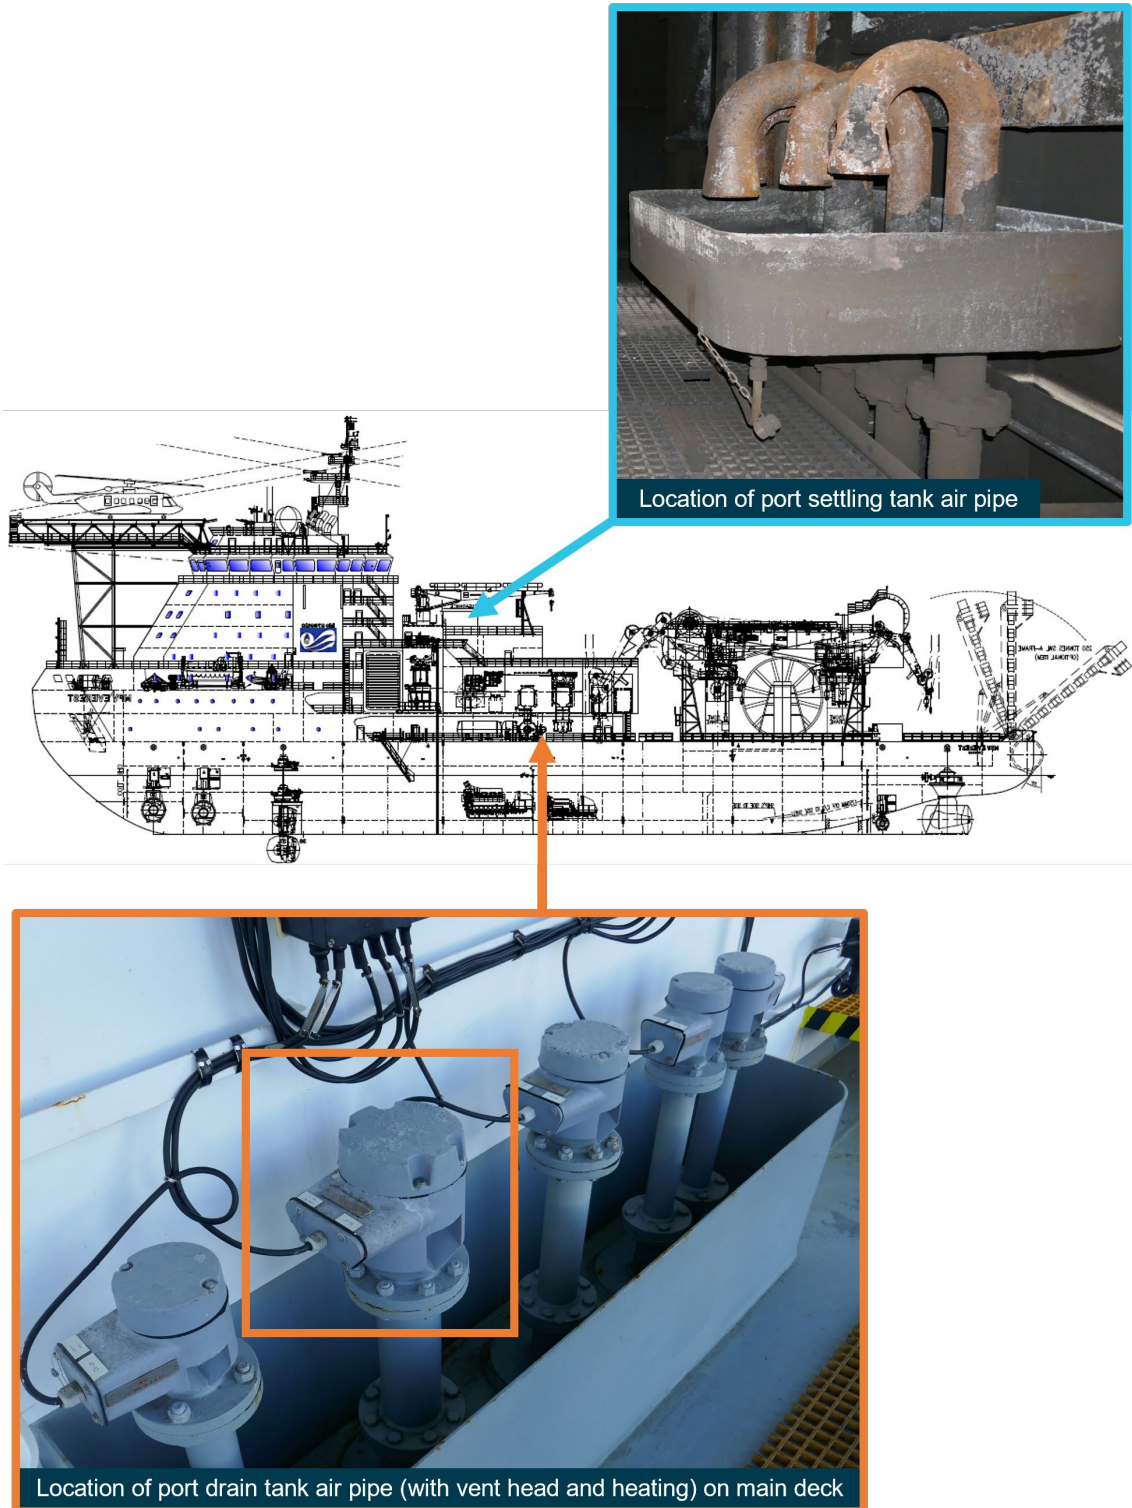
Figure 17: Relative positions of port settling tank and port drain tank air pipes

An air pipe for the port settling tank ran upwards through the port engine room exhaust ventilation casing and terminated in a goose neck vent within a save-all inside the casing just above the upper accommodation deck level (see Figure 13 and Figure 17).

The port drain tank air pipe terminated in a vent head located externally on the main deck near the port accommodation ladder (Figure 17). The drain tank and its vent head were both respectively at a lower level than the settling tank and the settling tank's air pipe in the ventilation casing. The vent head was fitted with an automatic closing device (float), a flame screen and an electric heating element. The vent head heating could be controlled automatically (by a thermostat located on the main deck aft) or operated manually from control cabinets. The vent head heater was most probably to have been in automatic mode at the time of the fuel transfer.

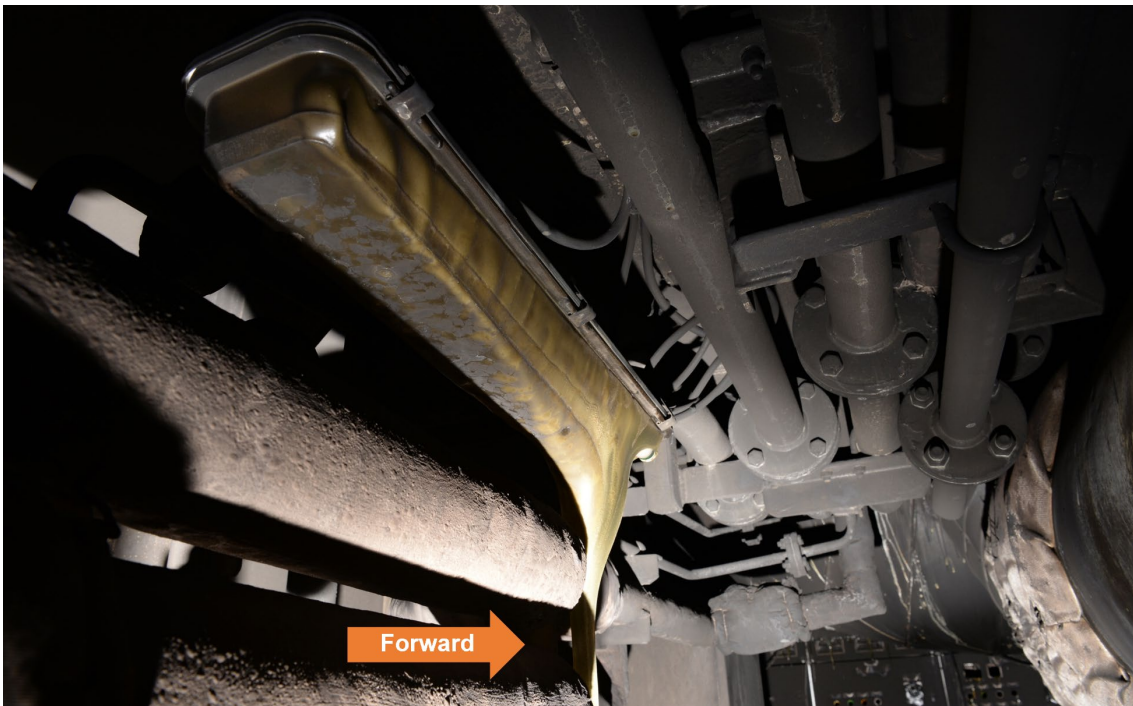
Figure 18: Light fitting on B-Deck

B-Deck generally showed increasing thermal damage and soot density from aft to forward, increasing with height. Colour changes to light fittings on the centreline bulkhead (on the starboard side of the port engine room) indicated temperatures had reached at least 145° C with no evidence of thermal damage to electrical cabling and pipework in this area. In the middle of the engine room, melted light fittings indicated temperatures of up to 300° C with cabling showing signs of sooting but only minimal thermal damage. On the port side, the forward end of a light fitting was melted while the aft end was intact but deformed indicating increased temperatures forward (Figure 18). Similarly, paint on handrails on centreline of the engine room was heavily sooted but intact whereas paint on the handrails on the port side had either decomposed or blistered with the extent of the damage increasing moving forward.

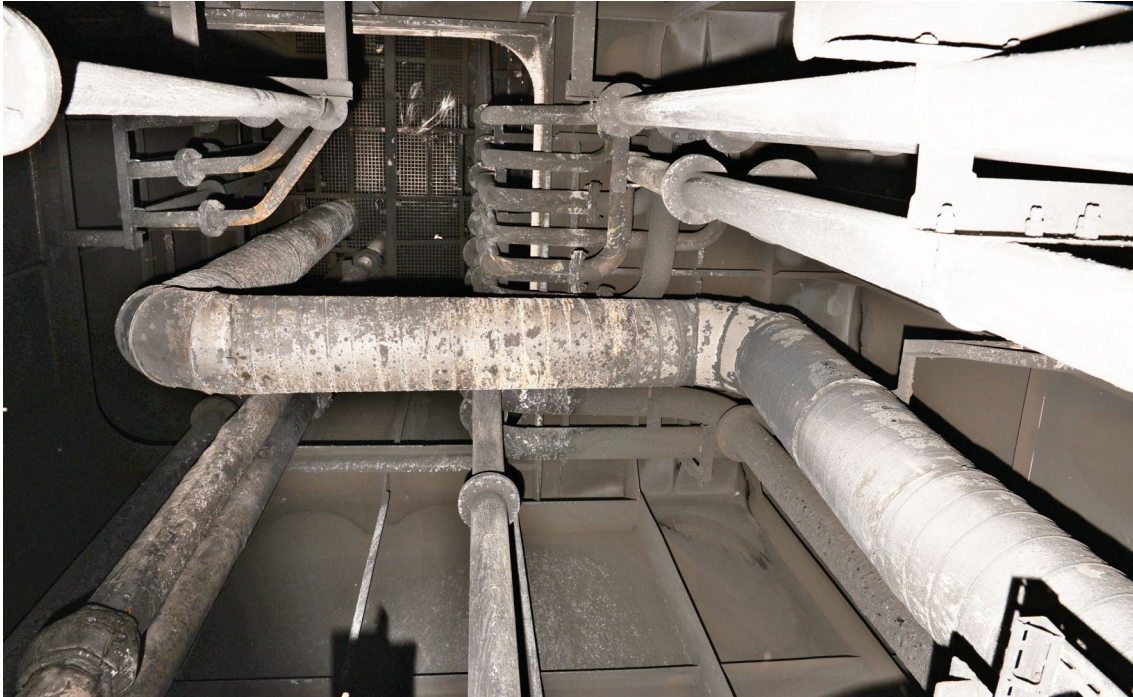
Figure 23: Forecastle deck, accommodation deck and upper accommodation deck

The section of the ventilation casing comprising the forecastle, accommodation and upper accommodation decks had no FRP grating, although the space was partially delineated by a steel deck at the accommodation deck level (Figure 23). Several of the pipes transiting these levels bent at the accommodation deck level before continuing vertically upwards. Pipework at the forward end of the space showed even fire damage along their length with damage greater on the side facing the centre of the casing. Horizontal sections of pipe showed heavy oxidisation with minimal sooting, indicating this area was subject to direct flame and hot gases. The oxidisation was also heavier on the upper surfaces of these pipes with visible oxidised liquid trails to lower surfaces, indicative of combusting liquid fuel falling from above. Evidence of clean burn areas at the accommodation deck level and increased levels of sooting indicated areas affected by direct flame and hot gases.

Photograph taken looking upwards from the lower forecastle deck. The visible grating at the top of the uppermost level of the exhaust ventilation casing where the port fuel oil settling tank air pipe and save-all was located.
Source: ATSB

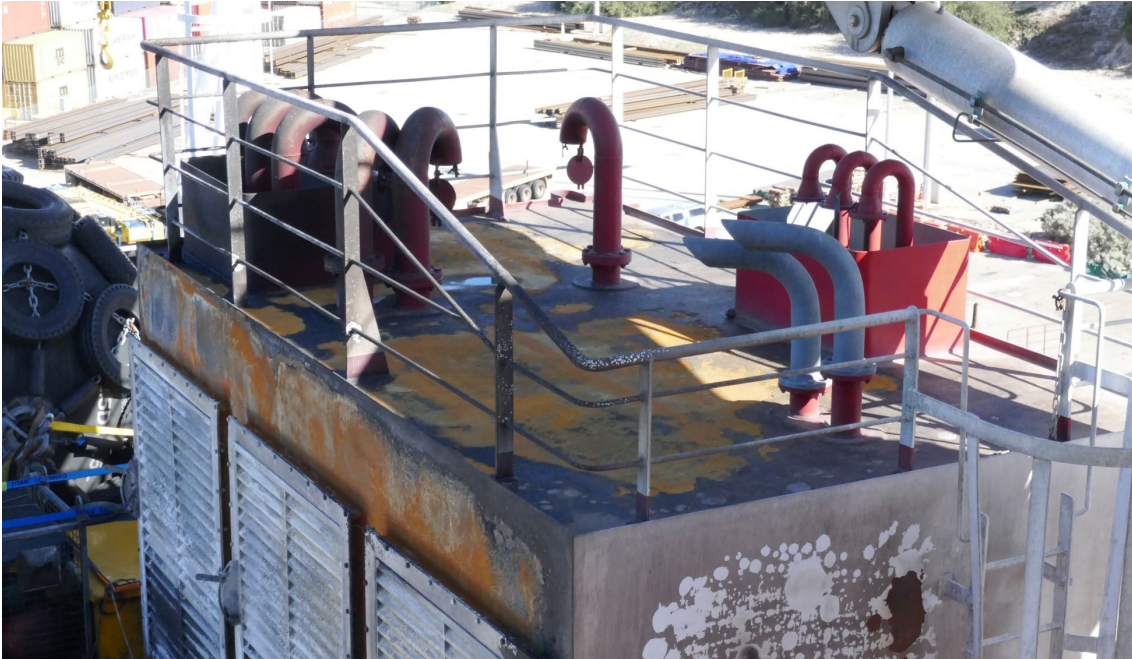
Figure 24: Top of exhaust ventilation casing

The external deck which formed the upper boundary of the ventilation casing contained goose-neck terminations of 11 pipes with 3 each in 2 save-alls and the rest terminating on the open deck (Figure 24). The goose-neck pipe terminations showed heavy sooting particularly on the side facing inboard. The deck itself showed large areas of paint damage and oxidisation. Handrails around the deck showed evidence of metal deformation due to thermal stress.

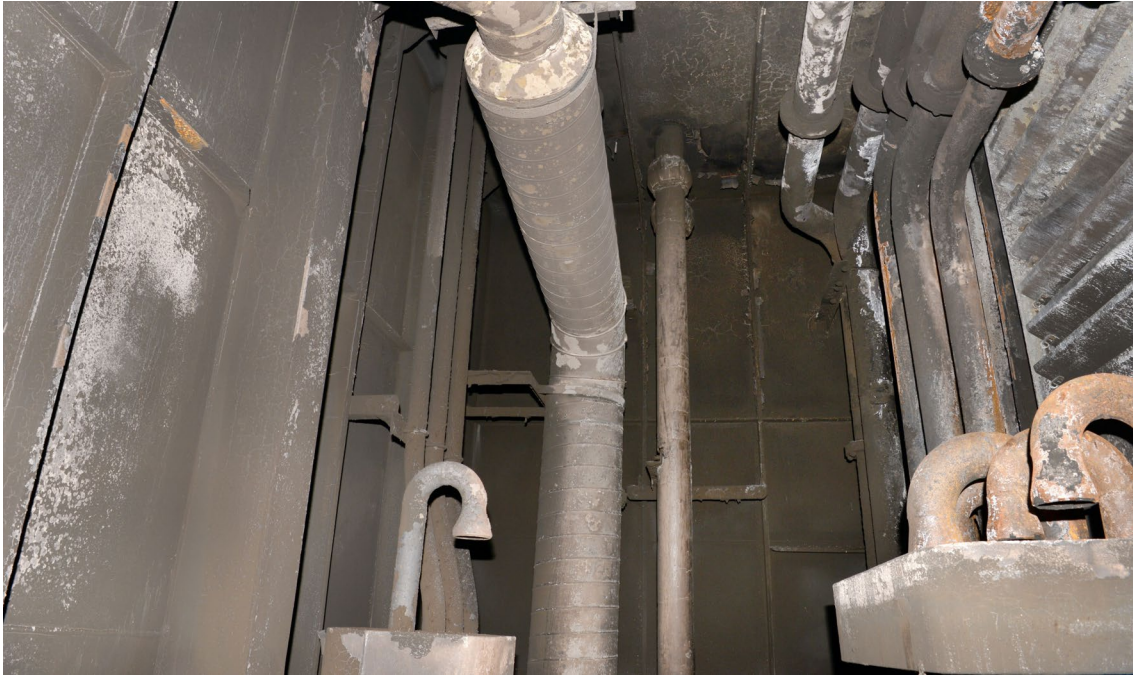
Figure 25: Interior of exhaust ventilation casing (upper level)

The interior showed heavy sooting forward on the port bulkhead with thermal damage and a clean burn pattern evident aft. There was heavy sooting on the starboard bulkhead below the louvres with evidence of a clean burn on the louvres themselves indicating direct flame contact. Similarly, all pipework including the port settling tank vent pipe in the save-all showed oxidisation, indicating direct flame contact (Figure 25). The deckhead showed heavy sooting and increased thermal damage in the centre and aft areas.

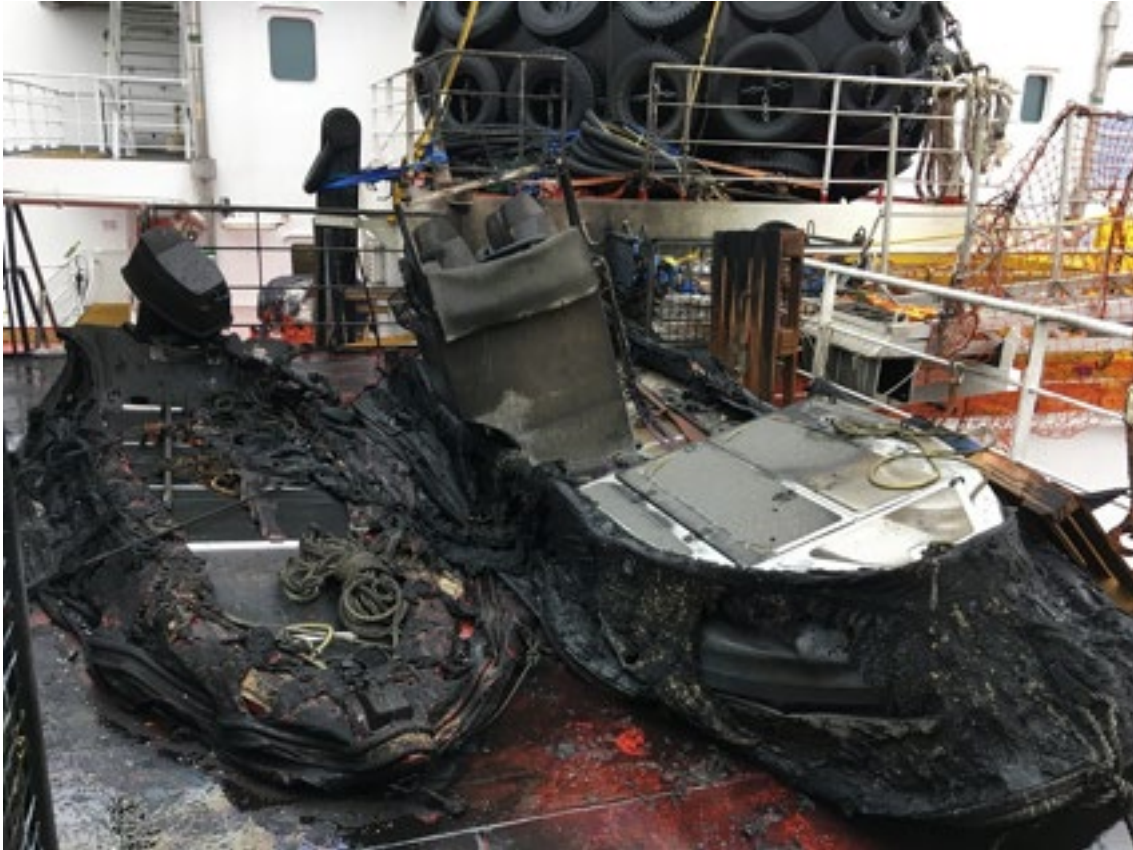
Figure 26: Boats, fenders and other equipment outside casing

The area outside the exhaust ventilation casing was used as a storage area for various pieces of equipment. The equipment included 2 rigid hull inflatable boats (RHIB) with outboard motors, Yokohama fenders with attached chains and shackles and several pallet cages with smaller fenders, cordage, and other equipment (Figure 26). Examination of this area showed general fire damage extending about 5 m from the ventilation louvres. The RHIBs were located directly outside the 3 ventilation louvres and generally showed greater fire damage on the side facing the louvres.
