# Descent below minimum altitude involving British Aerospace BAE 146, VH-SFV

15 km south of Rockhampton Airport, Queensland on 5 January 2023

**ATSB Transport Safety Report**

AO-2023-004

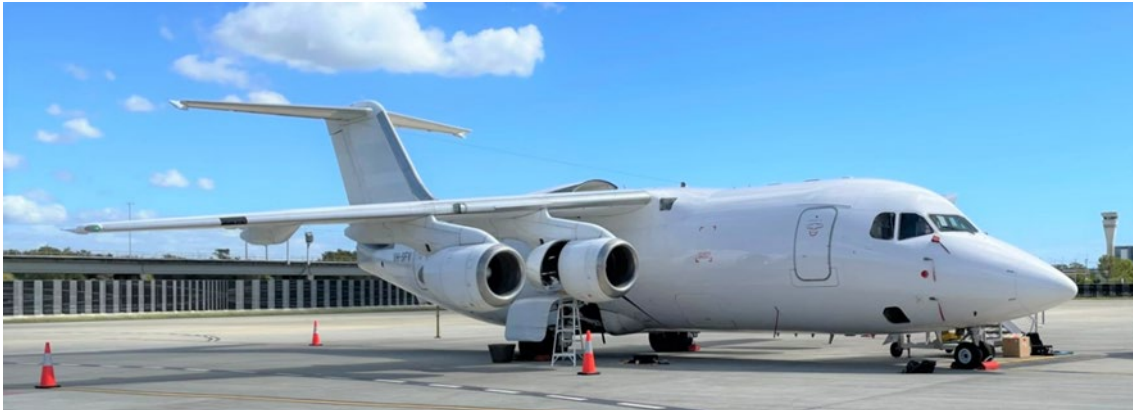
**Figure 4: VH-SFV**

The BAE 146 is a 4-engine, high-wing, regional jet aircraft. VH-SFV was manufactured in 1987 and was configured for air freight operations (Figure 4).

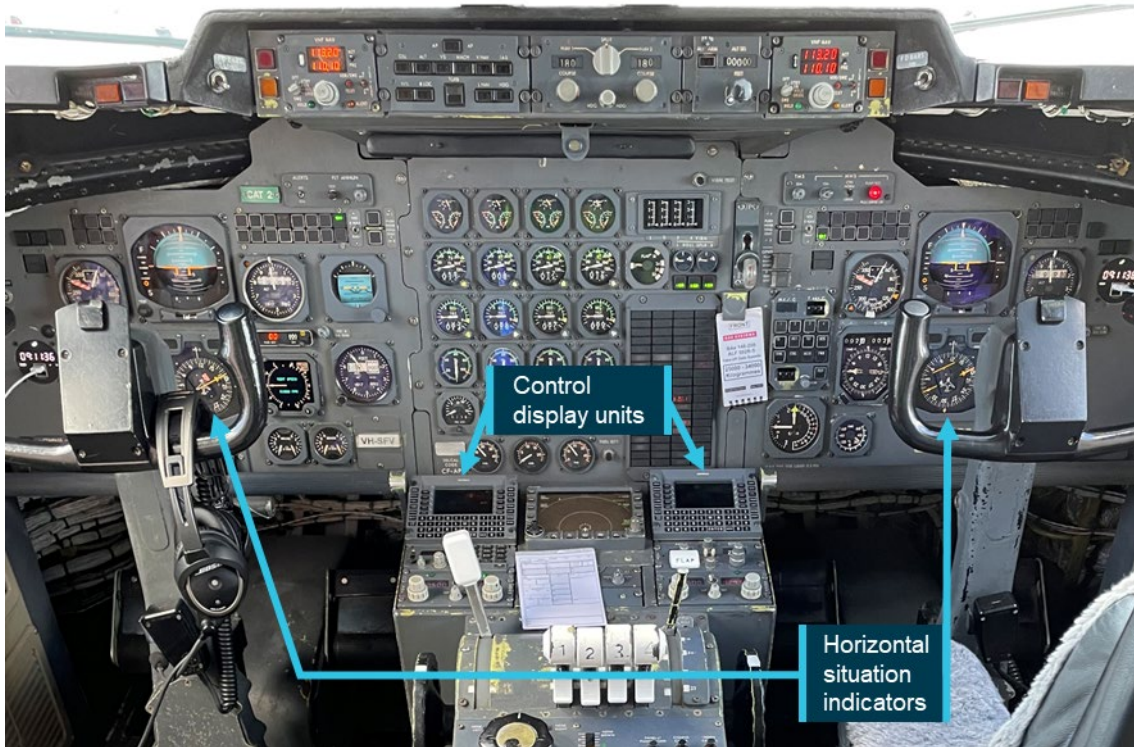
**Figure 5: VH-SFV instrumentation**

The BAE-146 entered service in 1983 and was fitted with an analogue cockpit based upon technologies and ergonomic considerations of the time (Figure 5). When manufactured, VH-SFV was not equipped with an integrated flight management computer (FMC) although one was later fitted to allow for operational practices introduced since the aircraft’s manufacture. The FMC fitted to VH-SFV included a lateral navigation function but did not include a vertical navigation function

or vertical path protection. Management of the vertical profile of the approach using the autopilot was achieved using the vertical speed mode. In this mode, the PF used the control column to descend the aircraft and, once the desired descent rate was achieved, pressed a 'sync' button to enter the targeted vertical speed into the autopilot.

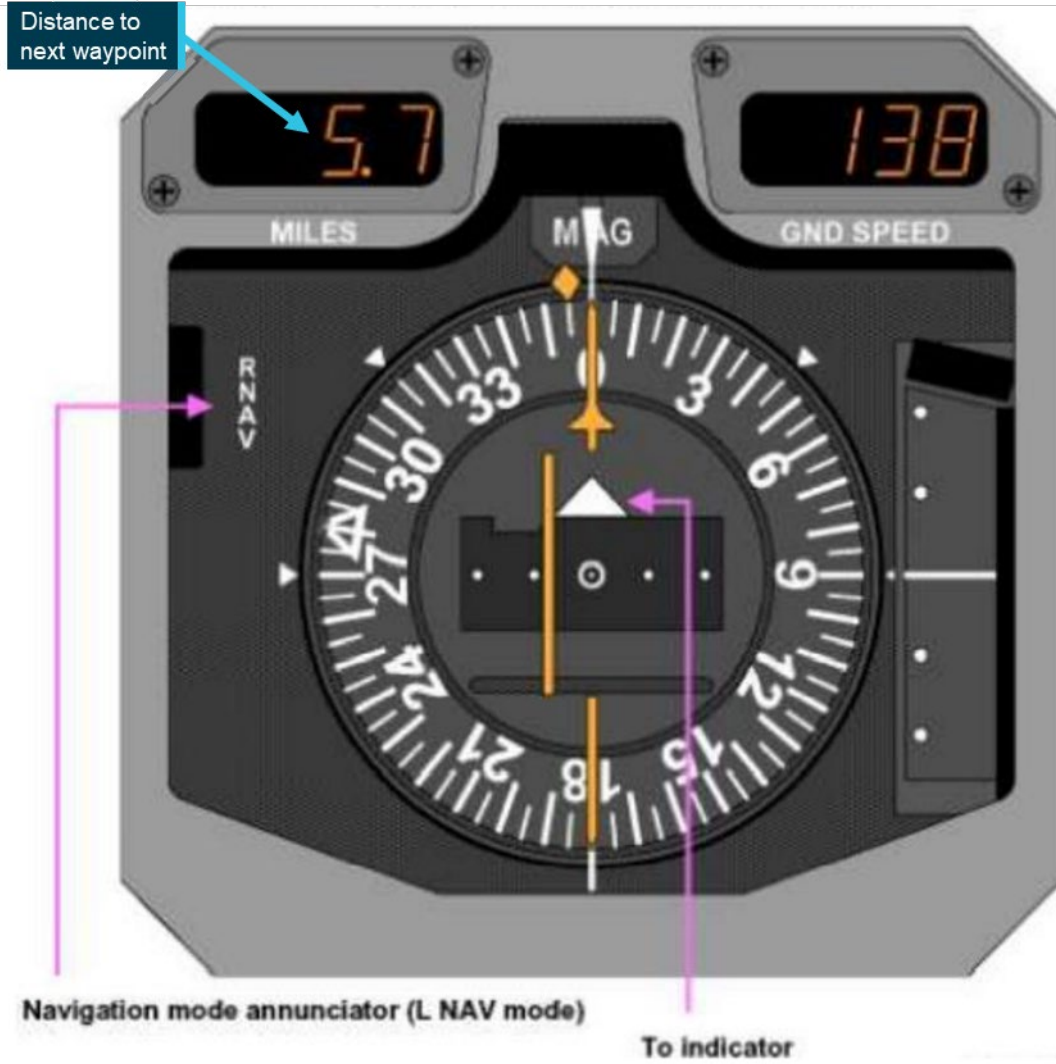
Figure 6: Horizontal situation indicator display

The control display units (CDU) of the FMC were positioned on the centre pedestal of the cockpit and allowed for the entry of navigation data. During an RNP approach, the FMC provided a waypoint distance to run indication on the horizontal situation indicator, but did not identify the waypoint name (Figure 6). Waypoint information, including the waypoint where the aircraft was tracking from and to, and the subsequent approach waypoint was displayed on the CDU screen (Figure 7).
