# Safeworking irregularity involving passenger trains 1898 and 18A0 near Thorneside, Queensland, on 7 March 2020

**ATSB Transport Safety Report**

Rail Occurrence Investigation (Defined)

RO-2020-003

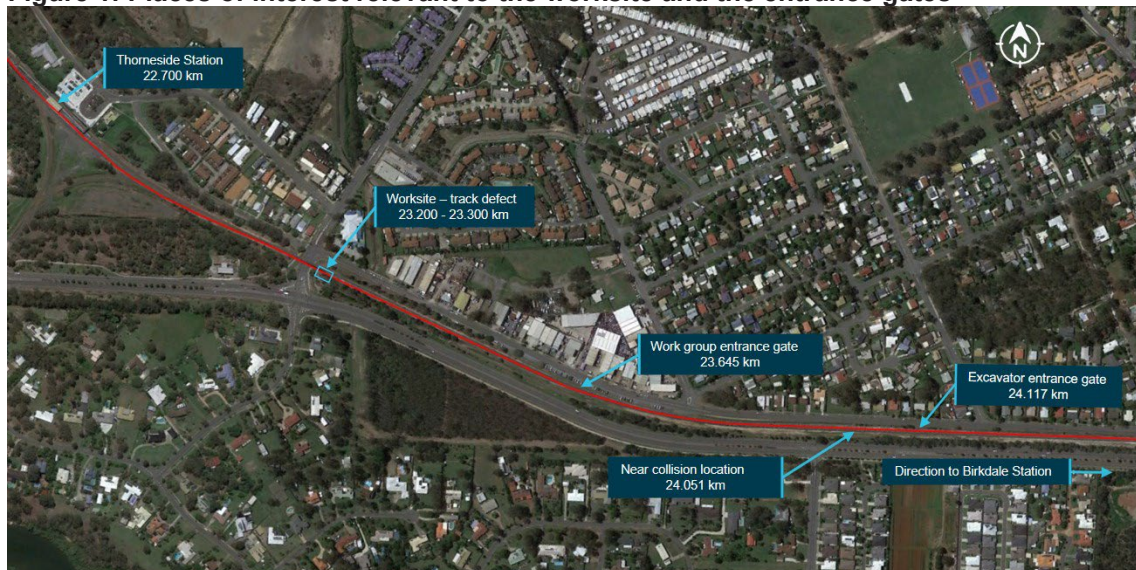
**Figure 1: Places of interest relevant to the worksite and the entrance gates**

The image shows Thorneside Station, the worksite, entrance gates for the work group and the excavator and near collision location. Source: Google earth, annotated by the ATSB

The excavator could not access the rail corridor through the same entrance gate as the work group, as cement troughing blocked its entry. Therefore, it was necessary to transport the excavator to the entrance gate about 470 m further east of the entrance gate used by the work group (Figure 1).

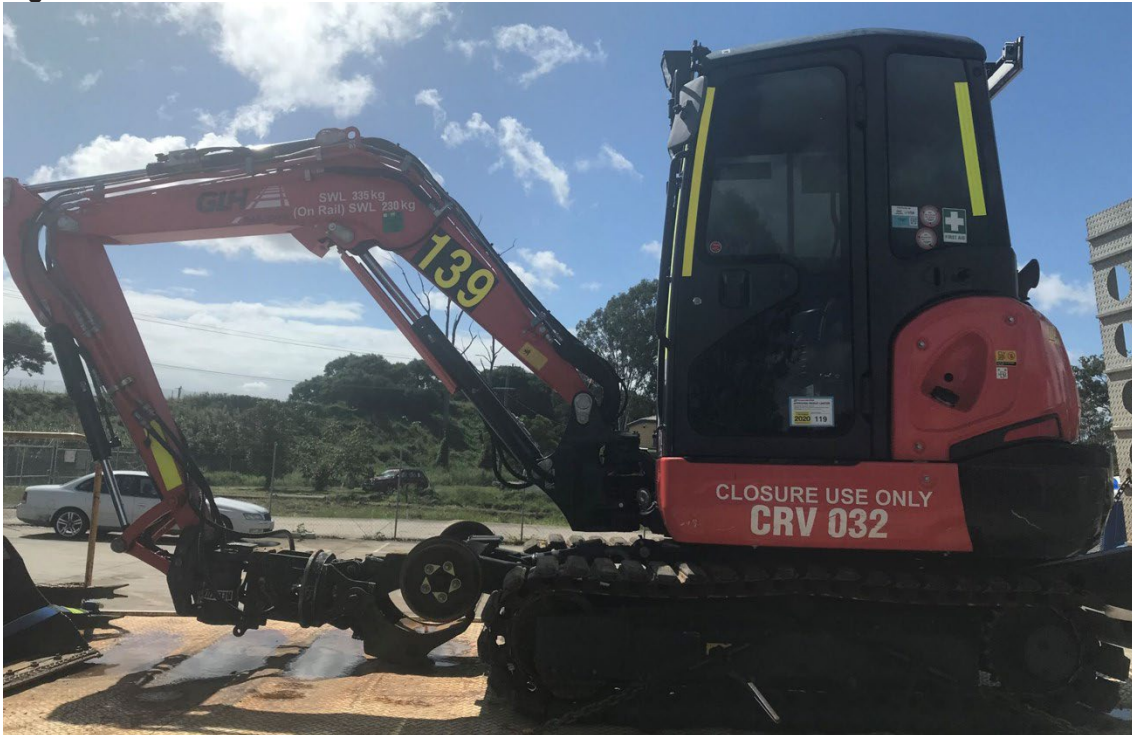
**Figure 4: Excavator involved in the near collisions**

The excavator involved in the near collisions was a Kubota CRV032 (Figure 4). It had an operating weight of 5 t and was fitted with small, retractable rail wheels enabling it to mount and operate on the running tracks.
