Collision between tram 6058 and tram 6062

East Melbourne, Victoria, on 20 September 2023

ATSB Transport Safety Report

RO-2023-008

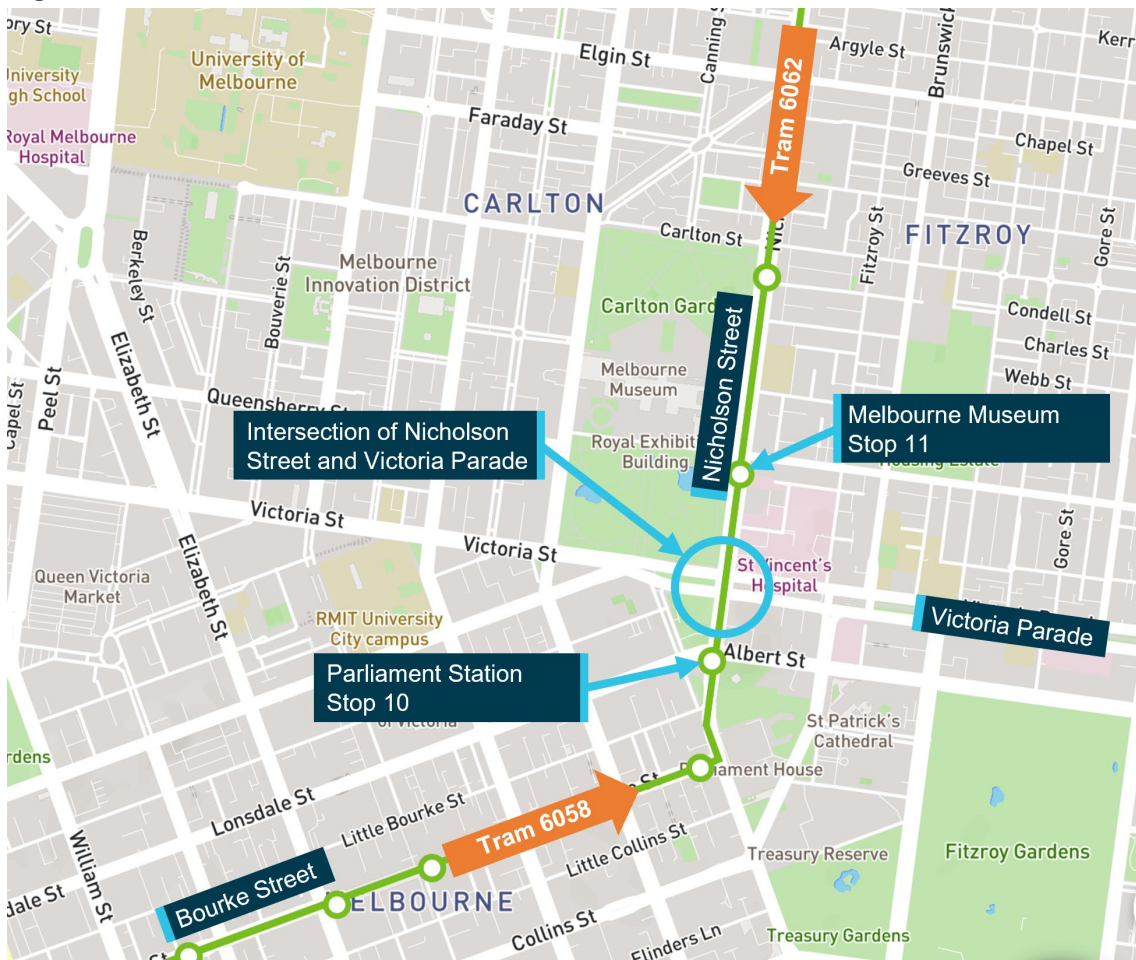
Figure 1: Intersection of Nicholson Street and Victoria Parade

On 20 September 2023, trams 6058 and 6062 were operating on route 96 between Brunswick East and St Kilda Beach in Melbourne. Tram 6058 departed St Kilda Beach at about 0912 travelling towards Brunswick East, and tram 6062 departed Brunswick East at about 0936 travelling towards St Kilda Beach. At about 0951, both trams on parallel tracks approached the Nicholson Street intersection with Victoria Parade (Figure 1).

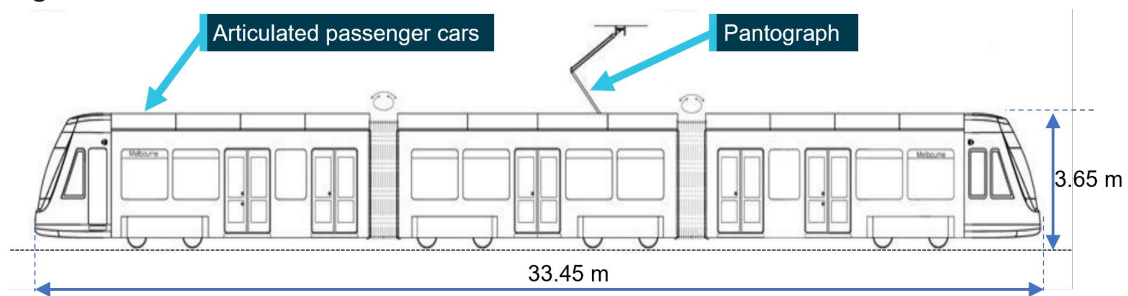
Figure 5: The articulated E2 Class tram

Trams 6058 and 6062 were both E2 class trams manufactured by Bombardier Transportation Australia. Each tram was comprised of 3 connected passenger units, giving a total length of about 33 m and a capacity of 64 seated and 146 standing passengers (Figure 5).³

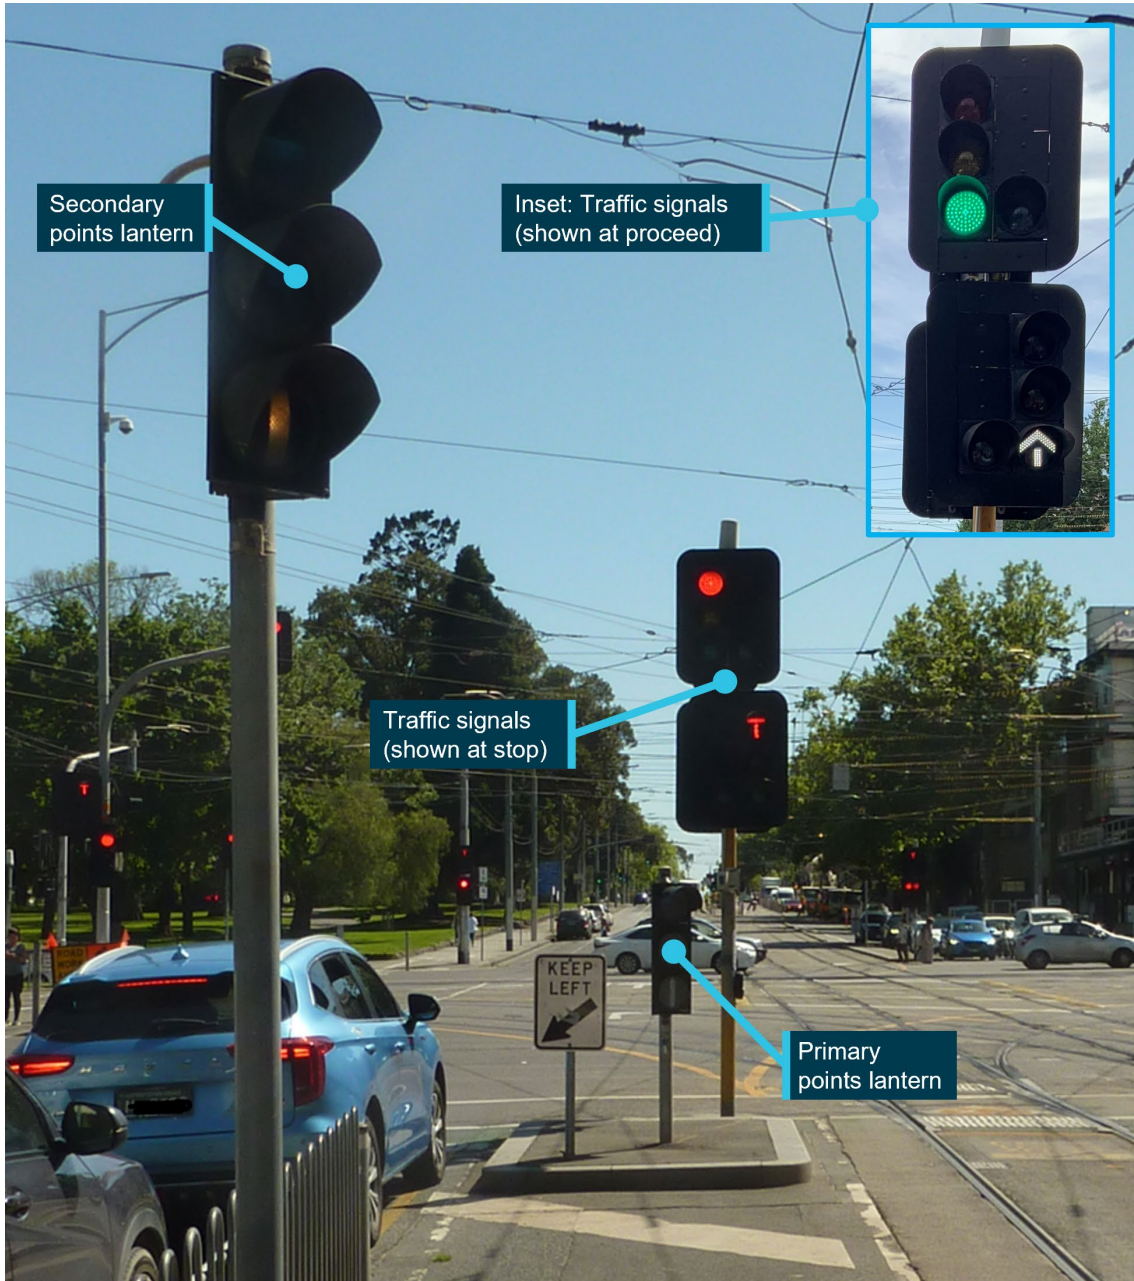
Figure 6: Traffic signals at intersection when travelling north on Nicholson Street

Northbound trams travelling along Nicholson Street were presented with traffic signals and primary and secondary points lanterns (Figure 6). When permitted to proceed straight, northbound trams were presented with a white arrow at 4 locations within the intersection.

The primary points lantern had 3 lenses with each lens designed to have an unlit (nil) or lit aspect (Figure 7).⁵ The central lens had 2 possible lit aspects and could indicate that the points were set to the left or to the right. The secondary points lantern was of the same configuration, however, on the day of the incident its central lens was non-operational.

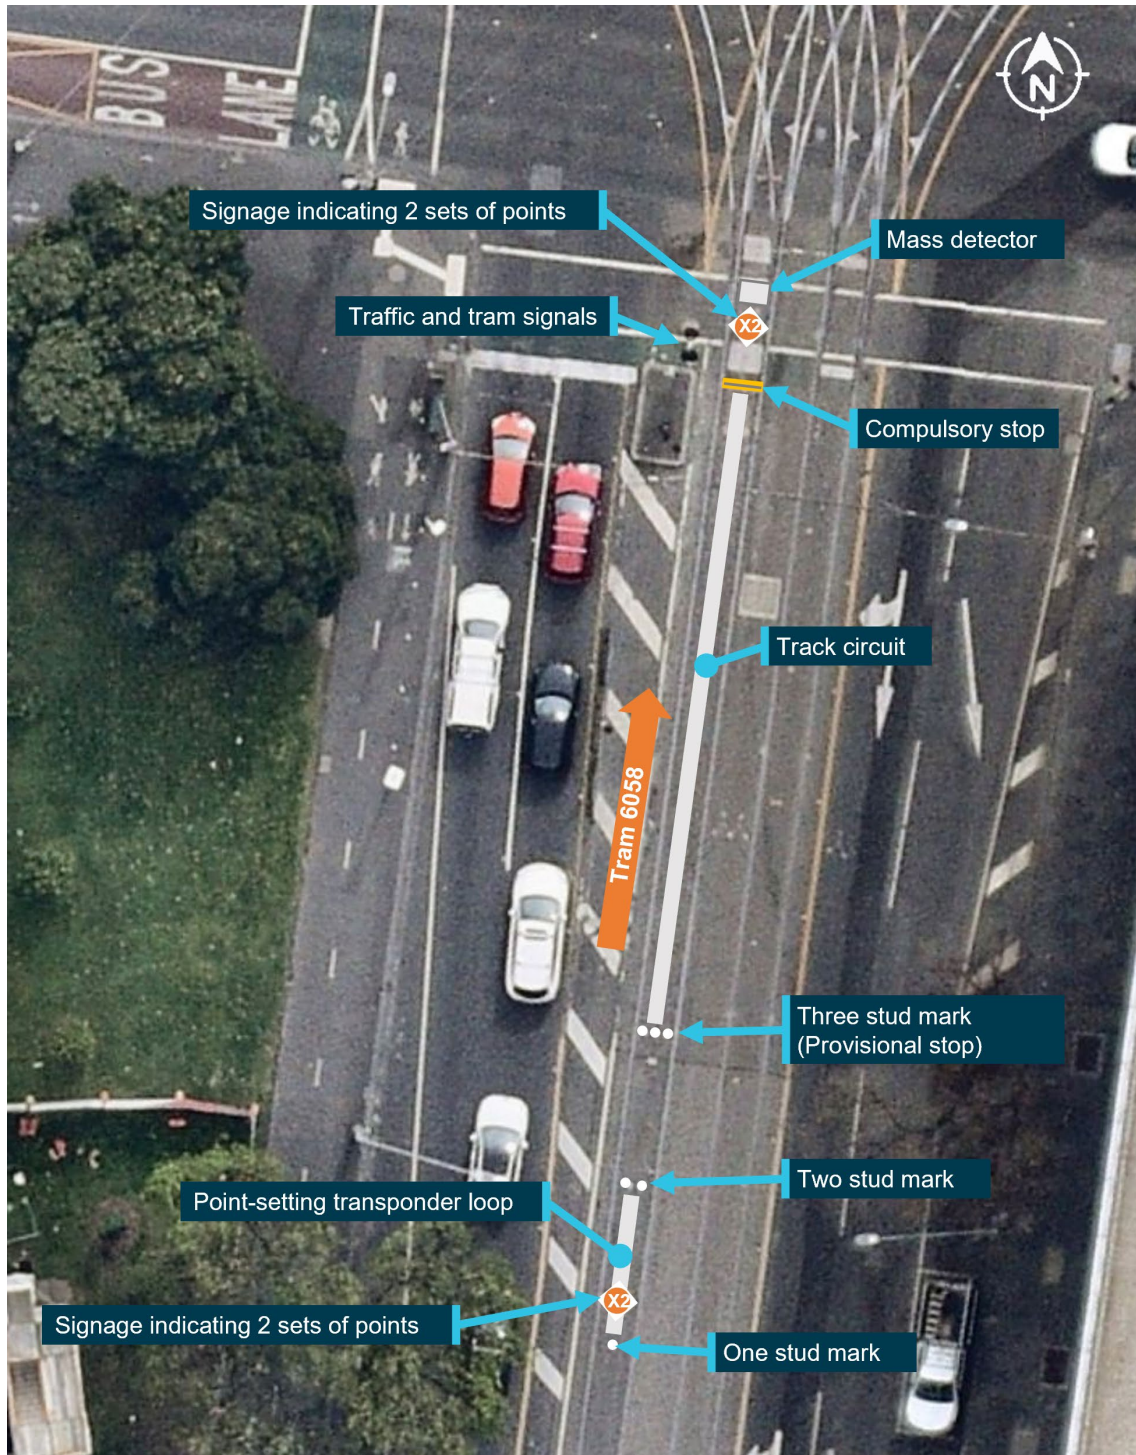
Figure 8: Track equipment and markings on Nicholson Street travelling north

The intersection of Nicholson Street with Victoria Parade was fitted with automatic points. Travelling north on Nicholson Street and approaching the intersection, in-track equipment interfaced with trams to provide input to the operation of points, and on-ground markers provided visual cues to drivers (Figure 8).
