VFR into IMC, loss of control and collision with terrain involving Airbus Helicopters EC130 T2, VH-XWD

near Mount Disappointment, Victoria, on 31 March 2022

ATSB Transport Safety Report

AO-2022-016

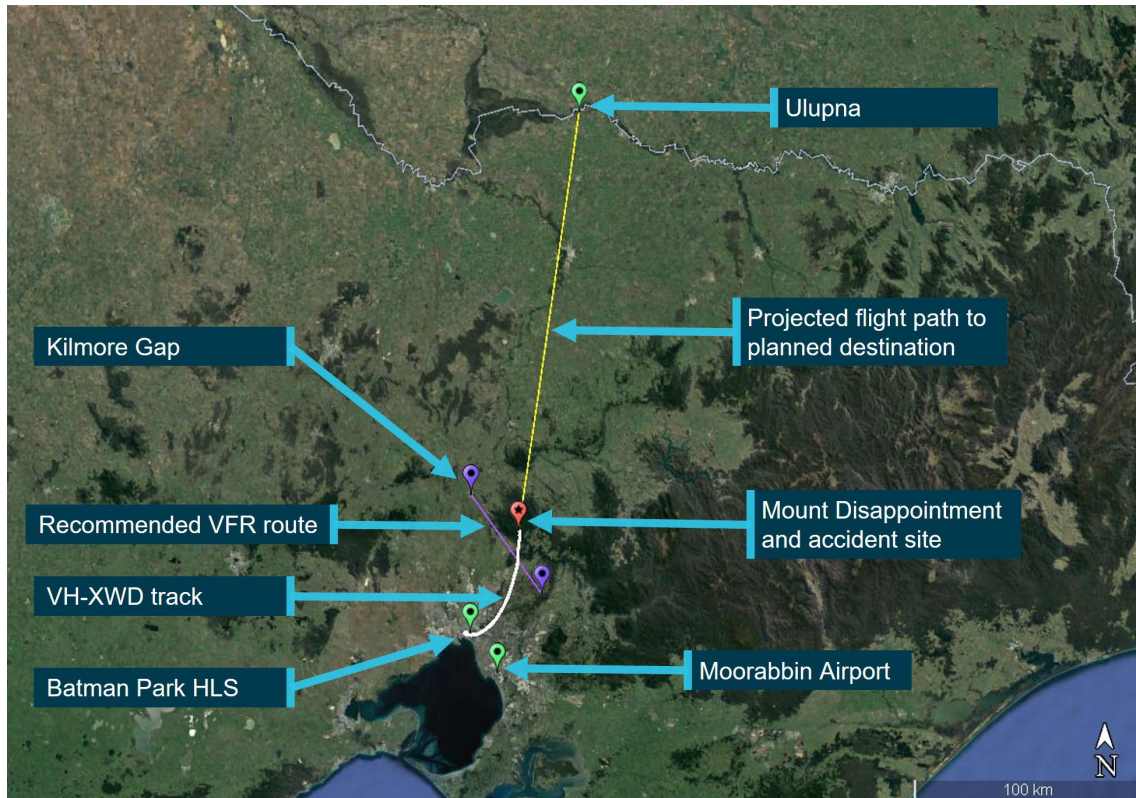
Figure 1: XWD accident flight and key locations

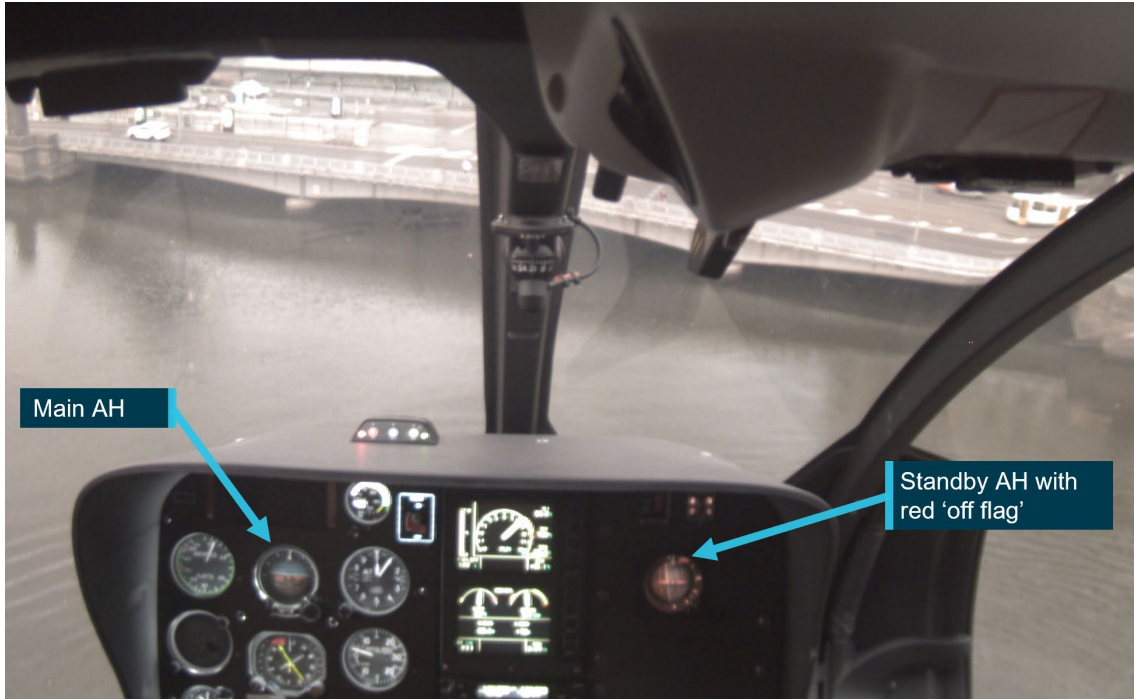
At about 0741, XWD departed from Batman Park 30 seconds behind WVV. The standby AH in XWD remained off and continued to indicate a 90° left roll attitude (Figure 3). Both helicopters were operating VFR outside controlled airspace without a flight plan.⁶ The helicopters initially headed east to remain outside controlled airspace before turning north toward Ulupna. As they tracked east and then north, the lower limit of controlled airspace increased,⁷ and the helicopters climbed from 1,500 ft above mean sea level to 2,500 ft and then to 3,500 ft. The pilots reportedly discussed the weather over the radio and noted the conditions to the west were consistent with the forecast, but that the conditions to the north had not deteriorated, and they continued to track northbound.

Figure 3: XWD take-off from Batman Park HLS

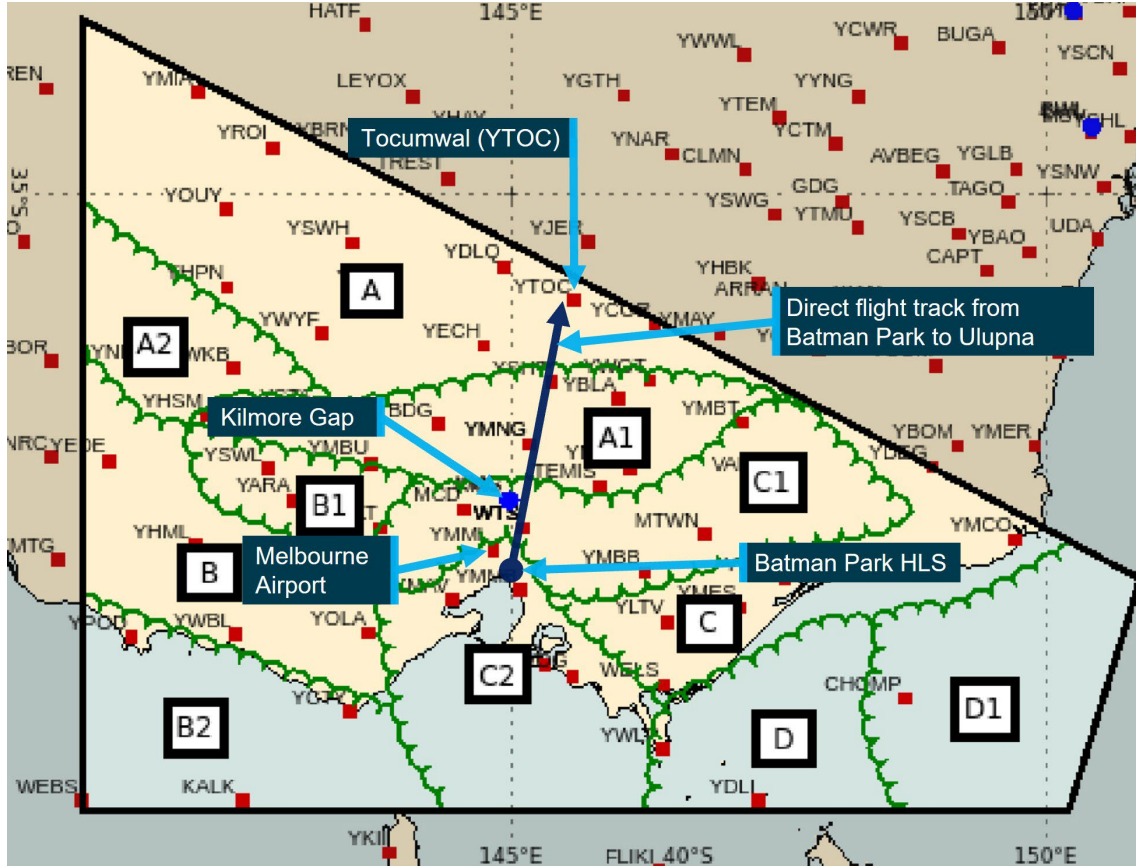
The GAF for Victoria, current at the time of the departure from the Batman Park HLS, was issued at 0321 on the morning of 31 March 2022 and was valid from 0400-1000. The GAF divided the state into 4 areas, identified as A, B, C and D, with sub-divisions in areas A, B and C, separated by green scalloped lines (Figure 10). The flight was planned to start in area C2, transit area C1 (including Mount Disappointment), A1 and end in area A. The destination of Ulupna is located 8 NM (15 km) west of Tocumwal (YTOC in Figure 10).

Figure 10: GAF with direct track from Melbourne to Ulupna west of Tocumwal (YTOC)

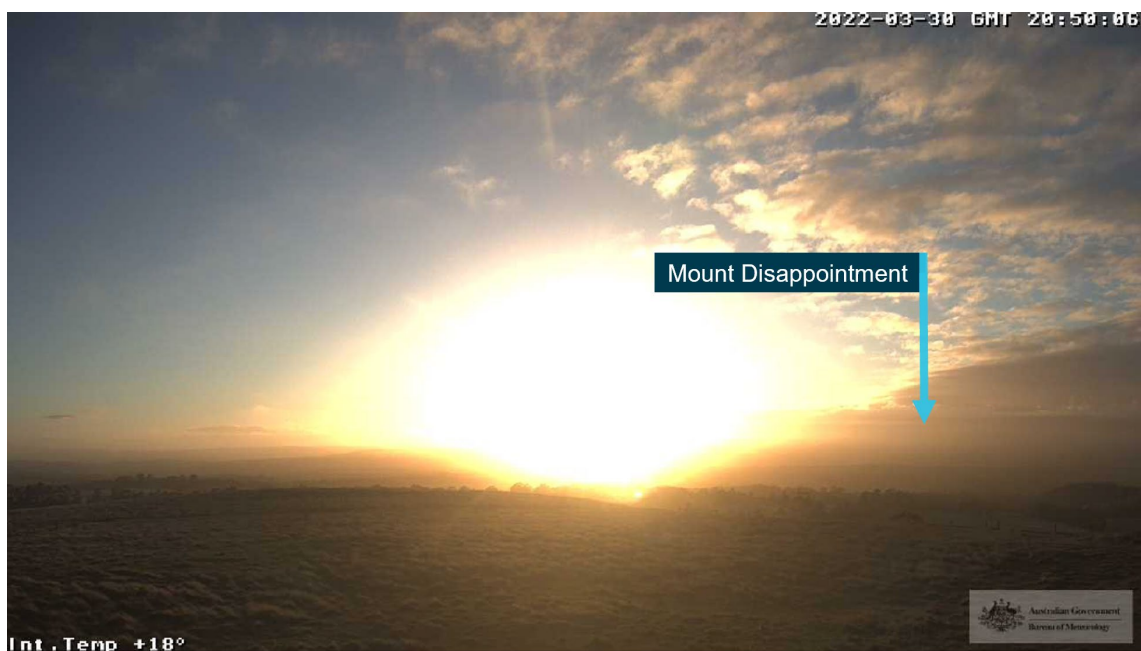
The Bureau of Meteorology Kilmore Gap weather station and web camera was located 19 km west-north-west of the accident site (Figure 11). At 0750, 8 minutes prior to the accident, the camera depicted cloud overhead Mount Disappointment (Figure 12). Shortly after the accident, at 0800 and 0810, the camera showed extensive development of low cloud in the area (Figure 13 and Figure 14).

Figure 12: View towards Mount Disappointment at 0750 (8 minutes before the accident)

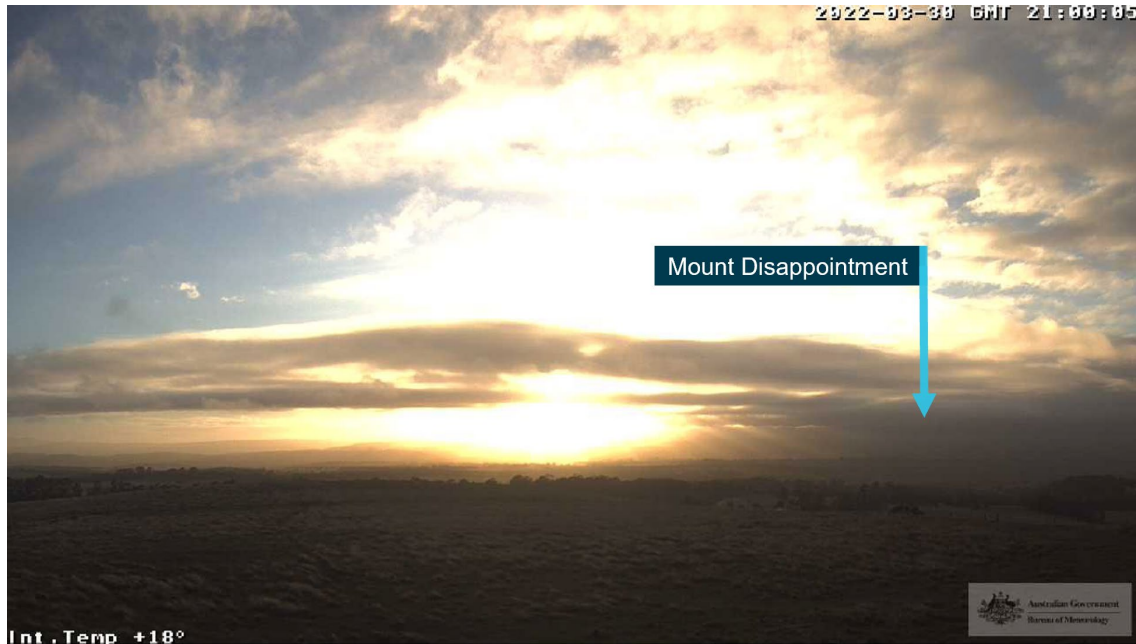
Figure 13: View towards Mount Disappointment at 0800 (2 minutes after the accident)

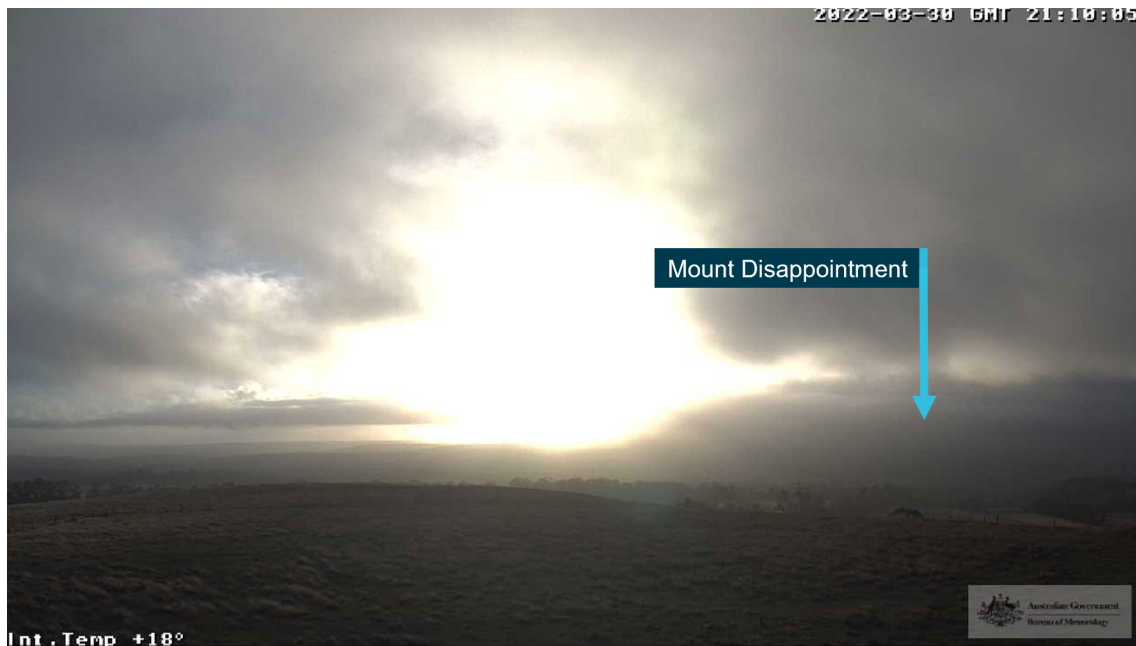
Figure 14: View towards Mount Disappointment at 0810 (12 minutes after the accident)
