# Mid-air collision involving Eurocopter EC130B4, VH-XH9, and Eurocopter EC130B4, VH-XKQ

Main Beach, Gold Coast, Queensland, on 2 January 2023

**ATSB Transport Safety Report**  
Aviation Occurrence Investigation  
AO-2023-001  
Interim – 2 January 2024

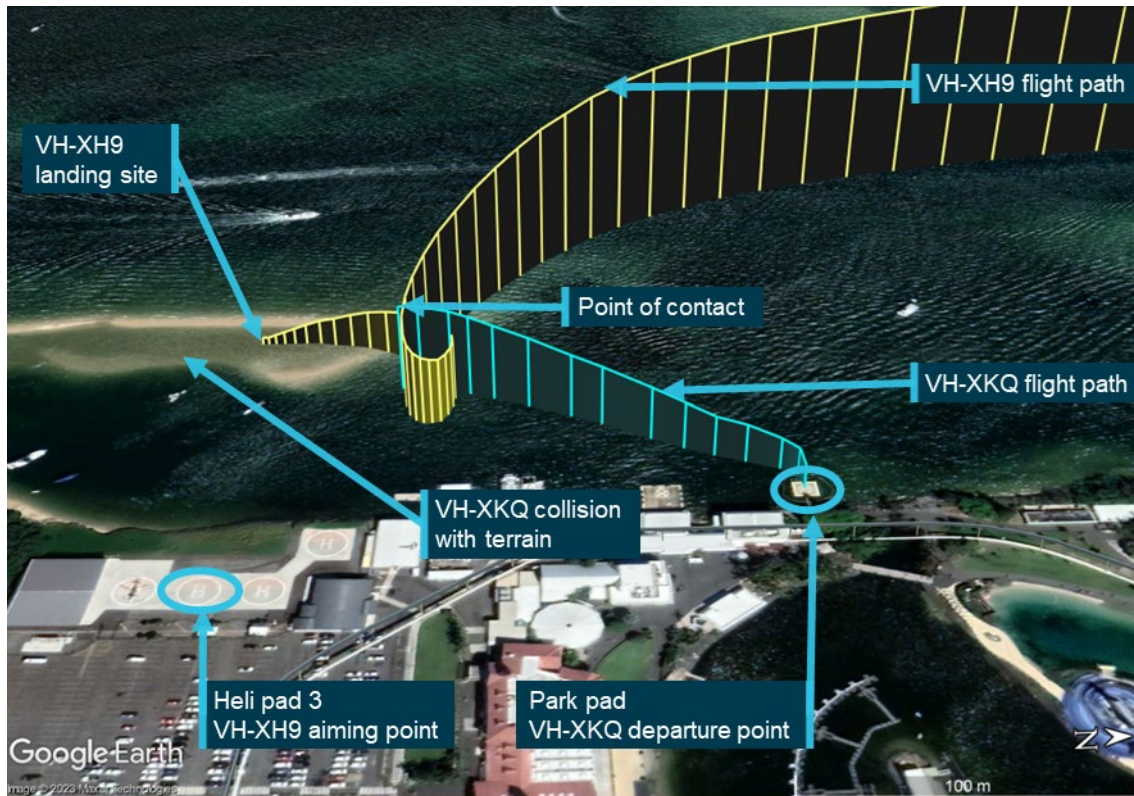
**Figure 1: Helipad configuration at Sea World on 2 January 2023**

On 2 January 2023, Sea World Helicopters was conducting a series of scenic flights in 2 Eurocopter<sup>1</sup> EC130B4 helicopters registered VH-XH9 (XH9) and VH-XKQ (XKQ). The flights were performed under the visual flight rules from its base at Sea World on the Gold Coast, Queensland. The helicopters were operating from separate helipads about 220 m apart. These were pad 3 at the operator’s heliport and the park pad inside the theme park (Figure 1).

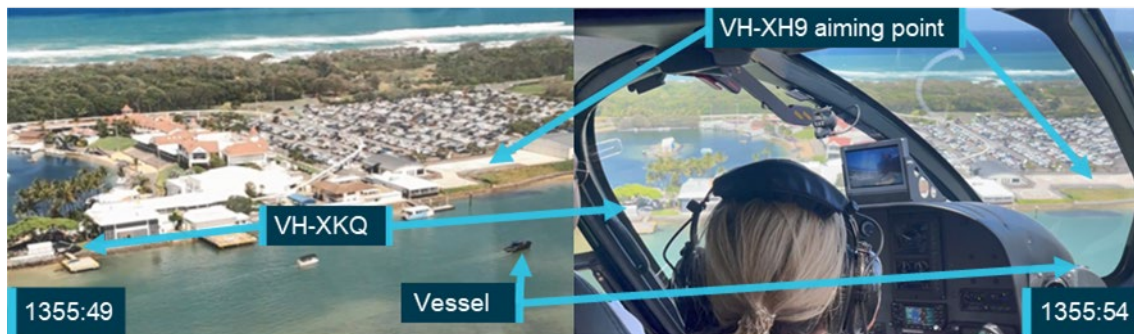
**Figure 2: Vessels on Broadwater**

There were two vessels on the Broadwater between the park pad and the heliport which XKQ passed to the outside of while climbing towards the sandbar south-west of the helipad. One of those vessels was crossing XH9's intended flight path, and the pilot of XH9 planned to pass behind it on their approach to the helipad (Figure 2).

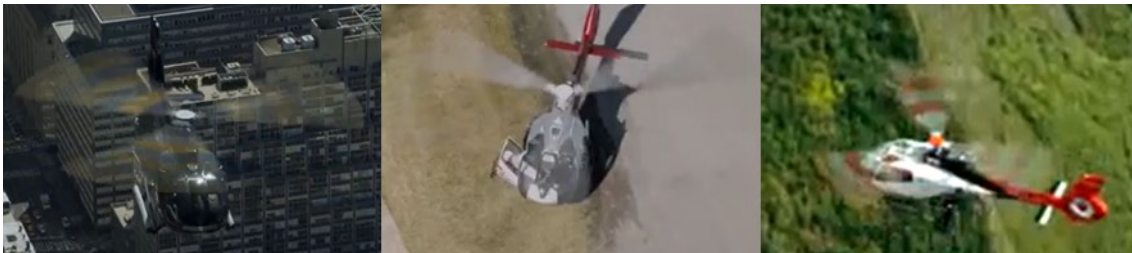
**Figure 4: Exemplar main rotor blade paint schemes**

The top side of XH9's main rotor blades were painted with a high visibility paint scheme (alternating white sections over the normal grey blade) in accordance with the maintenance manual. The result being, when viewed from above, the rotor disc would appear to be a series of concentric white circles (see Figure 4). The undersides of main rotor blades are not painted to reduce risk of flicker vertigo,<sup>5</sup> so the main rotor disc was not as visible when viewed from below.

*Effect of paint schemes on blade visibility. The centre panel has no high visibility paint and the rotor system is harder to detect.*  
Source: Airbus Helicopters

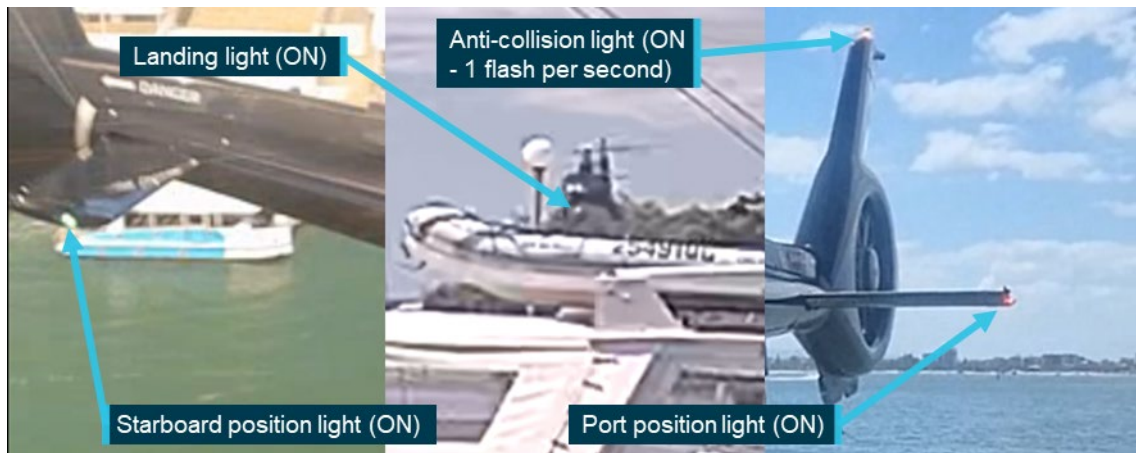
**Figure 6: VH-XKQ lighting configuration**

XKQ was fitted with 3 position lights, one anti-collision light, a taxi light and a landing light. Figure 6 shows the known lighting configuration of XKQ for the accident flight. While the aft position light could not be detected in video of the aircraft, likely due to bright daylight conditions, that light was switched on with the port and starboard position lights. XKQ did not have high visibility markings on its rotor system (Figure 7).

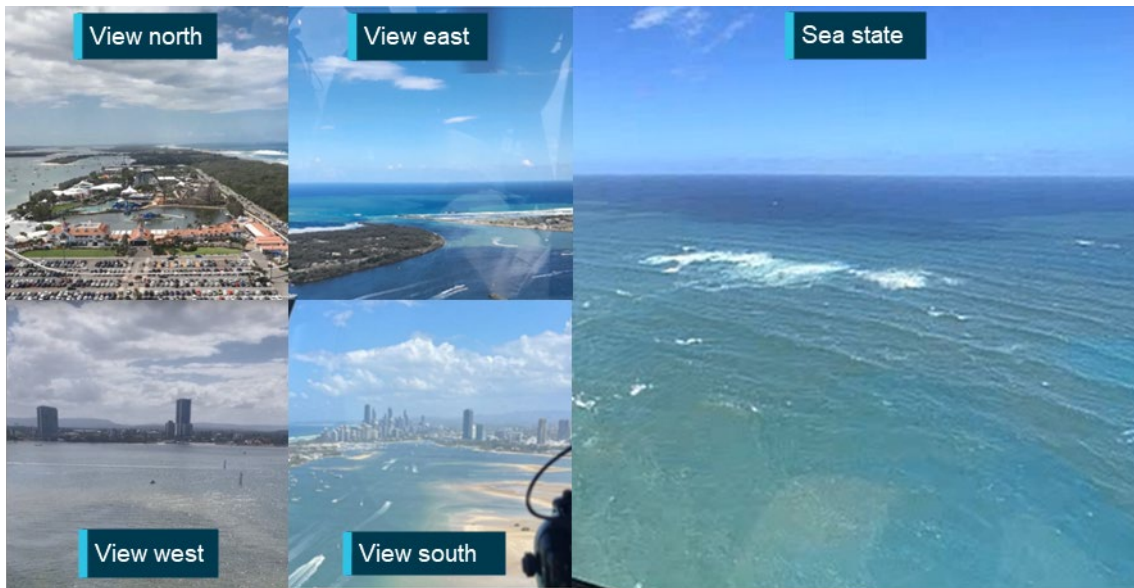
**Figure 9: Passenger photographs showing inflight conditions**

The sea state from passenger photographs near Porpoise Point showed small waves and a few whitecaps starting to form on the surface of the sea suggesting wind speeds of 11 to 16 kt (Figure 9).

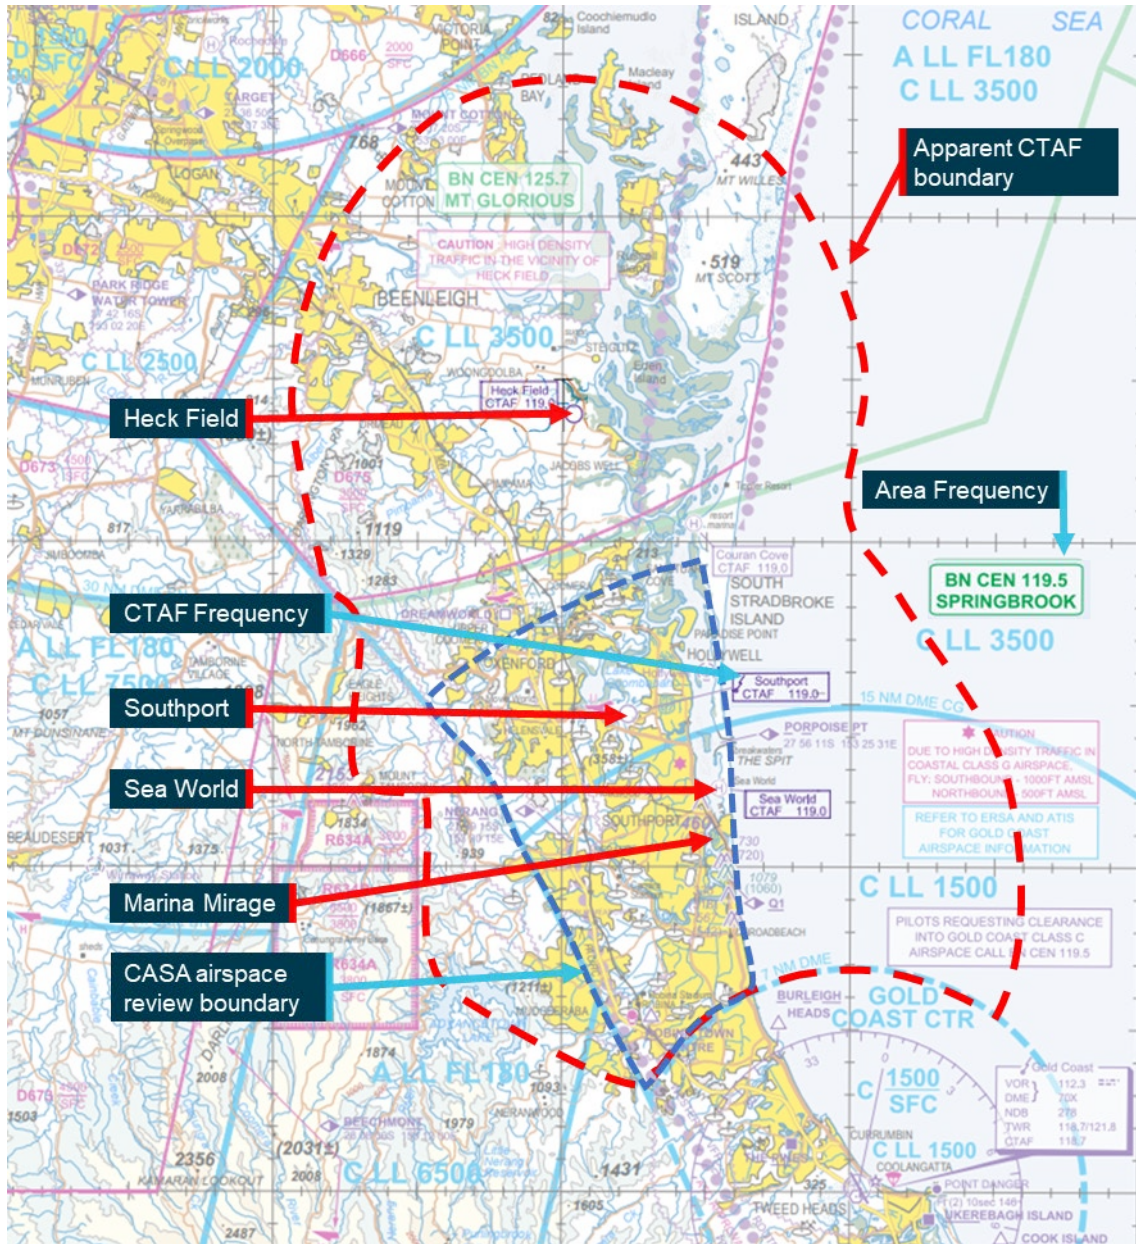
Figure 12: Apparent CTAF boundary for 119.0 MHz

The area was not a mandatory broadcast area and the CTAF did not have a defined boundary. The limits of the airspace were defined only by controlled airspace to the south, restricted areas to the west and the recommended positional broadcast at 10 NM from an aerodrome when conducting flight in the vicinity of it. The apparent boundary of the area using 119.00 MHz is shown in Figure 12.

The ATSB interviewed 6 local helicopter pilots. Each raised issues with congestion on the CTAF on account of it covering a large area of high volume traffic. The CTAF covers the area shown in Figure 12 from Heck Field, past Southport and to the controlled airspace boundary 2 NM north of Burleigh Heads.

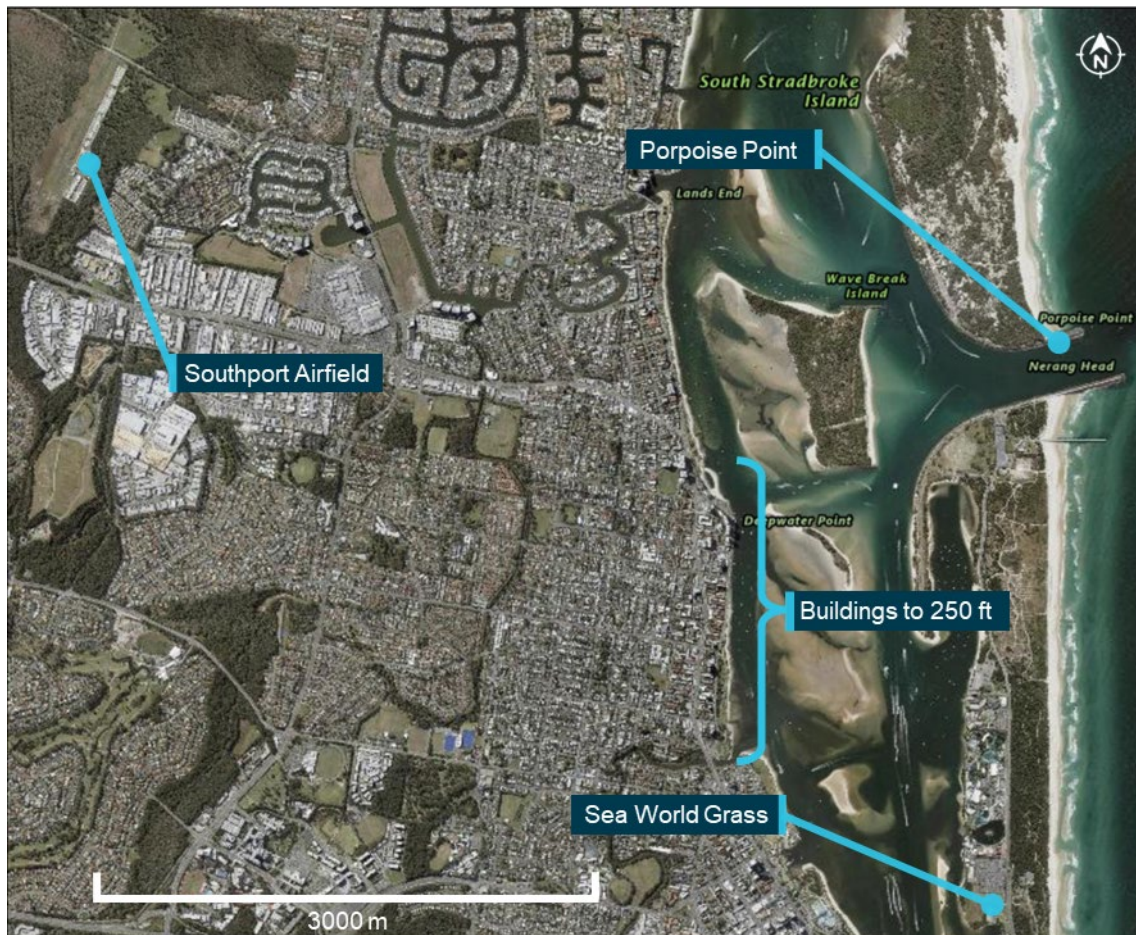
Figure 16: Southport Airfield and building shielding to Sea World

The CTAF was recorded at Southport Airfield about 3.6 NM north-west from the Sea World Heliport (Figure 16). Southport Flying Club received CTAF radio calls through a regular vertical antenna. The estimated detection envelope for the antenna was 30 NM for aircraft above 500 ft. Buildings along the foreshore of the Broadwater between Southport Airfield and Sea World Heliport were up to 250 ft tall. Therefore at lower altitudes, the built environment reduced the detection envelope, resulting in calls from aircraft around 200 ft and below not being detected at Southport Airfield.

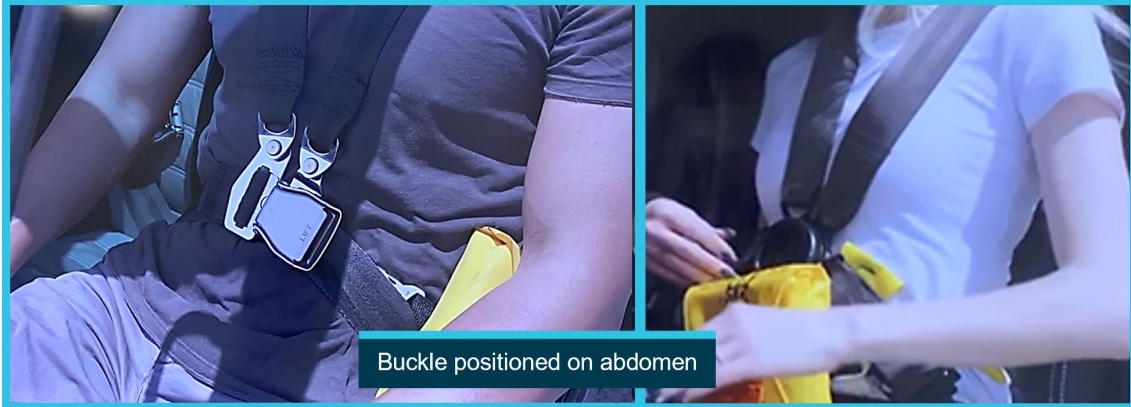
**Figure 19: Still images from safety briefing video**

While Sea World Helicopters provided information about how to fit the different types of seatbelts on each of their helicopter types in their pre-flight safety briefing video, some aspects of the above guidance were not followed in the pre-flight safety briefing video (Figure 19). This was due, in part, to the positioning of the constant wear lifejacket worn by passengers.

- a new position of ‘Pad Boss’ traffic advisory role
- air traffic systems added as supplement to each helicopter avionic system
- increased communication protocols for SWH pilots
- aircraft visibility
  - high intensity strobe lighting added to all SWH aircraft
  - Airbus strobe painting system added to main rotor blades
- introduction of mandatory human factors awareness course for all staff
- updated briefing videos and ground crew training on seatbelt fitment.

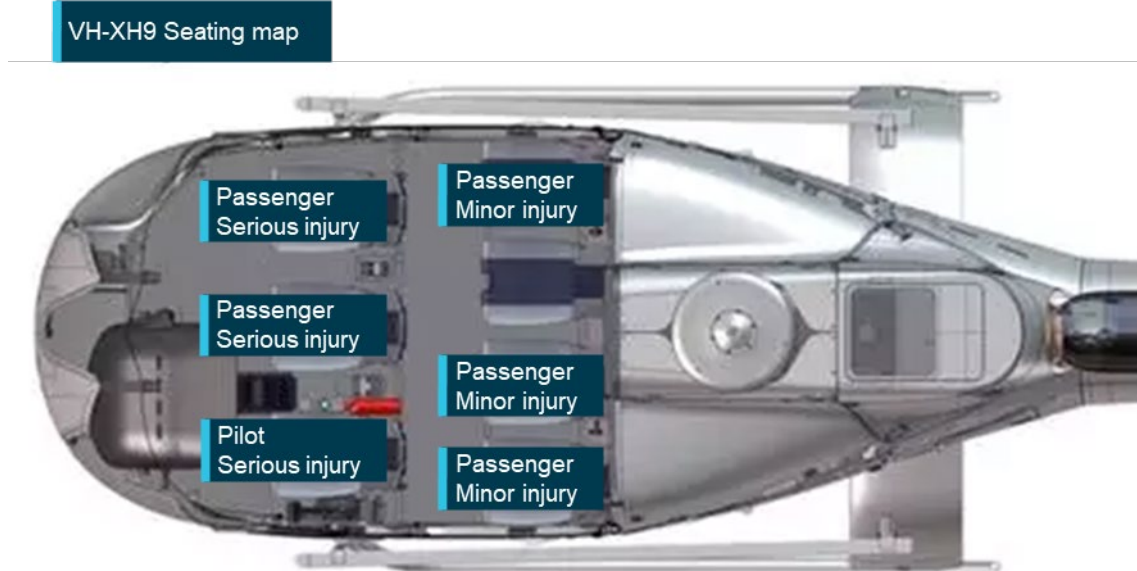
**Figure 21: XH9 seating map**

Four people aboard XKQ were fatally injured and 3 were seriously injured (Figure 22). Three people aboard XH9 were seriously injured and 3 had minor injuries (Figure 21).

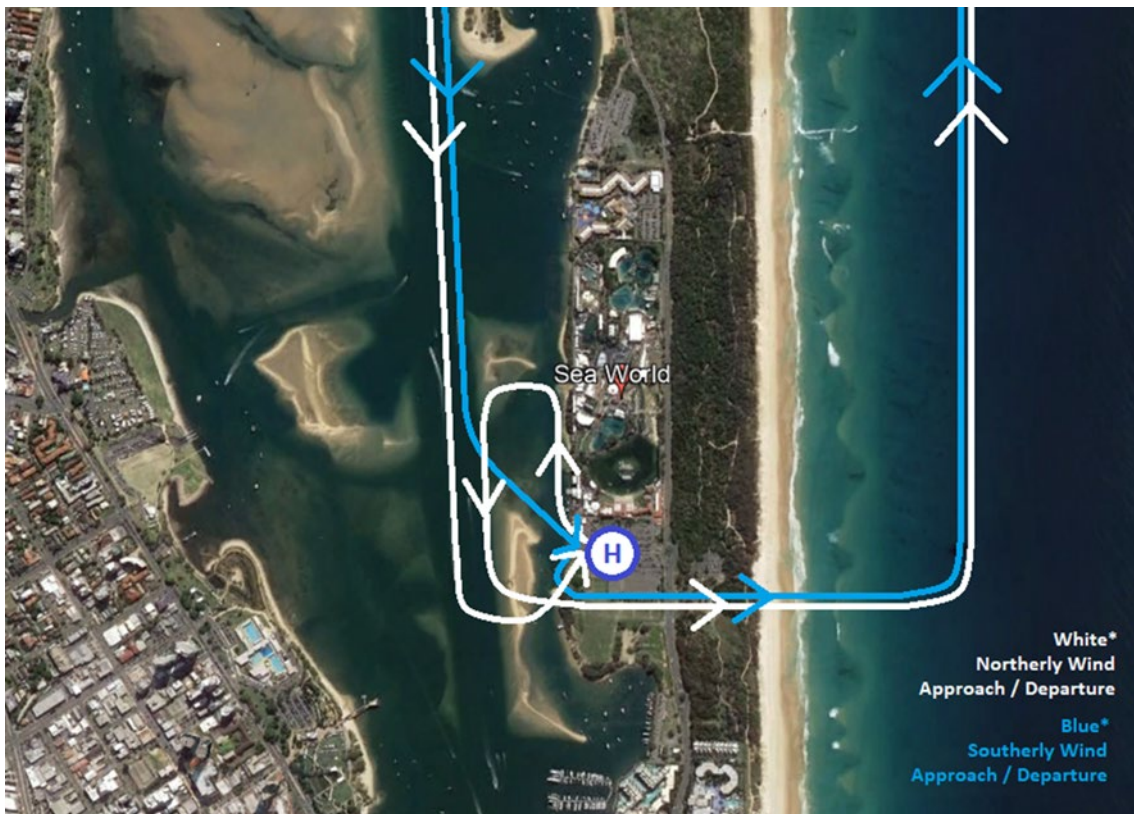
**Figure 28: Operator’s declared Sea World heliport approach and depart paths**

The operator published approach and departure tracks for Sea World heliport in an annex to their aircraft operations manual (Figure 28). Paths for approach and departure from the park pad were not included.

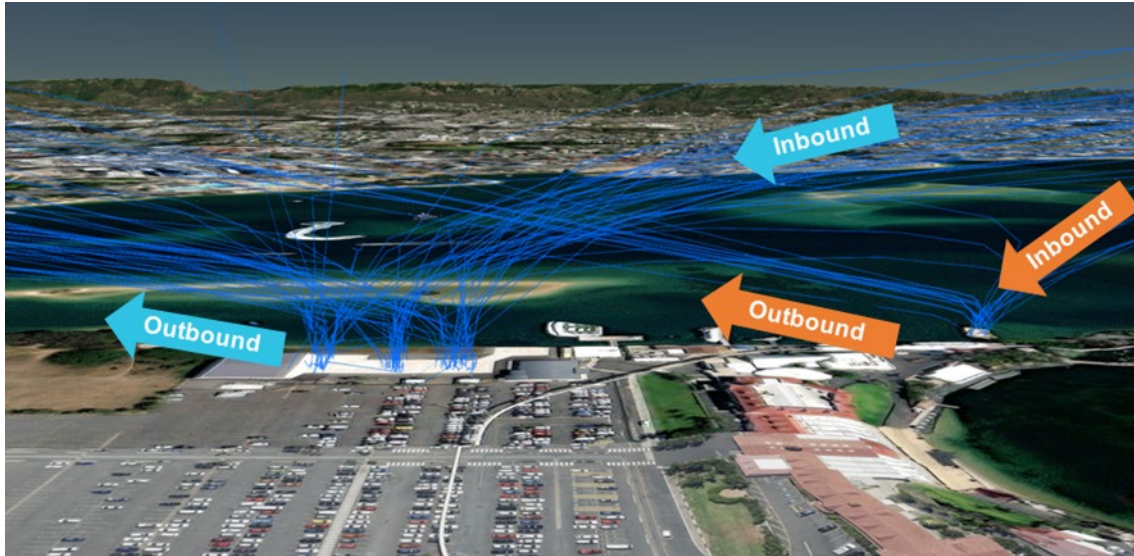
**Figure 29: Traffic flow to and from the park pad and heliport 26 December 2022 to 2 Jan 2023**

Analysis of tracking data for flights conducted from 26 December 2022 to 2 Jan 2023 in XH9, XKQ and one of the operator’s AS350 helicopters showed that intersecting paths flown to and from the helipads had no vertical or horizontal separation at the point where the helicopters collided (Figure 29). The operator stated that the intersecting flight paths conducted at Sea World were controlled through communication and rules of the air as at any aerodrome with intersecting runways.
