Loss of control and in-flight break-up involving Robinson R66, VH-KFT

near Hawks Nest, New South Wales, on 26 October 2023

ATSB Transport Safety Report
Aviation Occurrence Investigation
AO-2023-051
Preliminary – 23 January 2024

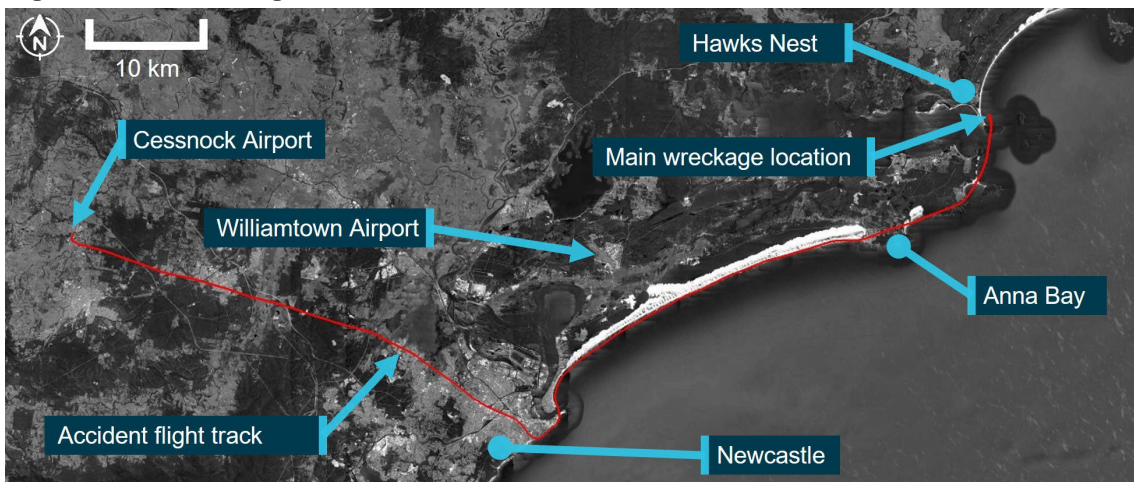
Figure 1: Accident flight of VH-KFT

On 26 October 2023 at about 0850 (local), the pilot and sole occupant of a Robinson Helicopter Company R66, registered VH-KFT, departed on a private flight from Cessnock Airport to Wallis Island Airport, NSW. The flight initially tracked easterly toward Newcastle (Figure 1). Onboard video¹ showed the helicopter flying close to the cloud base at heights between 500 ft and 1,000 ft above ground level. Light rain was visible on the windshield. Small deviations in attitude and direction were also shown in the video, consistent with the presence of light turbulence.

On approach to the coast, the pilot requested and received clearance from Williamtown air traffic control (ATC) to transit Williamtown restricted airspace northbound at 500 ft above mean sea level (AMSL) via the coastal visual flight rules (VFR) route until reaching Anna Bay. On reaching Anna Bay, Williamtown ATC provided further clearance below 2,000 ft AMSL for the remainder of the coastal VFR route (Figure 1). At this time the onboard video showed the pilot had the autopilot² system engaged, with heading hold, and altitude hold modes selected.
