# Runaway and derailment of loaded grain train 3966

Dombarton (12 km from Wollongong), New South Wales, on 15 December 2020

**ATSB Transport Safety Report**  
Rail Occurrence Investigation (Defined)  
RO-2020-022  
Final – 24 January 2024

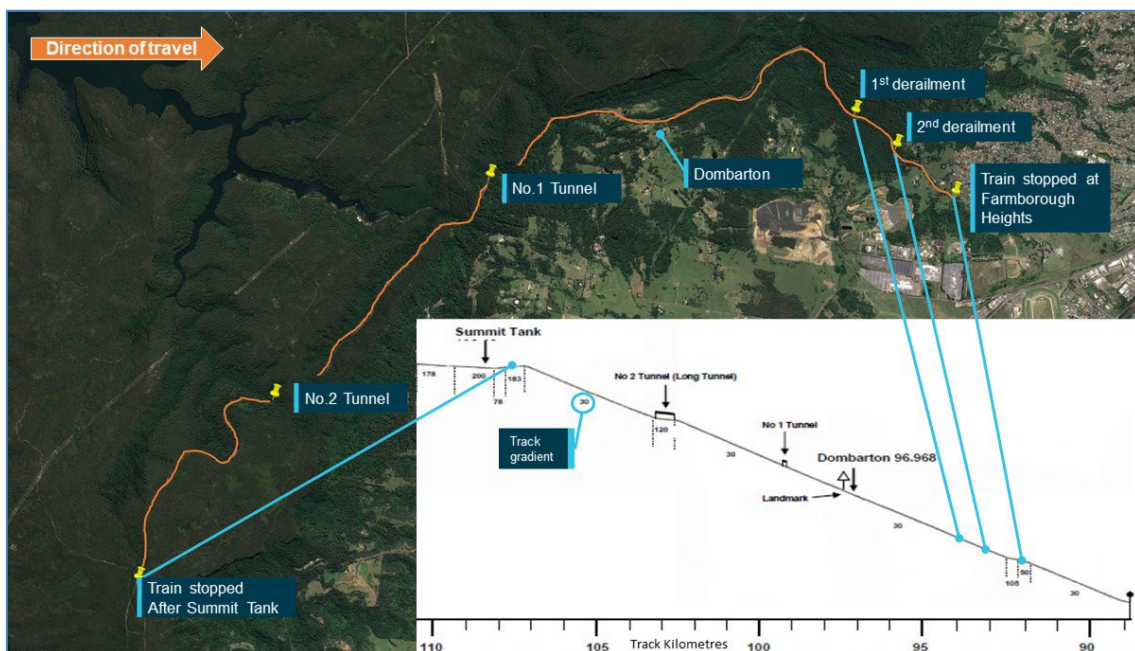
**Figure 1: Section of Moss Vale to Unanderra rail line between Summit Tank and Farmborough Heights**

On 14 December 2020, at approximately 1815 Eastern Standard Time (EST),<sup>1</sup> Qube loaded grain train 3966 departed Temora, New South Wales (NSW) bound for Inner Harbour Port Kembla, NSW. The train travelled through the night and in the early hours of 15 December 2020 commenced the descent on the Moss Vale to Unanderra rail line. Between Summit Tank and Farmborough Heights, the train ran away,<sup>2</sup> derailed and separated at two locations. The 29<sup>th</sup> to 41<sup>st</sup> wagons derailed and separated at approximately 93.730 km from Sydney's Central Station. Then the 3<sup>rd</sup> to the 28<sup>th</sup> wagons derailed and separated at approximately 93.220 km, before the locomotives and two remaining wagons came to a stop at Farmborough Heights (Figure 1).

This image shows where the train stopped prior to descending the mountain, the points of derailment and where the train stopped. The inset is the track gradient diagram with corresponding stop points and derailments.  
Source: Google Earth and QUBE, annotated by OTSI

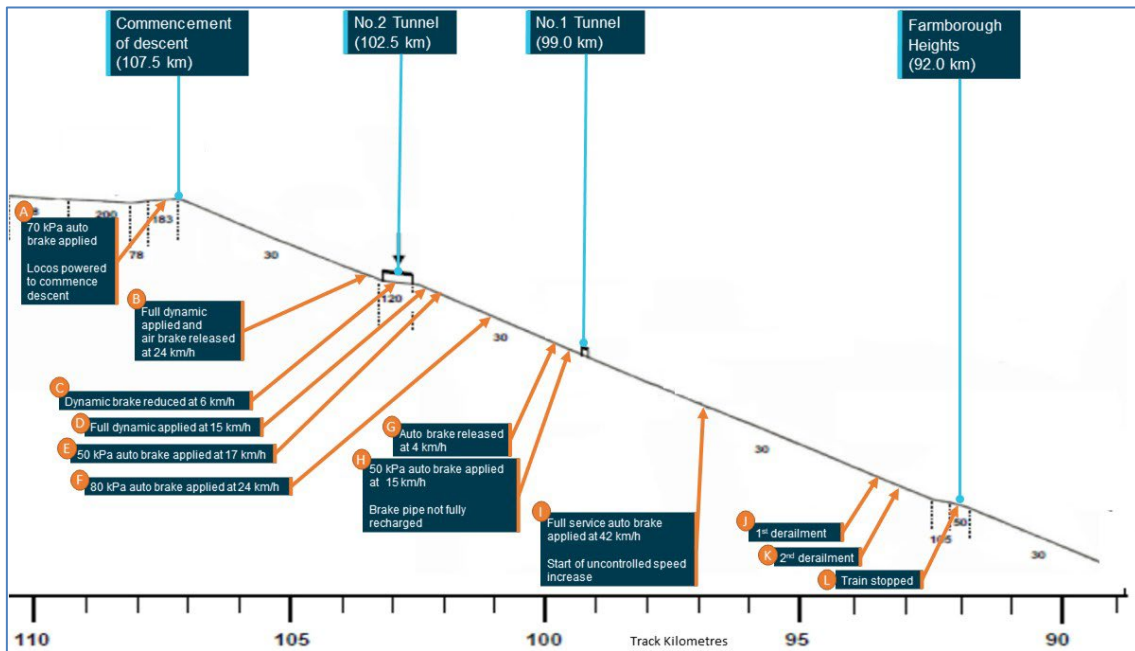
Figure 2: Sequence of events

This image shows the sequence of events leading up to the loss of control and derailments.

At 0436 the train entered No.2 Tunnel travelling at 24 km/h. The driver applied full dynamic brake and released the automatic brake (see B in Figure 2).

At 0453, at about 97.1 km, with the train speed at 42 km/h, the driver applied the automatic brake to 'full service'<sup>14</sup> (see I in Figure 2). The train continued to increase speed up to 45 km/h over the next 20 seconds. The driver was heard on the in-cab recorder to say, 'we're not going to stop', and then contacted Network Control. Over the next 90 seconds the speed increased to over 60 km/h.

At 0457, with the front of the train at 93.100 km and travelling at about 98 km/h, the 3<sup>rd</sup> wagon up to the 28<sup>th</sup> wagon derailed and separated from the front part of the train. The train was on a right-hand 200 m radius curve in the direction of travel (see K in Figure 2).

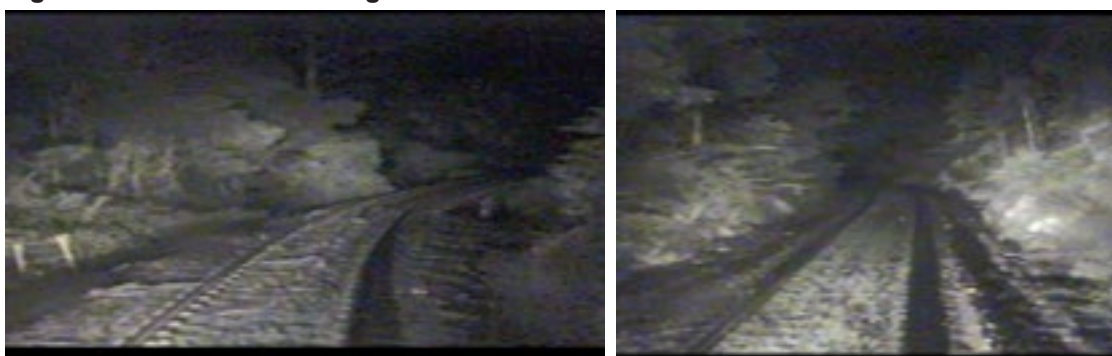
**Figure 4: Front of train footage of track**

*Taken from 3966 front of train camera between 104.000 km and prior to entering No.2 tunnel. Tree foliage lines the track.  
Source: Qube*

During the post incident track inspections, the contaminant observed on the head of the rail lines was more prominent in areas where the tree foliage was denser and dissipated as the trees cleared. The condition of the rail line closer to the top of the escarpment near Summit Tank was not observed during the site inspection, however it was considered likely the condition of the rail line at that time would have been similar to that observed at the derailment sites. The front of train footage (see Figure 3) indicated the density of tree foliage to be similar.

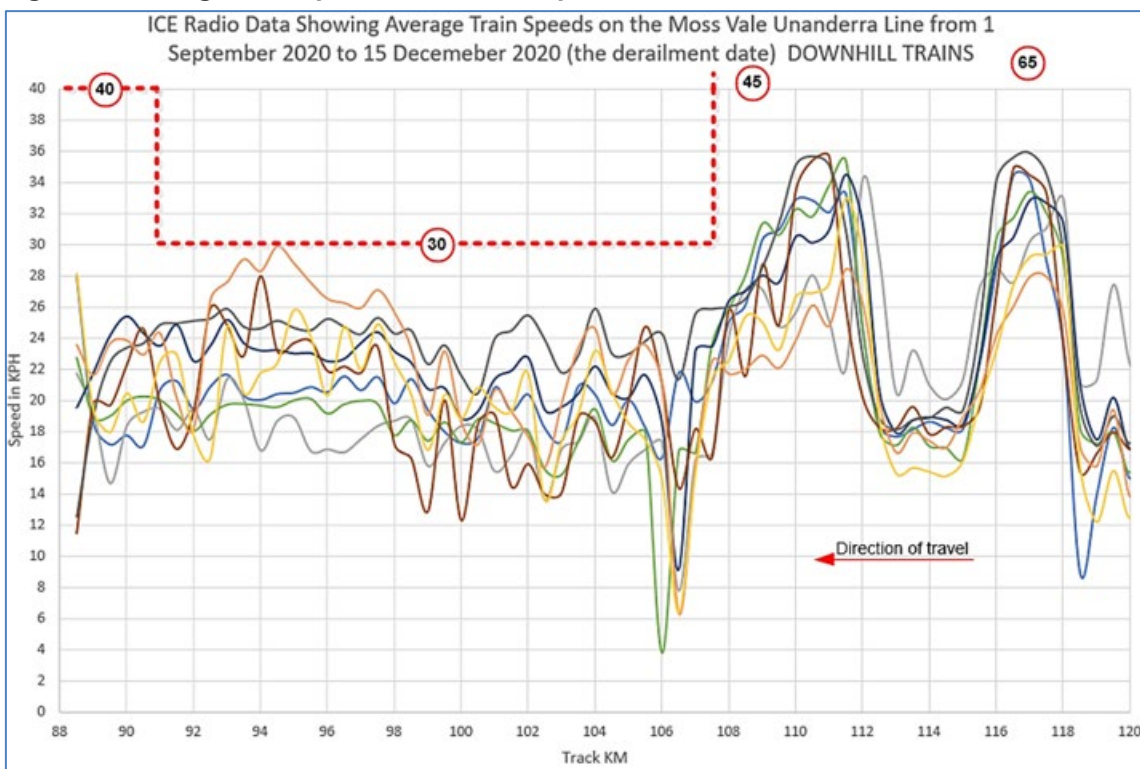
**Figure 6: Average train speed all RSOs 1 September 2020 to 15 December 2020**

Between 1 September 2020 and 15 December 2020 there were 412 services. Each coloured line on Figure 6 represents an RSO and the average speed of their combined services.

Each coloured line represents a RSO and the average speed of all their train services that travelled down the mountain. The red dotted line indicates the speed limit in that section of track.

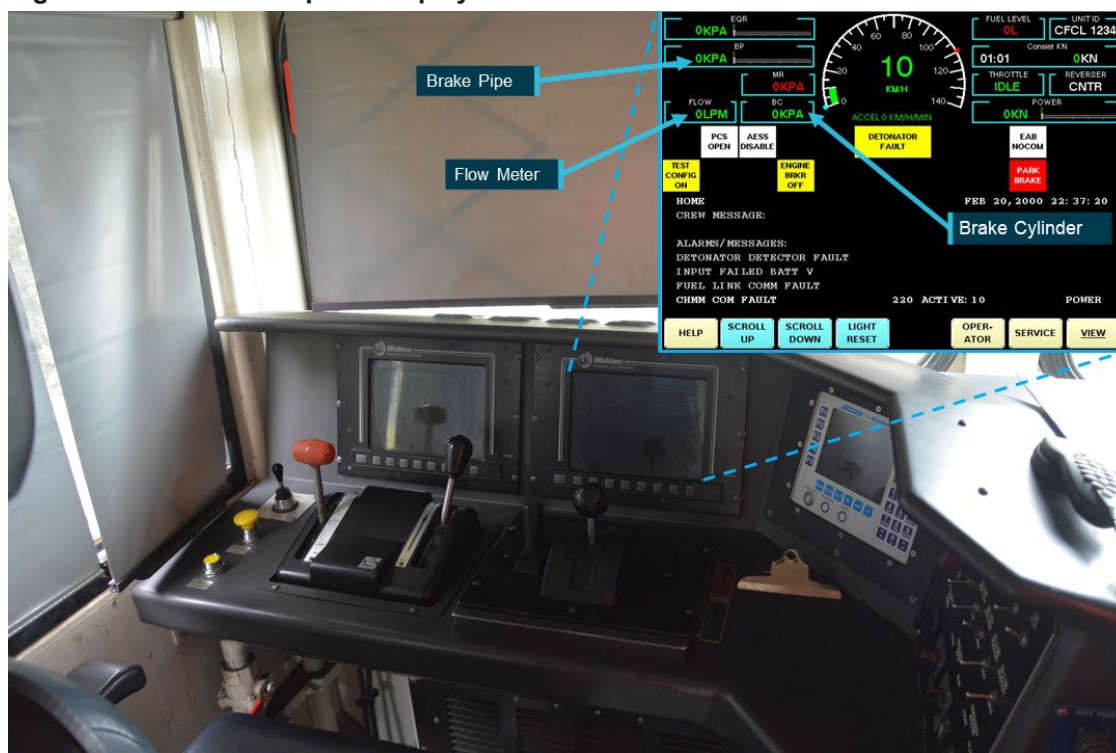
**Figure 22: Driver's computer display unit**

On the CM class locomotive, the brake pipe charging flow indicator is on a computer display unit (CDU) on the driver's control station. The indicator consists of a numeric value of main reservoir to brake pipe air flow expressed in litres per minute. It is located at the bottom of a bank of similar numeric displays including the brake pipe, main reservoir and locomotive brake cylinder pressures (see Figure 22). There is no accompanying visual annunciator tile or audible alarm to draw the driver's attention to the activation of the brake pipe charging flow indicator.
