Australian Transport Safety Bureau

Derailment of coal train 9QJ5

near Mount Rainbow, Queensland, on 30 October 2021

ATSB Transport Safety Report
Rail Occurrence Investigation (Short)
RO-2021-013
Final – 30 January 2024

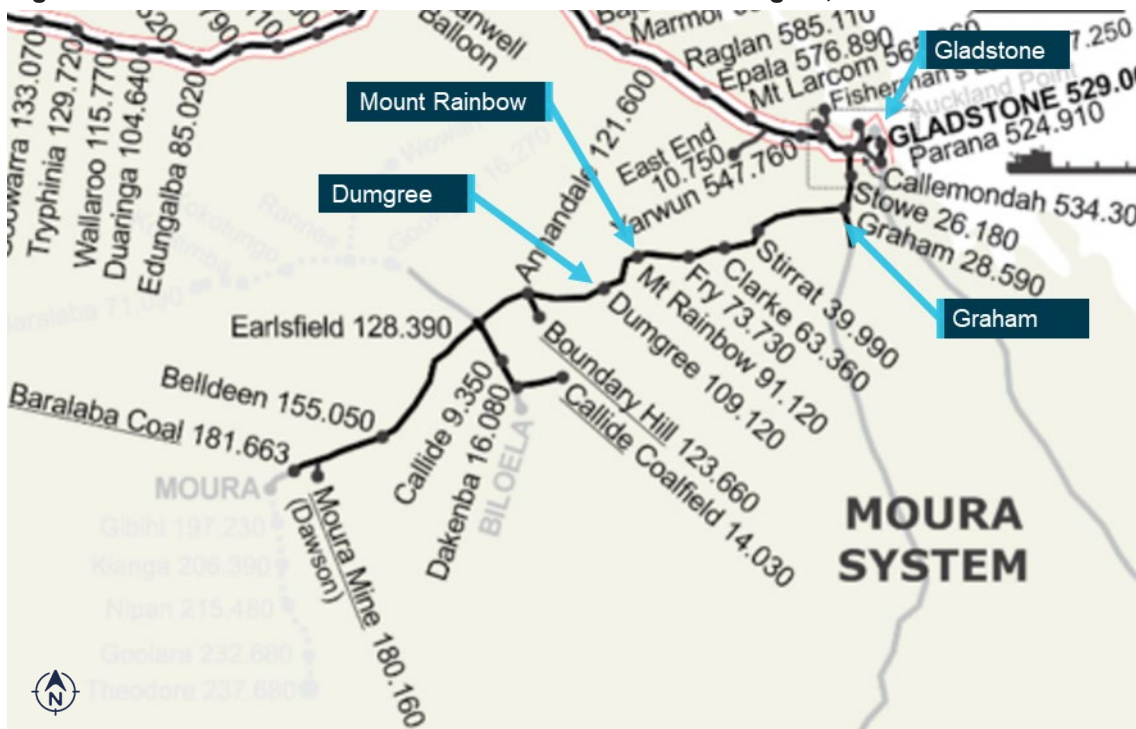
Figure 1: Location of the track works Mount Rainbow – Dumgree, Queensland

On 27 October 2021, at about 1230 local time, Aurizon’s RM902 ballast cleaning machine began ballast undercutting work along a section of track between Dumgree and Mount Rainbow, Queensland, from 99.800 km to 98.300 km. The work was part of planned track maintenance on Aurizon Network’s Moura system, integrated possession number 75, between Graham and Dumgree (Figure 1).
