ATSB TRANSPORT SAFETY REPORT

MO-2011-001

**Thermal oil heater explosion on board the
products tanker**

Qian Chi

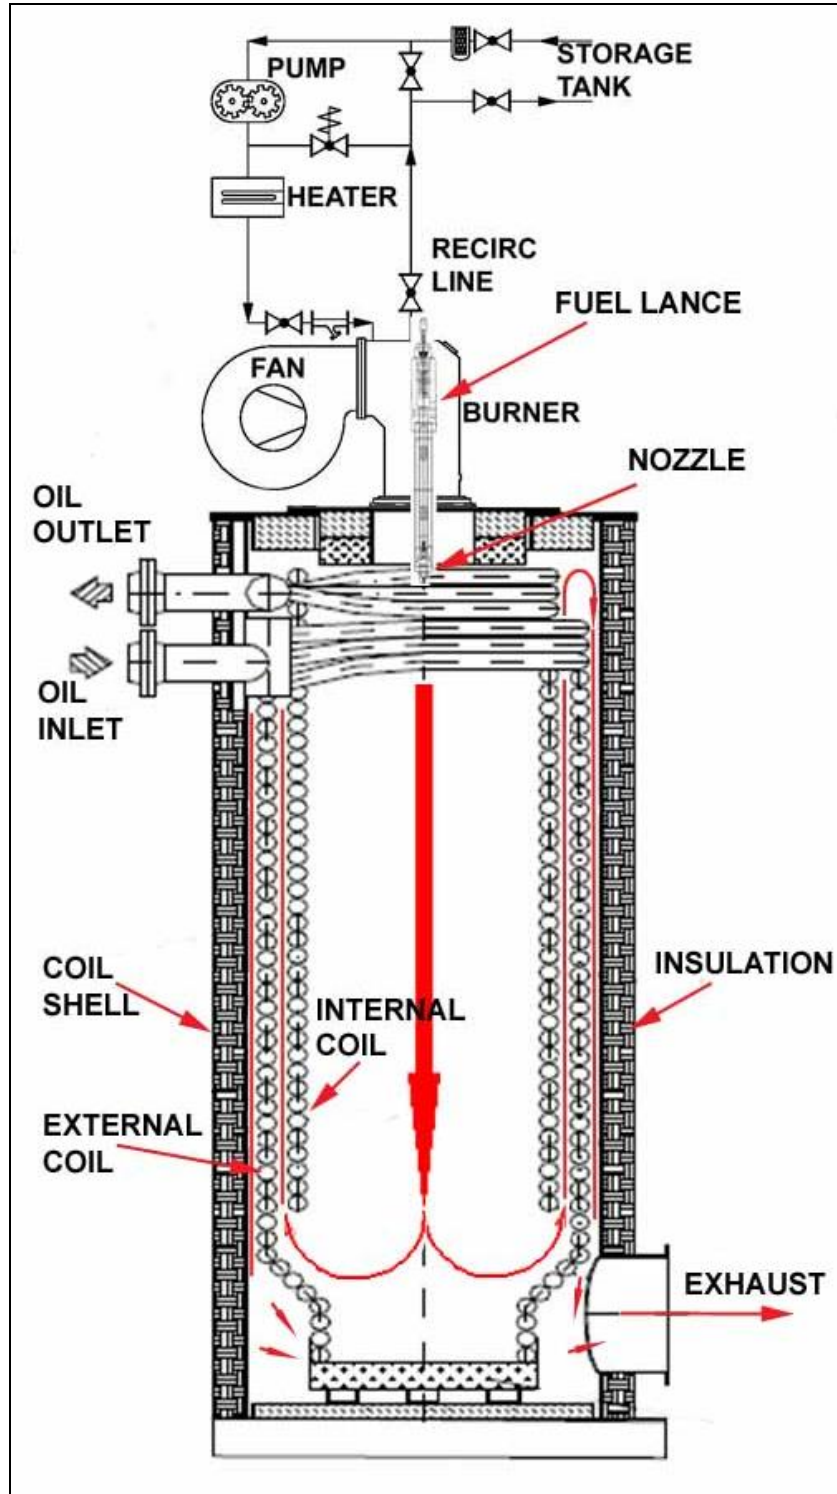
Figure 2: Garioni Naval vertical thermal oil heater as fitted in *Qian Chi*

The oil-fired thermal oil heaters were approximately 6.2 m tall and had a diameter of 2.5 m. They were located on platform A in the after part of the engine room and spanned two decks, extending up the funnel space (Figure 8). They were of roof-

fired vertical design with heating surfaces formed by two concentric coils of thermal oil circulation piping. This created three passes of combustion gas flow over the coils (Figure 2).

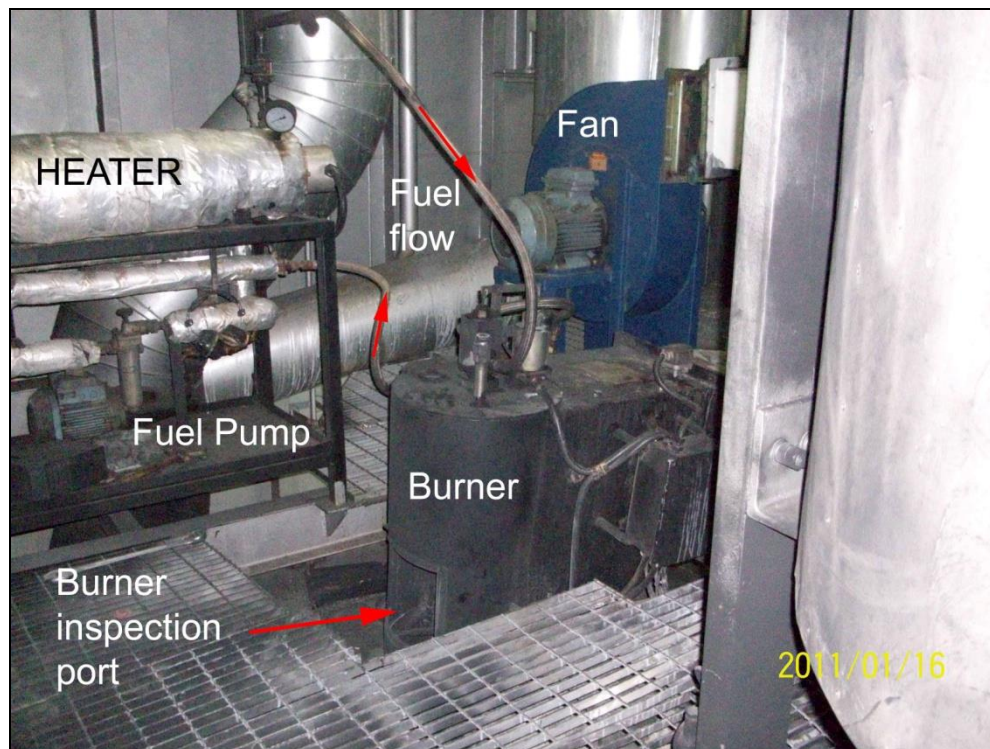
Figure 3: Thermal oil heater top showing burner and fuel supply layout

The firing system consisted of an external forced-draught fan and a fuel treatment unit feeding the roof mounted burner lance, nozzle and combustion head (Figure 3). Fuel from a storage tank was pumped to the inlet of the fuel unit burner pump. This pump then boosted the fuel pressure and circulated it through the electric heater, to the burner lance and nozzle, returning through the regulating valve to the suction side of the pump.

Combustion air was ducted from the fan to the side of the burner unit and flowed, via a modulating damper, down around the oil lance and into the furnace.

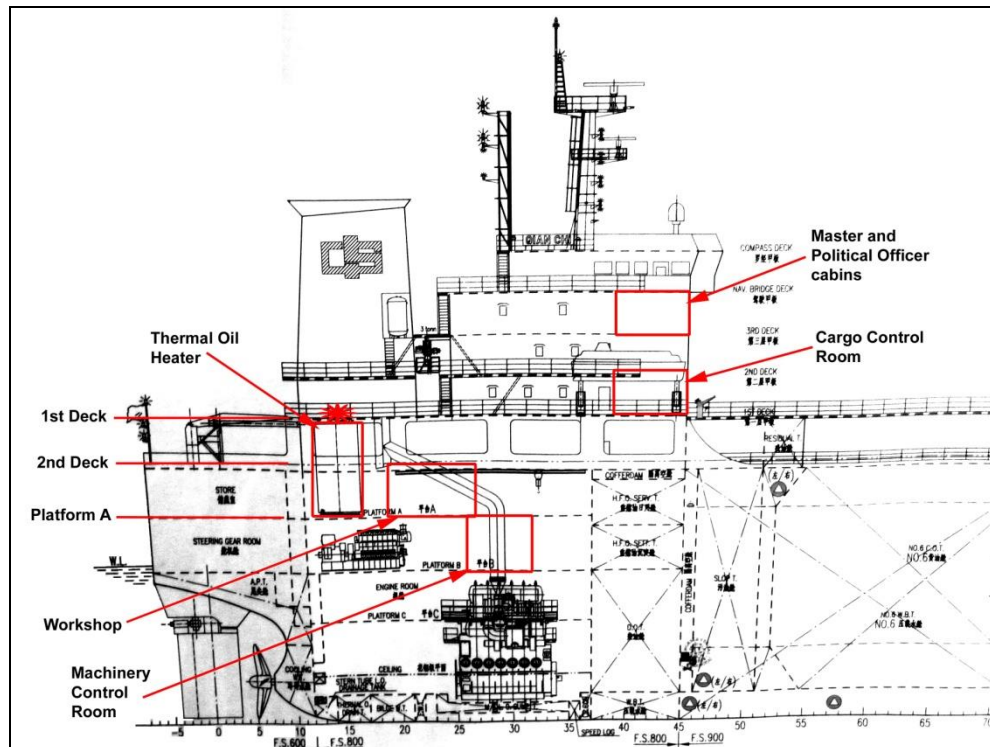
Figure 8: *Qian Chi* arrangement showing general location of explosion, workshop, cargo control room, machinery control room and master's cabin

The electrician and the cadet made their way onto the open deck and forward to the accommodation where they met the chief mate, who told them to go to the political officer's cabin for medical treatment (Figure 8). The third engineer escaped down into the engine room and made his way toward the workshop where he met the chief engineer who had heard the explosion and was making his way aft to investigate. He directed the third engineer to the political officer's cabin to seek medical assistance.
