ATSB TRANSPORT SAFETY REPORT

Marine Occurrence Investigation
MO-2011-005
No. 286
Final

**Investigation into the capsizing of the
Australian registered tug**

Adonis

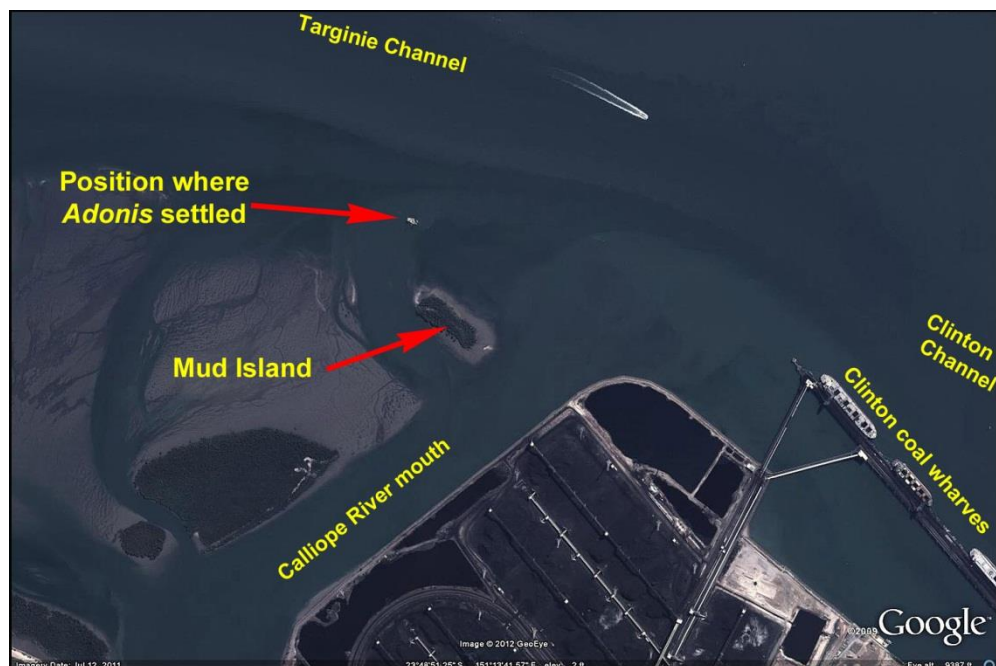
Figure 15: Image showing the position where *Adonis* settled

Sometime between 1430 and 1530, *Adonis* sank in position 23° 48.6'S 151° 13.5'E, to the north of Mud Island (Figure 15). It settled on its starboard side in about 6 m of water.

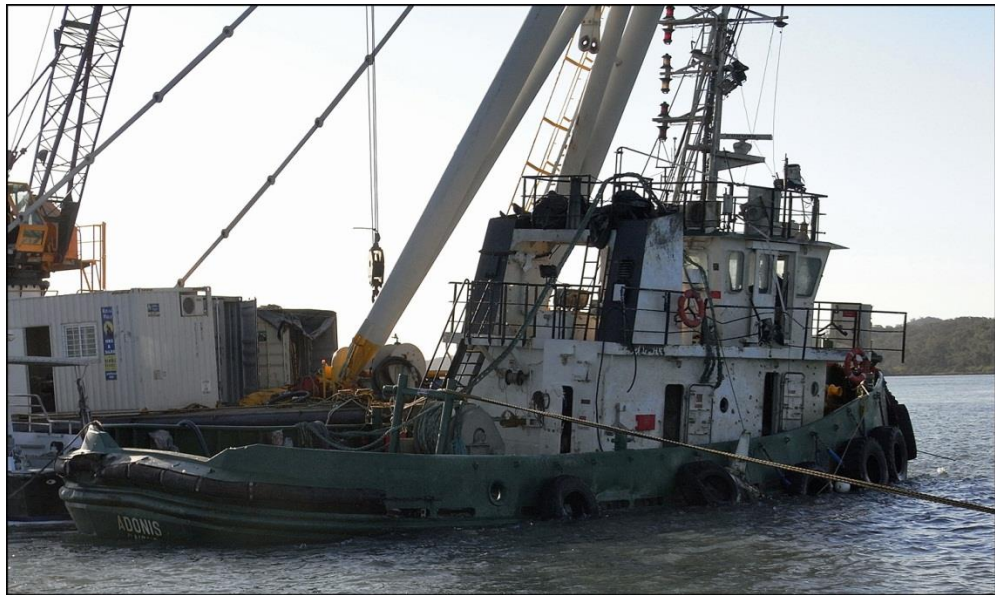
Figure 16: *Adonis* immediately following its refloating

Towards the end of June, salvors were appointed by Sea Swift to refloat *Adonis*, and in mid-July, the tug was brought clear of the water (Figure 16).

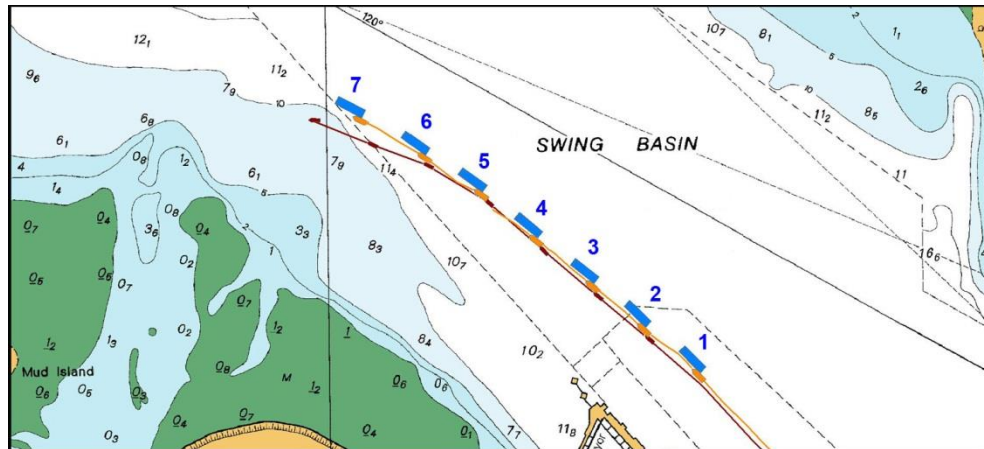
Figure 17: AIS positions of the tugs and barge

12:46:28. It is therefore reasonable to conclude that the tug started to enter a capsize situation at about 1246 and within 30 seconds had capsized.

The data also shows that there was a measurable reduction in the speed of *Wolli/Chrysus* 10 seconds after *Adonis* capsized and that this reduction continued. It is likely that the initial drop in speed, and course change to port, was the result of *Adonis* acting as a ‘drag’ on the other two vessels and the effect of *Wolli*’s engines going astern.

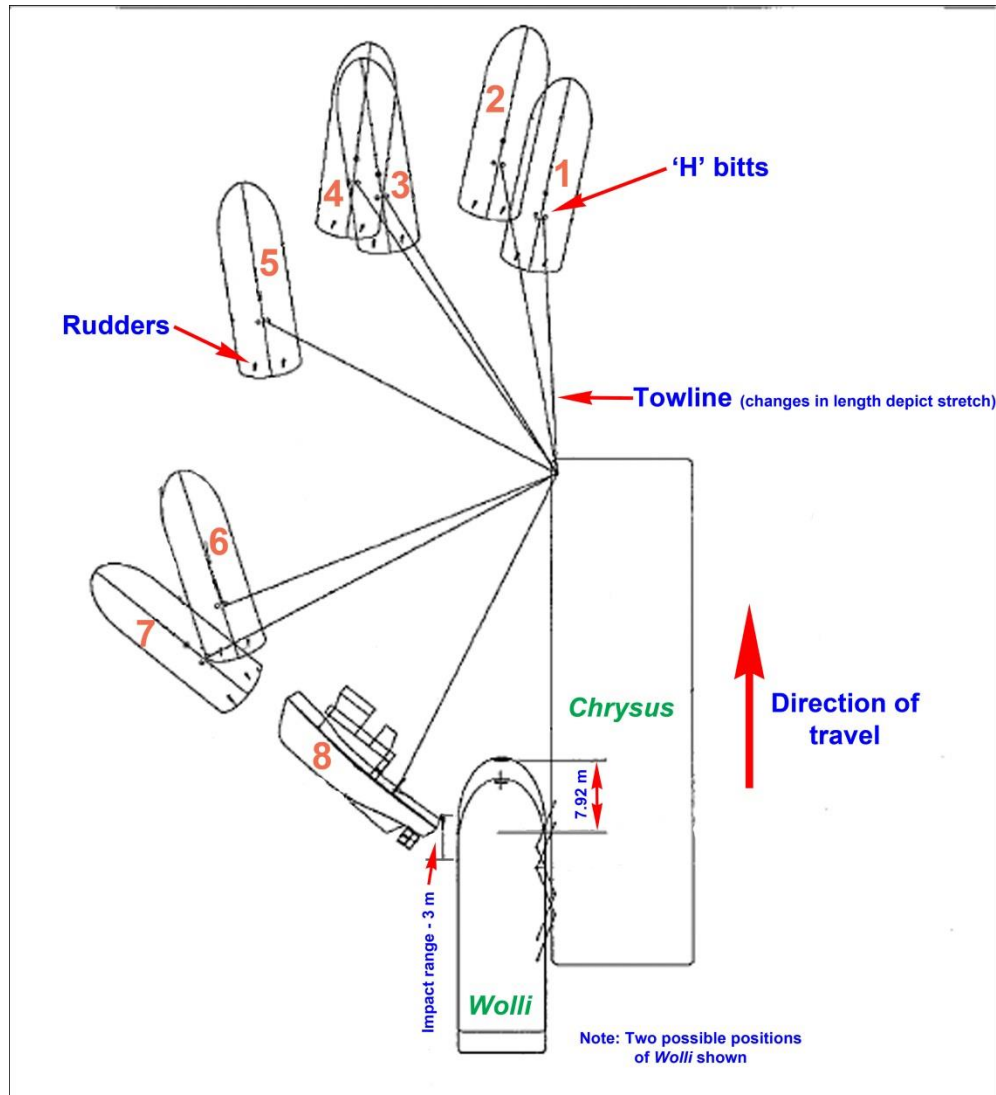
Figure 18: Diagram showing *Adonis*'s possible positions and aspect to the direction of travel before capsizing

Consequently, when *Adonis* began to move to port (Figure 18), the speed of the barge had not decreased and as a result, the towline forces acting on *Adonis* began to increase. As *Adonis* moved further to port, the master commented that he was having trouble steering the tug, indicating that he could not manoeuvre the tug back to a position at the front of the barge. Still, the speed of the barge was not reduced.

While the masters of both tugs were aware of what it meant to 'girt a tug', neither of them recognised that *Adonis* was entering a classic girting scenario when *Adonis*'s master said that he had lost steerage of the tug. If swift action had been taken to reduce the speed of the tow as soon as *Adonis*'s master said that he had lost steerage, the towline forces would have reduced and that may have enabled *Adonis*'s master to regain steerage and take the weight off the towline, thereby avoiding the capsizing.

Consequently, *Adonis*'s master lost steerage of the tug and the tug's movement came under the direct control of the towline forces. This resulted in the tug swinging around on the towline and colliding with *Wolli*'s bow (Figure 18).

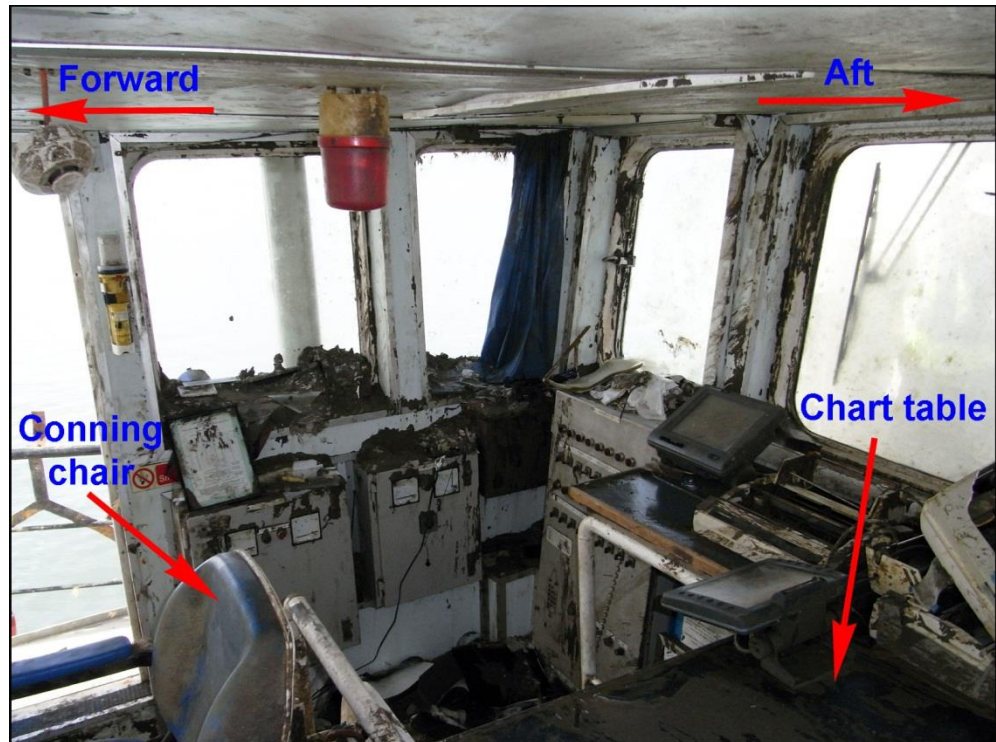
Figure 22: Wheelhouse overview

The wheelhouse remote release for *Adonis's* towing hook was situated at the after end of the wheelhouse, under the chart table (Figures 22 and 23). In that position, it was not possible for *Adonis's* master to reach the remote release handle while he was actively trying to manoeuvre the tug. Consequently, on 11 June 2011, he called out to the deckhand who was standing aft of the wheelhouse to release the hook. The deckhand then passed this instruction to the engineer who was closer to the hook at the time and better placed to move the release lever on the hook itself.
