Contact with buoy by *Navios Northern Star*

Prince of Wales Channel, Torres Strait, Australia | 15 March 2016

ATSB Transport Safety Report
Marine Occurrence Investigation
325-MO-2016-003
Final – 23 June 2017

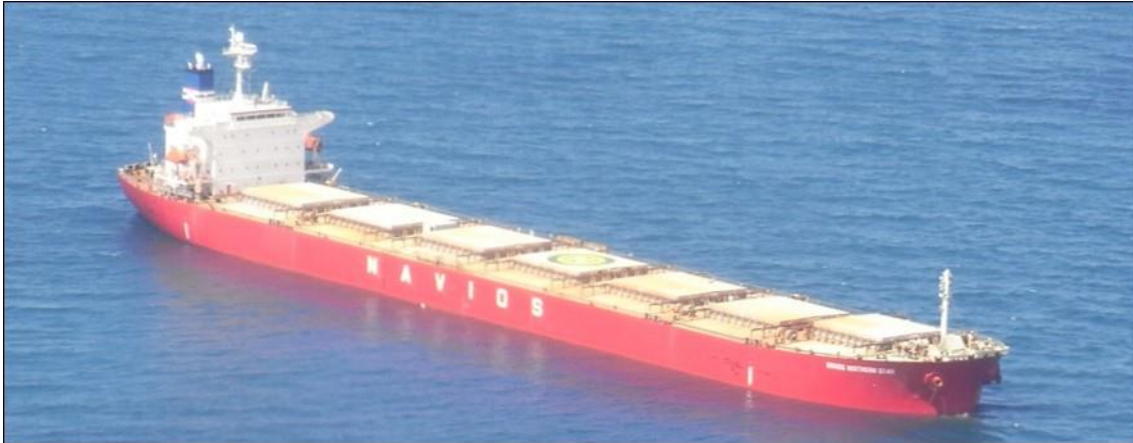
Figure 1: *Navios Northern Star*

On the evening of 14 March 2016, the 225 m bulk carrier, *Navios Northern Star* (Figure 1) sailed from Gove (Northern Territory) bound for Gladstone (Queensland) via the Torres Strait. The ship was nearly fully laden with a cargo of bauxite and would transit the Torres Strait at the maximum permitted draught of 12.2 m. After transiting the Prince of Wales Channel (PoWC) in the Torres Strait, the deep draught ship would turn south and sail through the Inner Route of the Great Barrier Reef (GBR) to its destination.

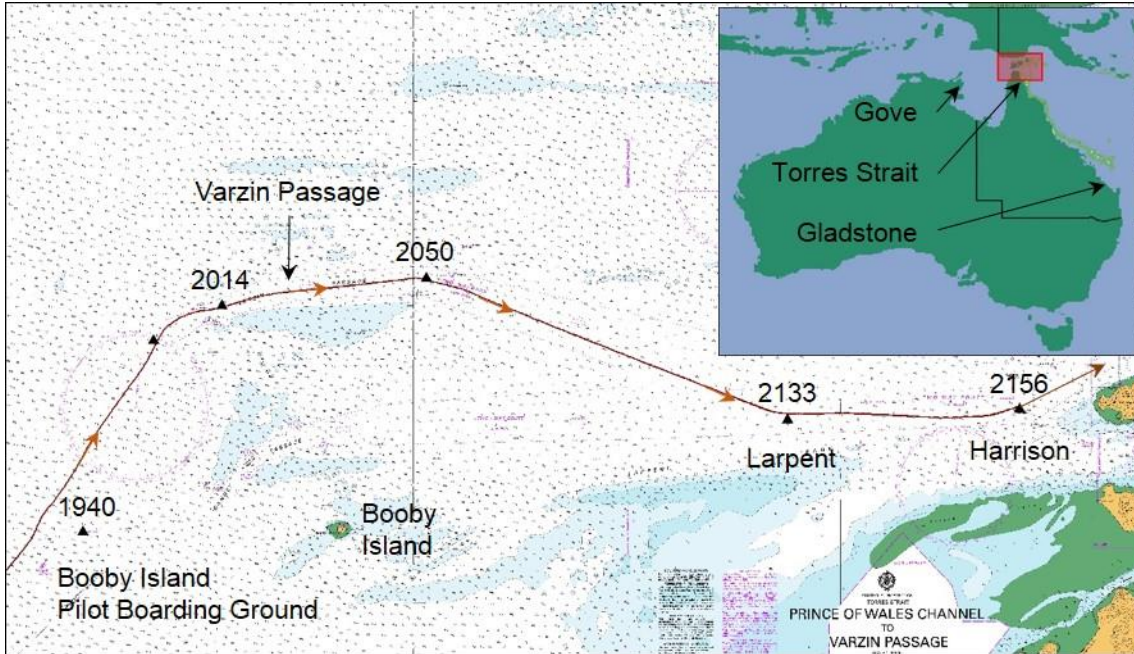
Figure 2: Section of ENC Aus 296 showing *Navios Northern Star's* actual track

At 1800¹ on 15 March, the ship started its approach to the Booby Island pilot boarding ground (Figure 2) to board a coastal pilot (pilot) for its GBR transit. The master took over the conduct² (con) of the ship and the chief mate, the officer of the watch (OOW) remained on the navigation bridge (bridge) to assist the master. The ship was in hand steering with a seaman at the wheel.

At 1940, the pilot and a trainee pilot (trainee) boarded *Navios Northern Star* near the Booby Island pilot boarding ground. The third mate escorted them up to the bridge, where the pilot started the master-pilot information exchange (MPX) with the master. After asking about the status of the ship's anchors, the pilot took over the con and reported to REEFVTS,³ the coastal vessel traffic service. He then configured the s-band⁴ radar display for the transit of Varzin Passage (Figure 2).

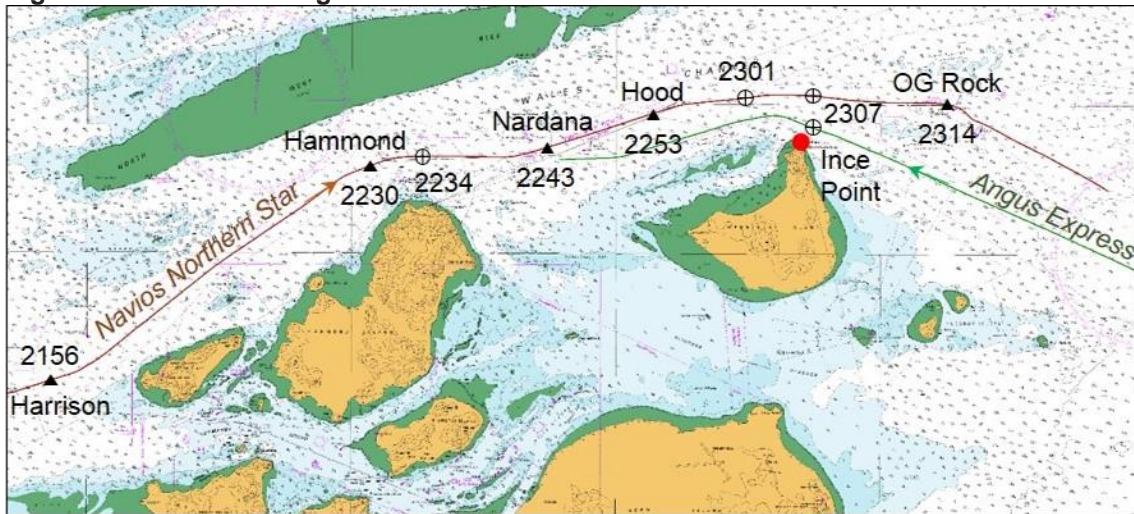
Figure 3: Section of navigational chart Aus 293 Prince of Wales Channel

Shortly after 2156, the ship entered the PoWC and was turned onto a north-easterly course. The transit through the channel (Figure 3) continued as intended by the pilot, with him conning the ship and the other bridge team members attending other tasks.

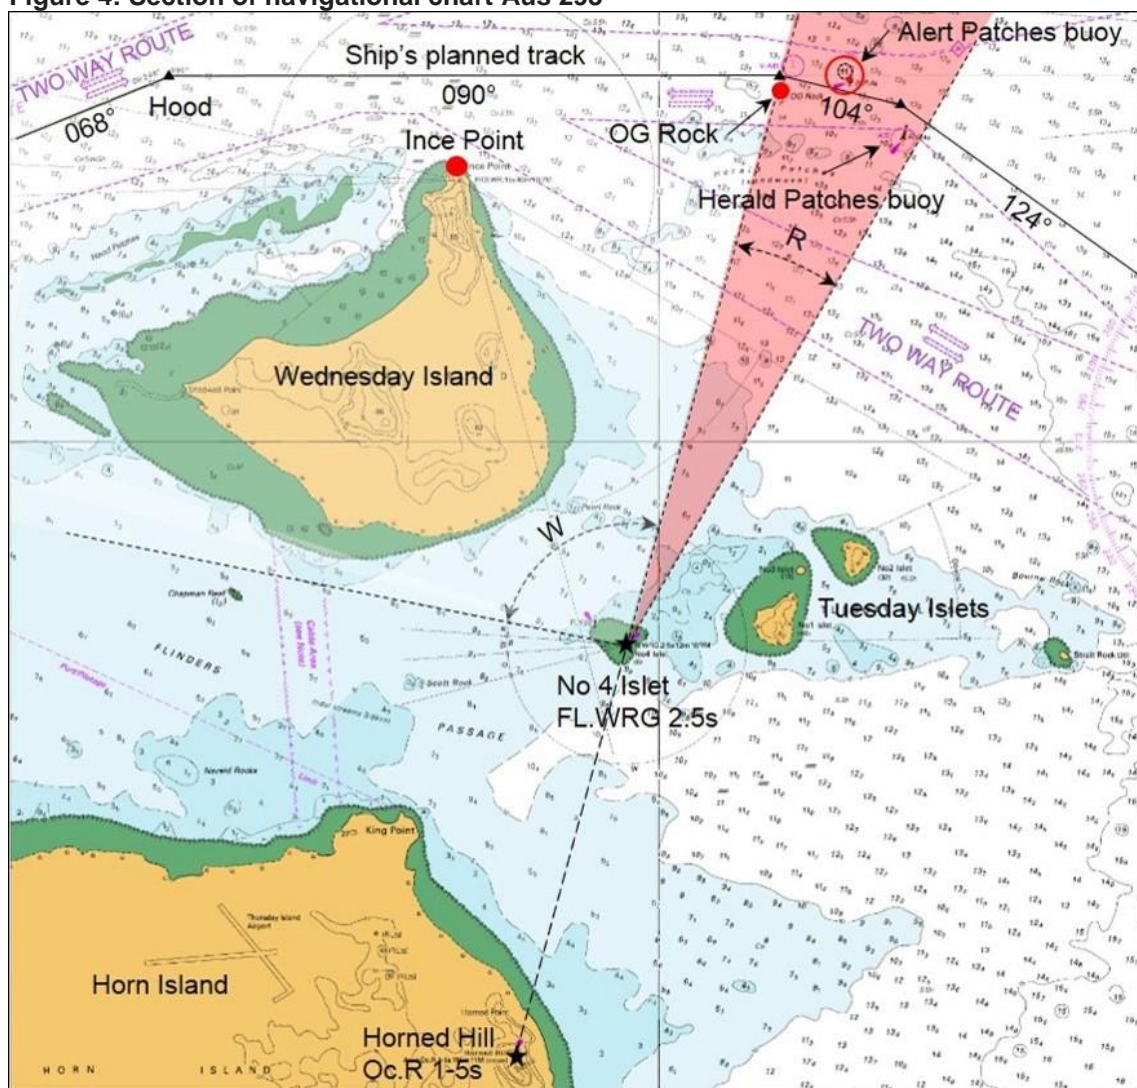
Figure 4: Section of navigational chart Aus 293

At about 2251, as the pilot and trainee continued their conversation, the third mate gave the pilot 7 cables notice to the next waypoint, Hood. The trainee then stated that when the Horned Hill light was in transit with Islet No 4 (Figure 4), the ship should be turning. The pilot agreed as the ship would then be in the red sector of Islet No 4.

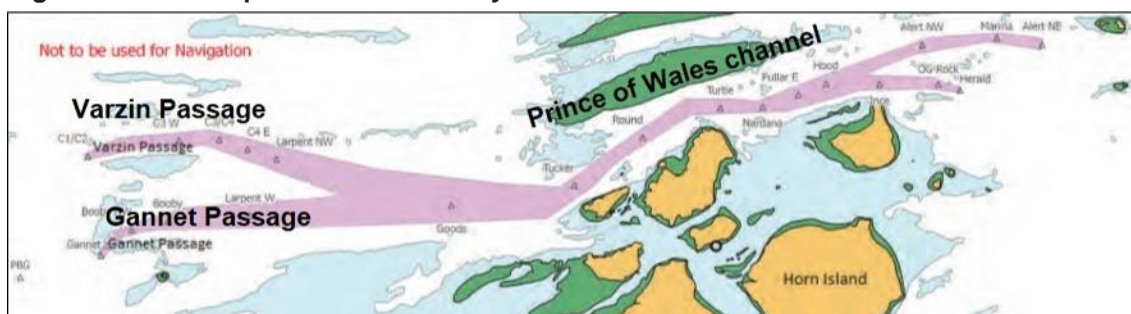
Figure 6: Area of operation of UKCM system in Torres Strait

It is an internet-based system that estimates a vessel's UKC in real time. By using a defined set of operational parameters, the UKCM system calculates tidal windows to meet AMSA's UKC requirements. The system monitors the ship's UKC margin throughout the transit. All coastal pilots transiting ships with a draught of 8 m or more, through the Prince of Wales Channel, the Varzin or Gannet Passages (Figure 6), are required to use the UKCM system.
