ATSB TRANSPORT SAFETY INVESTIGATION REPORT

Rail Occurrence Investigation – 2006/007

**Derailment of Train 2CM3
near Seymour, Victoria**

12 September 2006

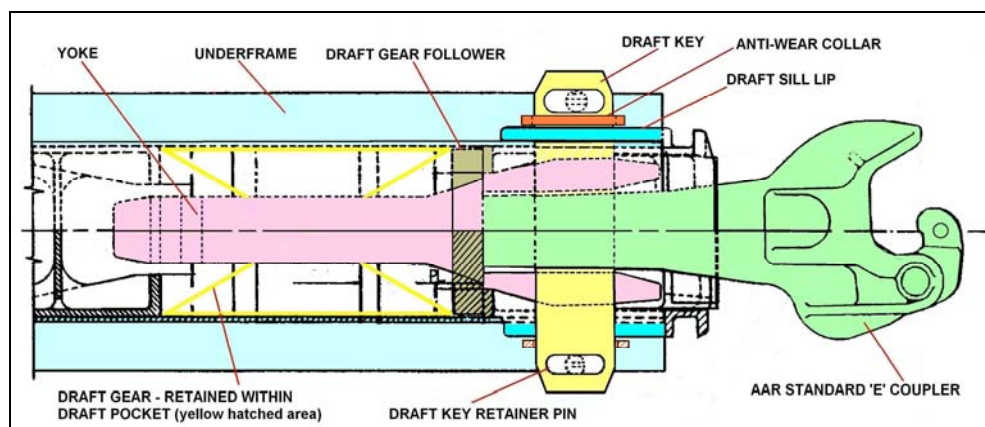
Figure 4: Sectioned general arrangement diagram of a mounted 'E' coupler and associated components

The draft equipment fitted to CQBY 0118A consists of the coupler, draft gear, draft key, yoke, yoke carrier and follower. Major components discussed in the investigation are shown in Figure 4.

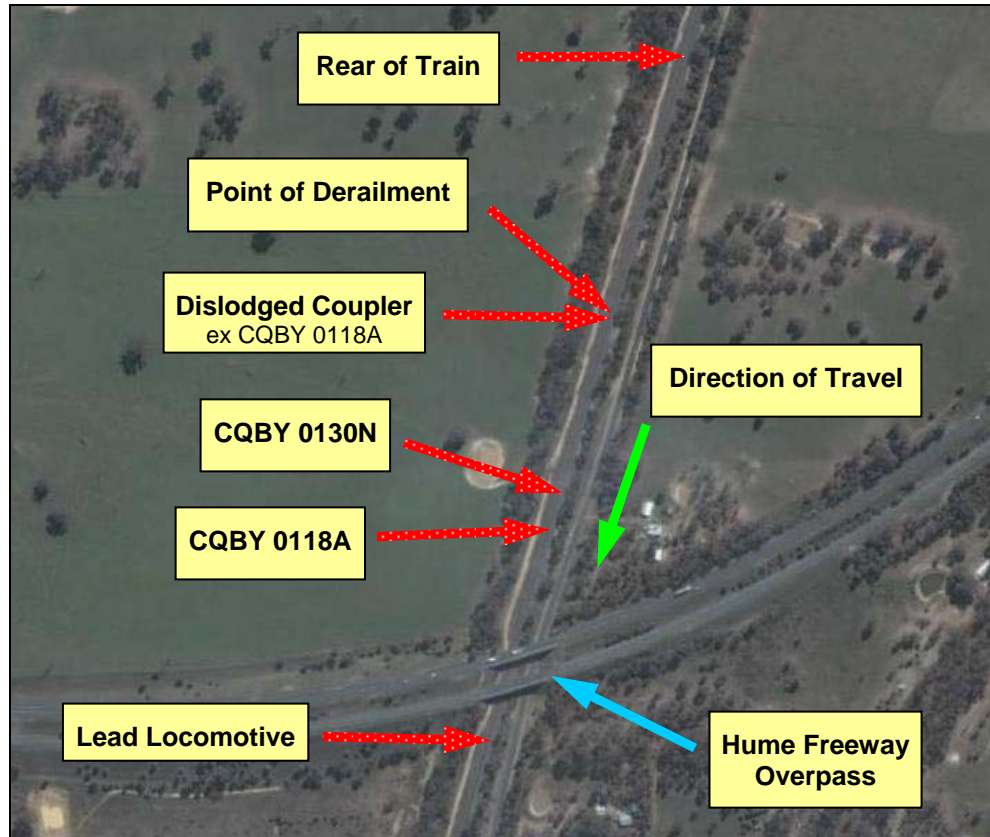
Figure 12: Aerial photograph of track showing point of derailment and location of vehicles in train consist

On inspection it was found that the coupler from the leading end of the eighth wagon (CQBY 0118A) had fallen onto the track. The dislodged coupler had bounced under the trailing vehicles causing minor damage to brake rigging and other low mounted equipment before being caught under the 11th wagon (CQBY 0130N) where it derailed both wheels of the rear axle on the leading bogie. The train continued over the dislodged coupler (Figure 13) that was later found

under the 22nd wagon (NQPY 14587T). The standing distance between the seventh and eighth wagons after separation was approximately 30 metres.

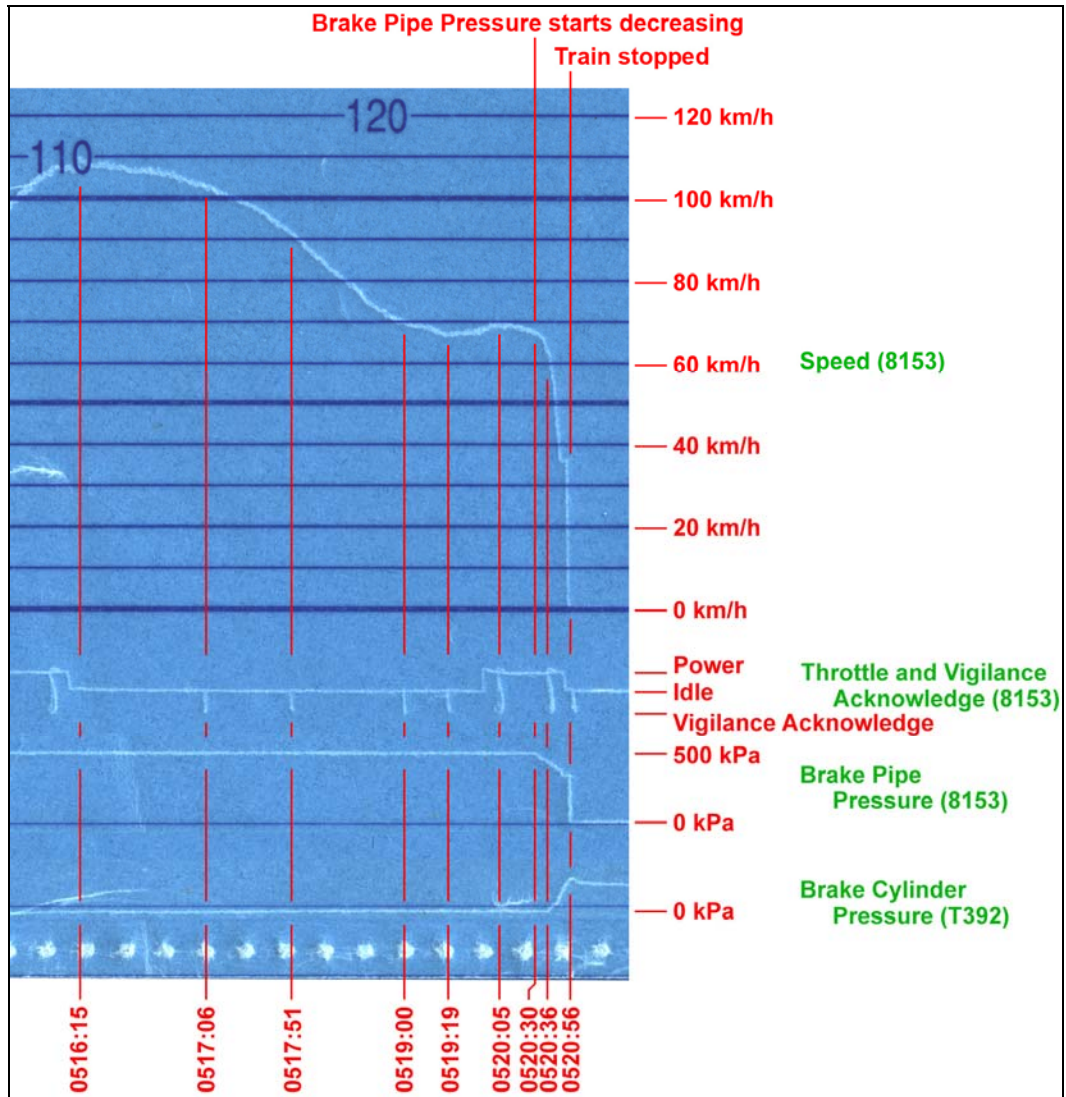
Figure 14: Combined extracts of 'Hasler' event data loggers from locomotives 8153 & T392 (horizontal blue line division = 10km/h)

Figure 14 provides a graphical representation of the sequence of events for train 2CM3 leading up to the train parting and shortly after the train came to a stop.
