# Axle failure on XPT ST24

Culcairn, NSW, 24 October 2014

**ATSB Transport Safety Report**  
Rail Occurrence Investigation  
RO-2014-019  
Final – 5 July 2016

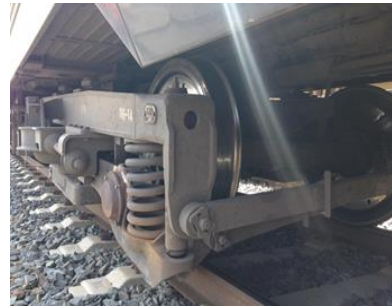
On 24 October 2014, the Melbourne to Sydney XPT service ST24 was approaching Culcairn station when there was a severe vibration. The driver stopped at the station and upon inspecting the train found that the axle had broken adjacent to the bearing box on the fourth passenger carriage. There were no injuries to passengers or crew. The passengers continued their journey to Sydney on chartered buses.

The ATSB found that the axle bearing had failed and completely seized, probably due to cage failure.

The probable cage failure caused the rollers to misalign and seize. This seizure of the rollers generated friction and excessive amounts of heat into the bearing journal. The heat applied to the bearing journal caused it to go 'plastic' and separate from the axle (commonly referred to as a screwed journal). In this case, much of the evidence was either lost or damaged beyond useful examination. Consequently, there was insufficient evidence available to determine why the bearing cage may have failed.

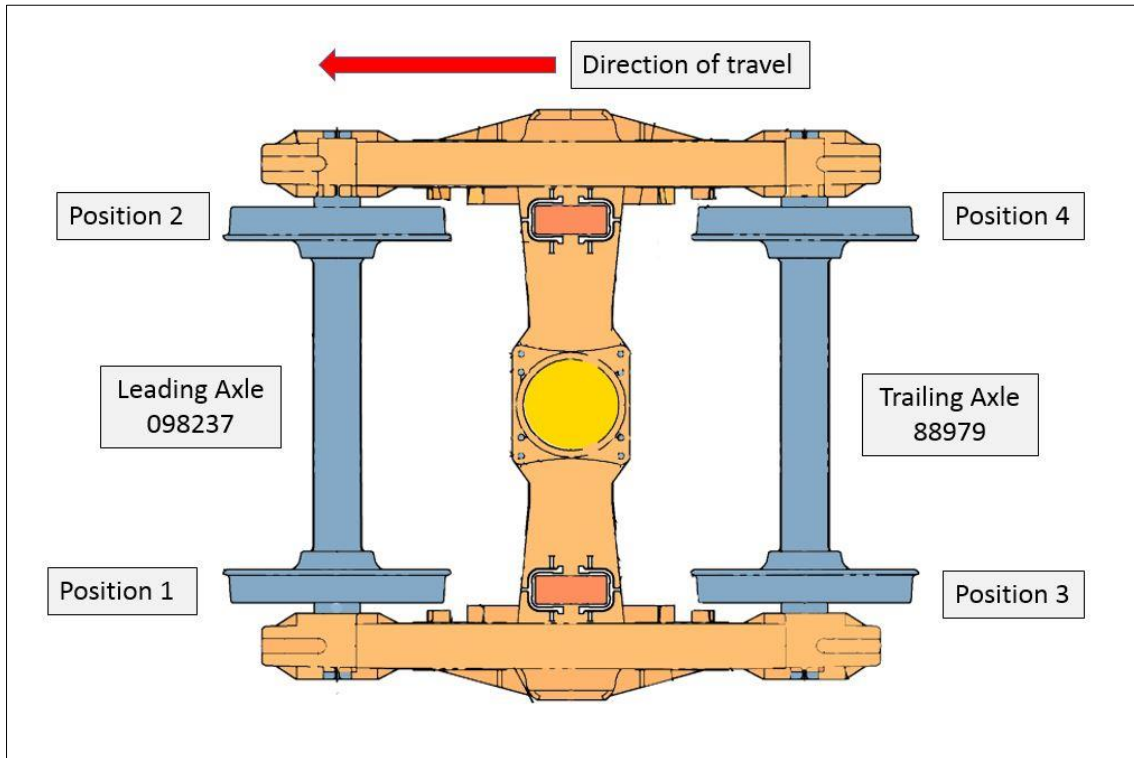
**Figure 5: Bearing position on bogie NHA-8B**

The bearing installed into position 3 (Figure 5) on bogie NHA-8B in June 2014 was a new bearing. The serial number of the bearing was 302379 with a manufacture date of July 2012.

Figure 5 is for illustrative purposes and not a direct representation of an XPT bogie. It illustrates the position number of the bearings and axle locations relative to the direction of travel. The failed bearing was located on the trailing bogie of car XL2235, in position 3, the left side of the trailing axle (in the direction of travel). Source: ATSB
