Shifted load collision with bridge

Great Western, Victoria, 9 December 2014

ATSB Transport Safety Report

RO-2014-022

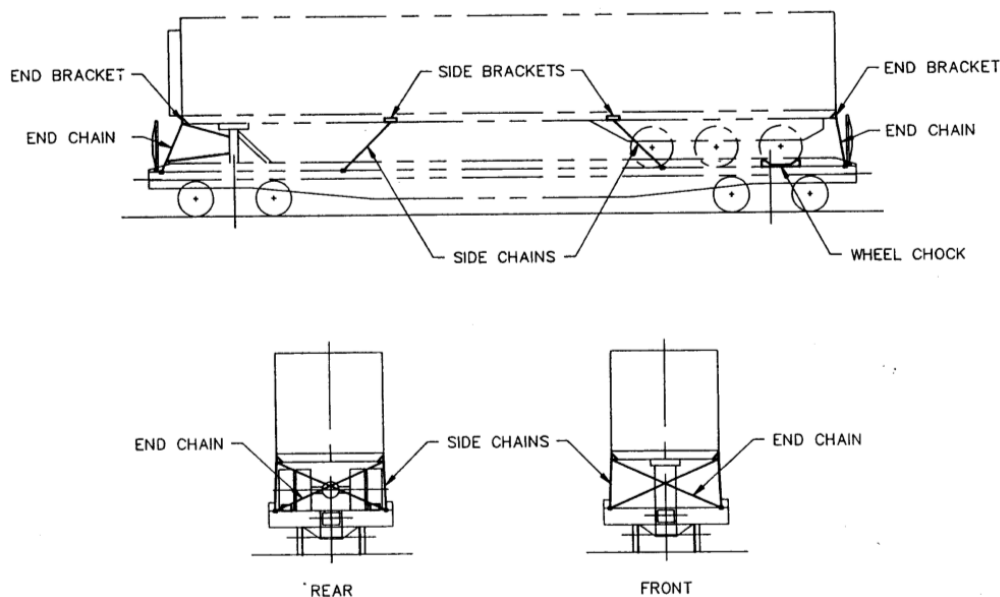
Figure 3: Lashing and securing typical arrangement

- a. Two (2) each end in diagonal configuration to provide lateral and longitudinal restraint.
 - b. Two (2) chains each side sloping away from each other to provide longitudinal restraint in both directions.

The RISSB CoP did not specifically provide for the double stacking of road vehicles. While SCT Logistics did not have any additional documented procedures addressing the securing and restraining of double stacking of road vehicles, it would be expected that the general principles of the CoP should still be applied.
