Signals Passed at Danger by Train 1240

Marshall near Geelong, Victoria | 29 May 2015

ATSB Transport Safety Report
Rail Occurrence Investigation
RO-2015-009
Final – 12 December 2016

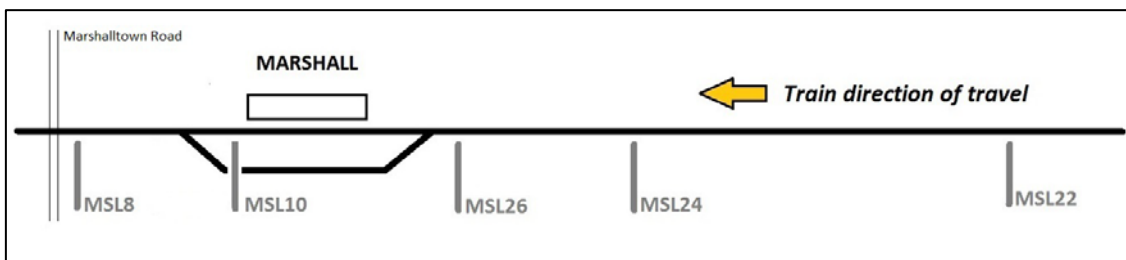
Figure 2: The signals controlling Geelong-bound rail traffic through Marshall

After the passage of the Melbourne-bound train (Train 8250), Train 1240 (the empty-cars) was signalled onto the mainline towards Marshall. It increased speed and travelled at between 80 and 90 km/h as it passed Waurn Ponds station. About a kilometre past Waurn Ponds, the train encountered Distant signal MSL22. This signal, about 3.6 km before Marshall Station, was the first of five signals that controlled Geelong-bound traffic on the mainline through Marshall (Figure 2).

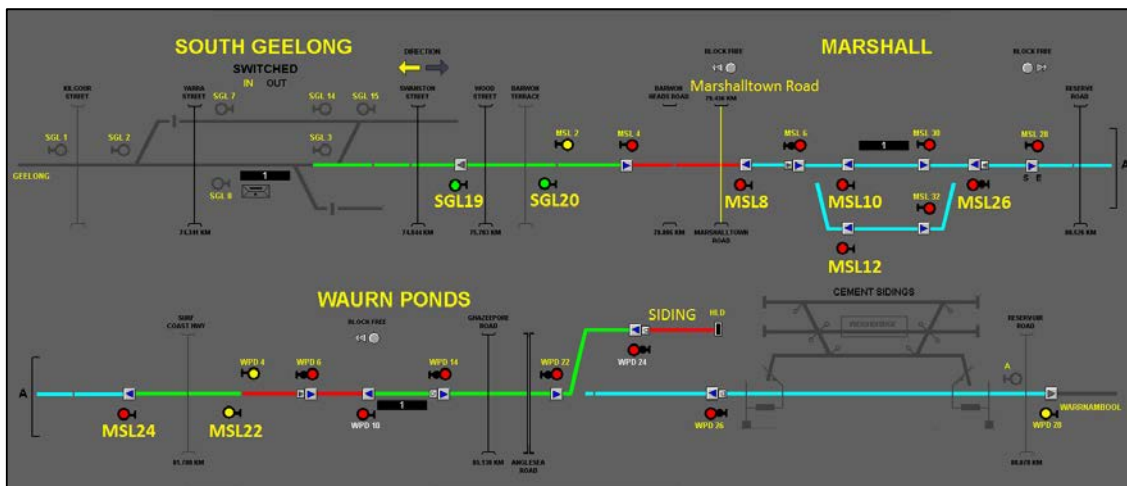
Figure 4: Extract of signalling control display South Geelong - Marshall - Waurn Ponds

Two-position coloured-light fixed signalling was in place between South Geelong – Marshall – Waurn Ponds. The signal numbers relevant to this event are shown enlarged on an extract of the signalling control display (Figure 4).

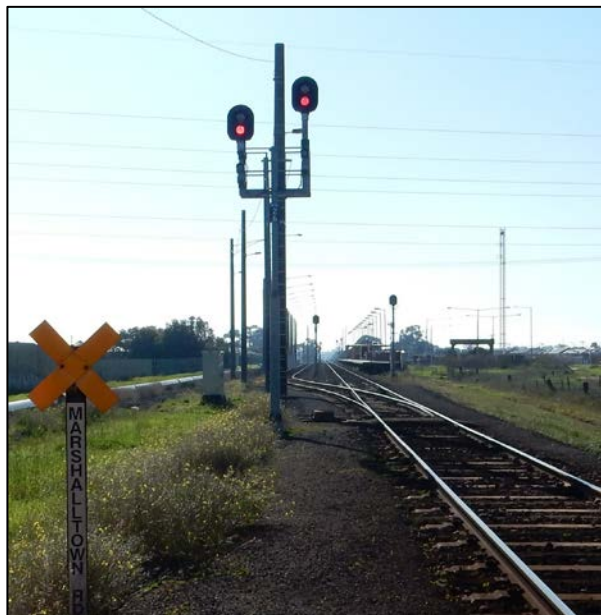
- The right hand signal provided an indication for the straight route and had a Green aspect (Proceed) for the passage of Train 1240.
- The left hand signal provided a signal indication for the loop track and was red for Train 1240.

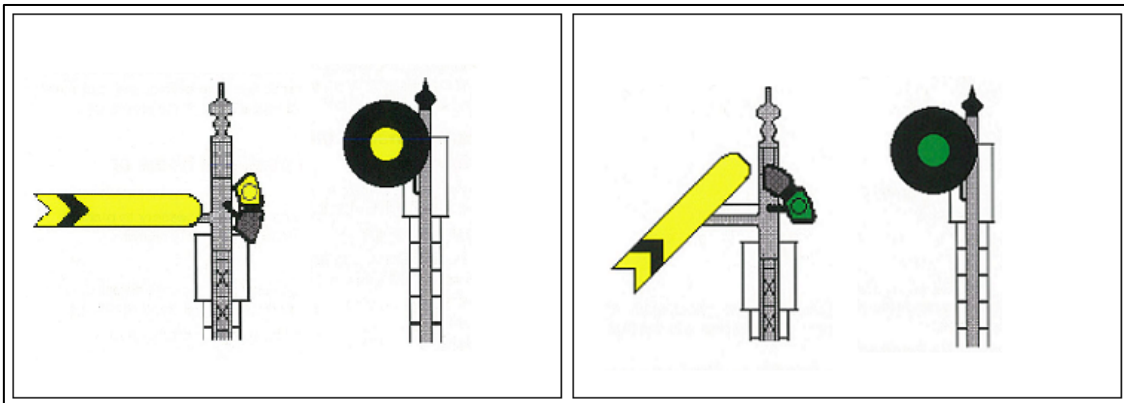
Figure 11: Distant signal aspects, Yellow (indicating Caution) and Green (indicating Proceed), as they appear in V/Line training material. The semaphore configuration, shown on the left for each aspect, is used for V/Line assessments on Distant signals.

- Yellow, indicating Caution and meaning that one or more of the Home signals applicable to the same line at that location may be at Stop.
- Green, indicating Proceed and meaning that all Home signals applicable to the same line at that location are at Proceed.
