Derailment of freight train 532

Near Nala, Tasmania, 6 August 2015

ATSB Transport Safety Report

RO-2015-014

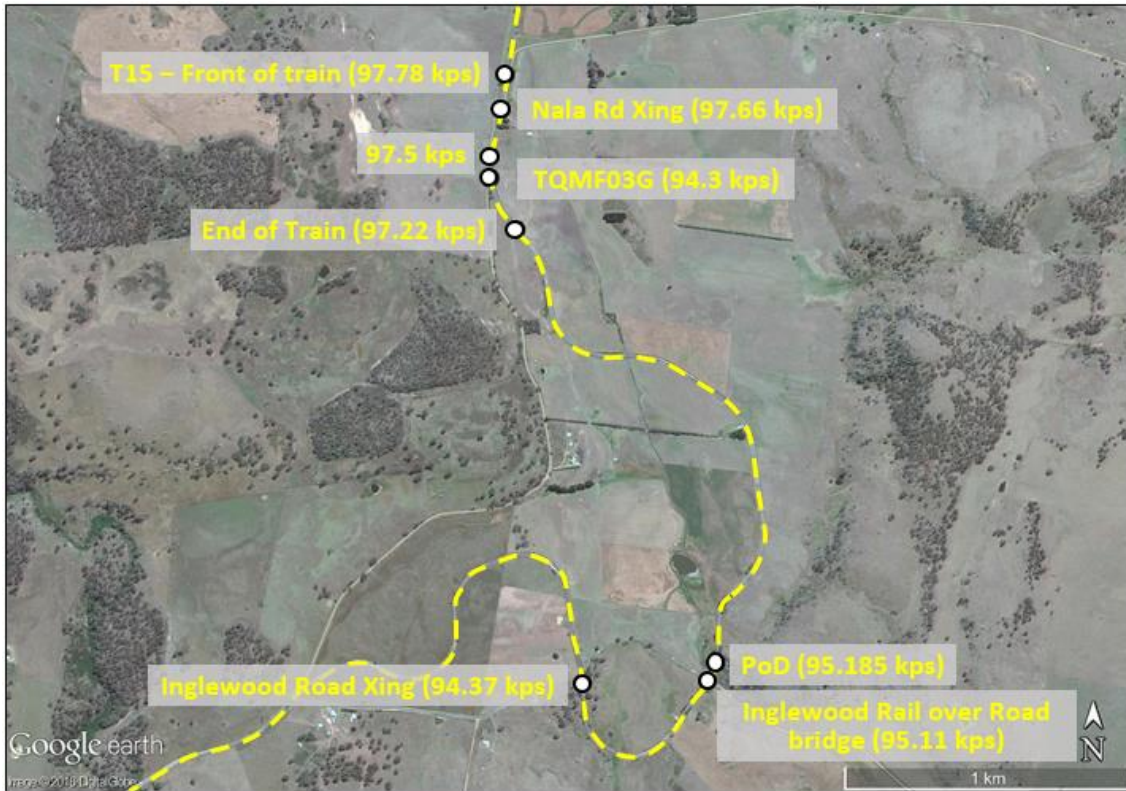
Figure 2: Derailment site near Nala

At 1856, the driver received authority to work through to Conara Junction. The train subsequently passed through Parattah, (about 9 km south of Nala) at 1911. At about 1921, the train passed over the Inglewood Road railway crossing (Figure 2) before entering a sweeping left curve (170 m radius). Just after passing, the 95 km point south, (kps)³ the train traversed a short straight section of track, and then crossed over the Inglewood rail over-road bridge. The train continued to snake its way north towards Nala.

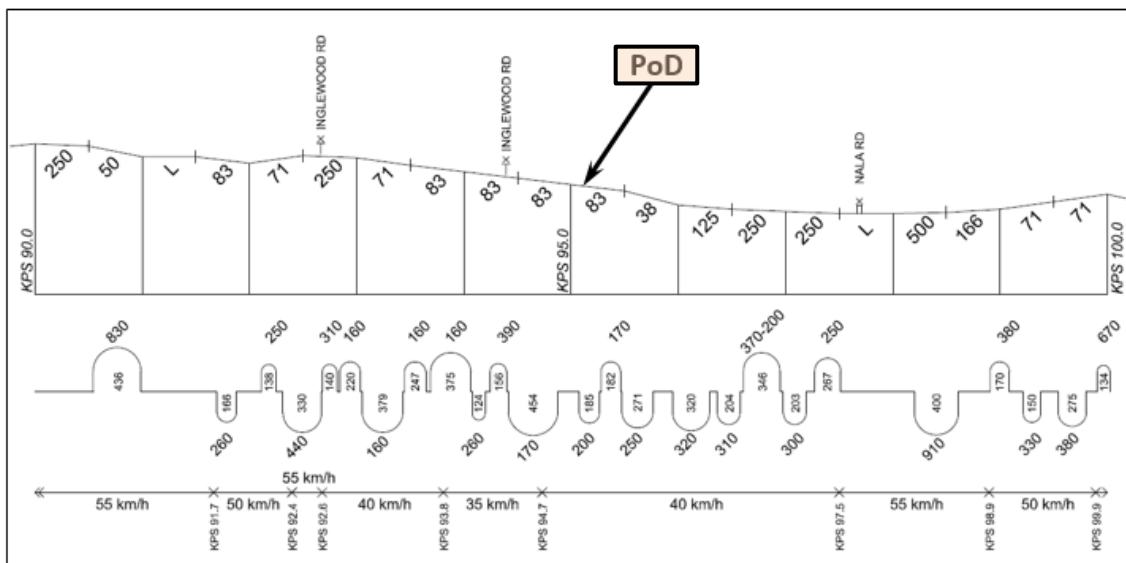
Figure 4: Curve and gradient chart, showing Point of Derailment (PoD)

The derailment occurred near Nala, midway between Campania and Conara Junction, (Figure 1) about 98 km north by rail from Hobart, on the south line. The track through the derailment site consisted of narrow gauge (1,067 mm), 41 kg/m rail, mounted on steel sleepers, with resilient fasteners (E Clips) on a nominal 100 mm bed of ballast. Axle loads were limited to a maximum of 18 t. The track leading into the derailment site was on a downgrade of 1:83 (Figure 4) through a nominal 200 m radius left-hand curve (direction of train travel). The track speed limit through the derailment site was 40 km/h and there was no temporary speed restriction (TSR) in place.
