# Collision involving road-train truck and train 8834N

near Narromine, New South Wales, 23 September 2015

**ATSB Transport Safety Report**

RO-2015-016

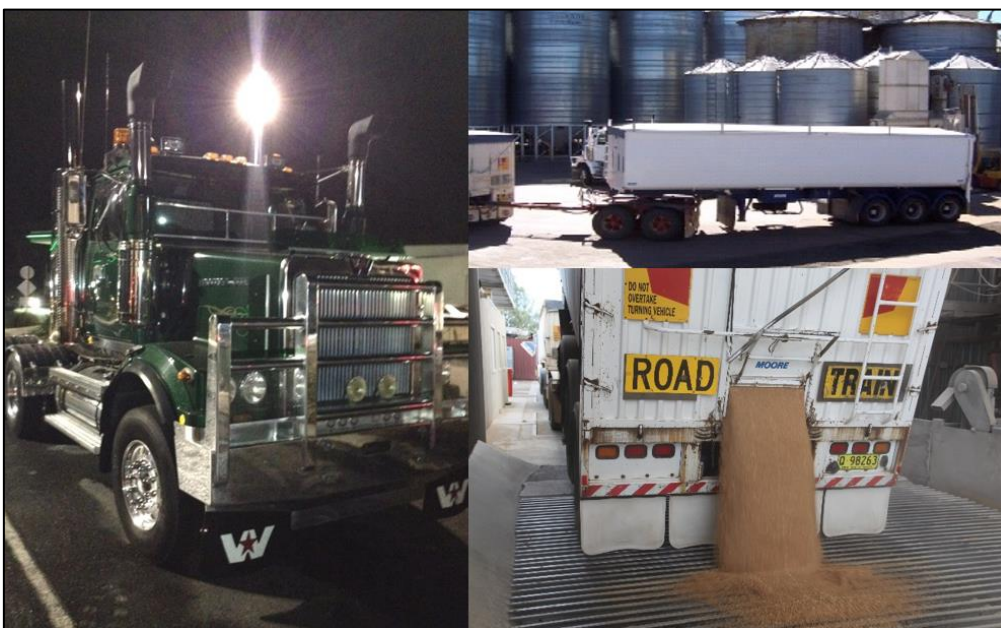
**Figure 10: Western Star prime mover (left photo) and road-train trailers (right photos)**

The company operates a small fleet of trucks, (including road-train trucks) in and around the Dubbo area. The road-train truck (double road train) involved in the collision consisted of a Western Star prime mover (Figure 10) towing two tri-axle trailers connected by a double-axle dolly. The overall length of the road-train truck was about 36 m with a gross mass of about 80 t.

Due to the extent of impact and fire damage, the NSW Police were unable to form a comprehensive picture of the mechanical condition of the road-train truck at the time of collision. However, examination of the brake linings determined that these were in good condition. In the moments just before the collision, the train drivers and witness (car behind the road-train truck) all noted that smoke billowed uniformly from all truck and trailer tyres. The post collision examination of the (tyre) skid mark pattern on the road/pavement surface revealed that this was consistent and uniform; there was no evidence of the vehicle skewing under heavy/emergency braking.

These observations in conjunction with maintenance records, strongly suggest that there were no mechanical deficiencies (braking performance) with the prime mover, trailers and dolly.

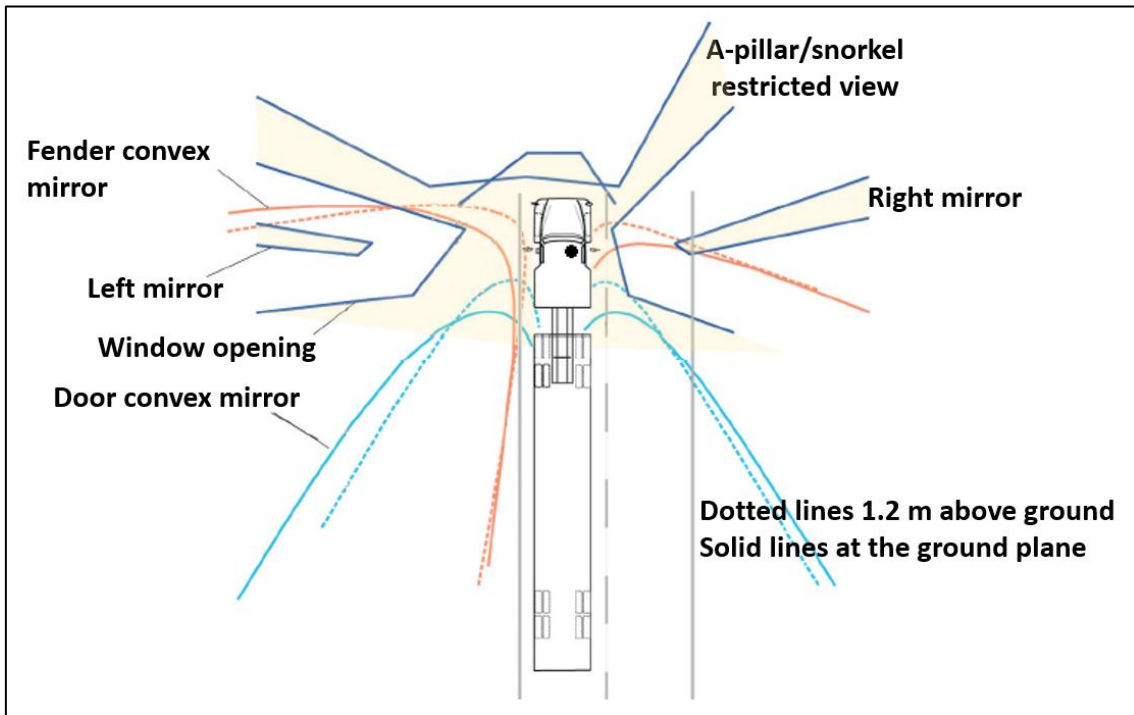
**Figure 14: Typical restrictions on field of view (shown yellow) for a truck/prime mover**

It was concluded that had the driver been specifically looking for the flashing lights, he would almost certainly have seen them operating. However, the 'A pillar' and air snorkel, (prime mover, driver near side, Figure 10) probably restricted the view<sup>20</sup> of the flashing lights (intermittently), as the truck approached the railway crossing (Figure 14).
