Derailment of grain train 9156

Ouyen, Victoria | 29 December 2015

ATSB Transport Safety Report
Rail Occurrence Investigation
RO-2015-029
Final – 12 July 2017

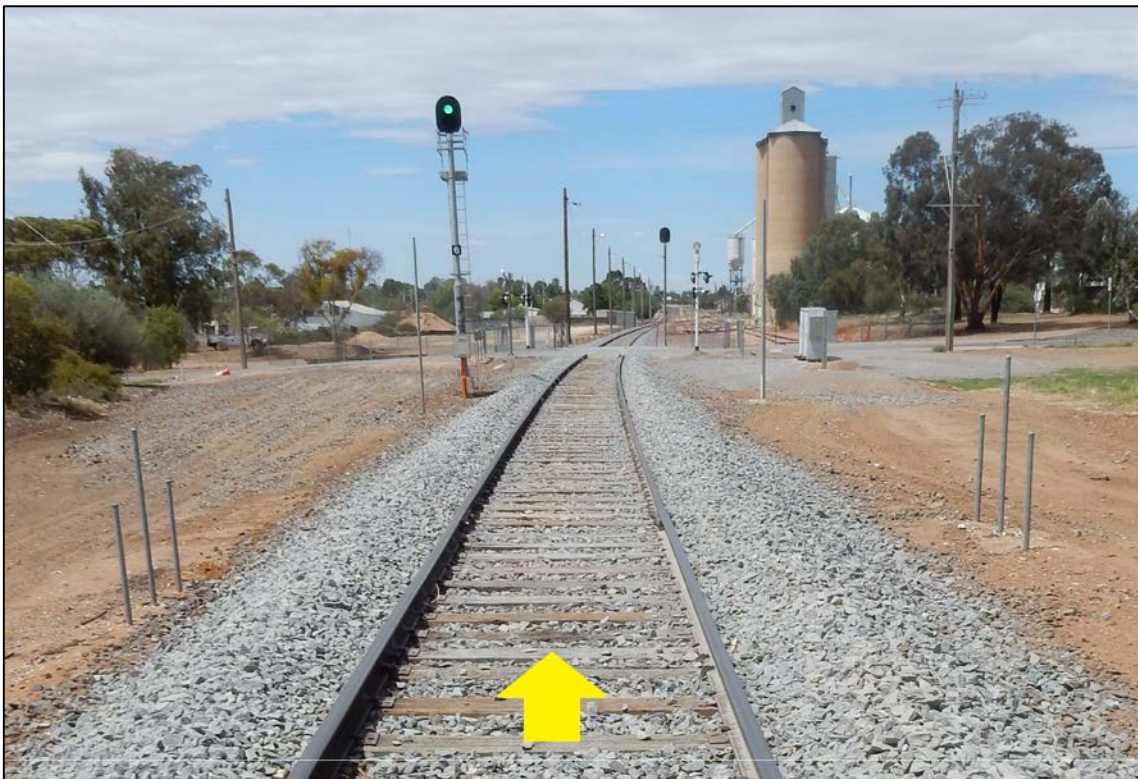
Approaching Ouyen from the 511 km post the track was undulating. There was a sag before the 510 km post, then an uphill grade (Figure 9). The track then crested before a slight undulation through to the William Street crossing where it descended on another slight grade towards to the yard and station. The track approaching and through the crossing had a right-hand curve of about 2000 m radius (Figure 4).

Figure 4: Approach to the William Street level crossing from Carwarp. The photograph was taken after track restoration that did not include the turnout on the Melbourne side of the crossing.

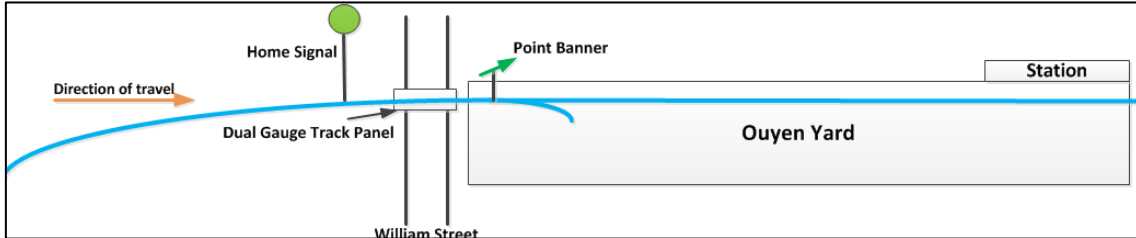
About 31 m on the Carwarp side of William Street there was a colour light Home signal to protect the crossing and control the movement of south-bound trains into Ouyen (Figure 5).

About 26 m beyond the crossing there was a set of facing points that provided access to and from the Ouyen yard. Their normal position was to be set and locked for the mainline.

Figure 5: Track layout and key features (not to scale)

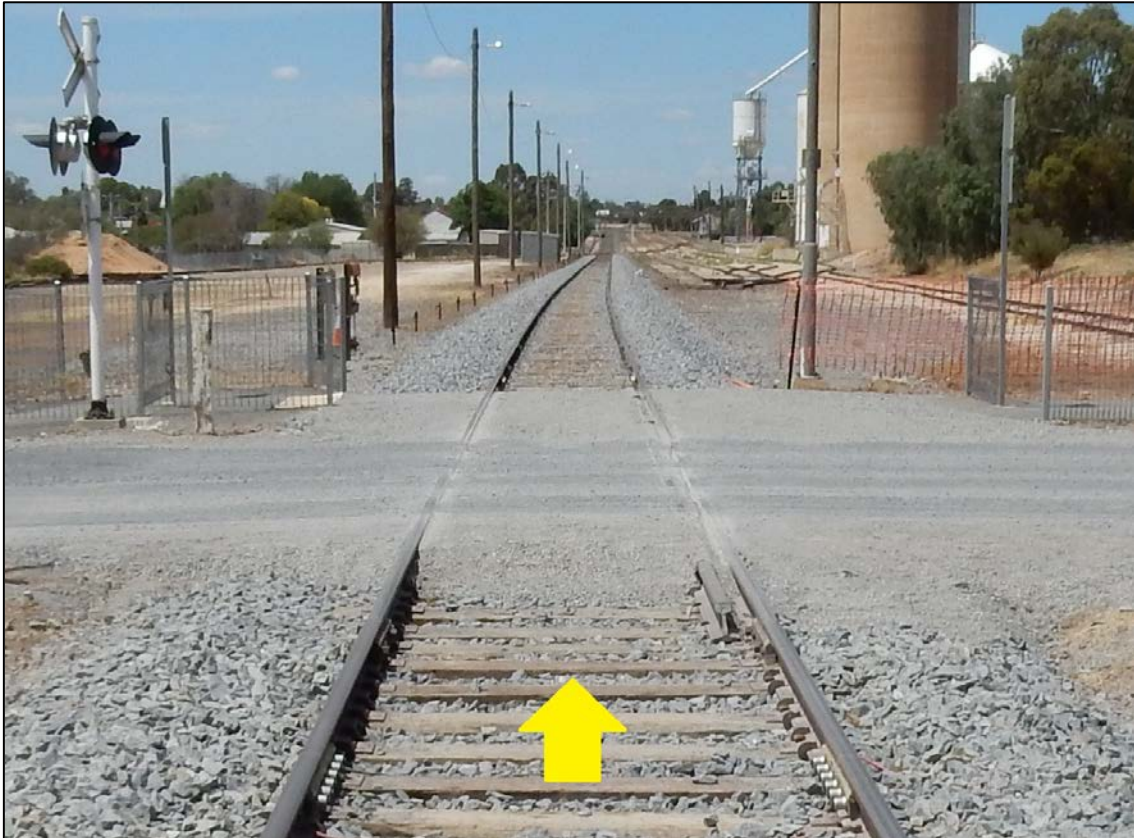
When reinstated following the derailment the configuration was similar except timber sleepers were used (Figure 7).

Figure 7: The William Street level crossing after reinstatement, similar in construction to the pre-derailment installation except timber sleepers used instead of concrete.
