VFR into smoke on a dark night and collision with terrain involving Robinson R22, VH-DLD

112 km south-south-east of Tindal Aerodrome, Northern Territory on
7 December 2023

ATSB Transport Safety Report

AO-2023-058

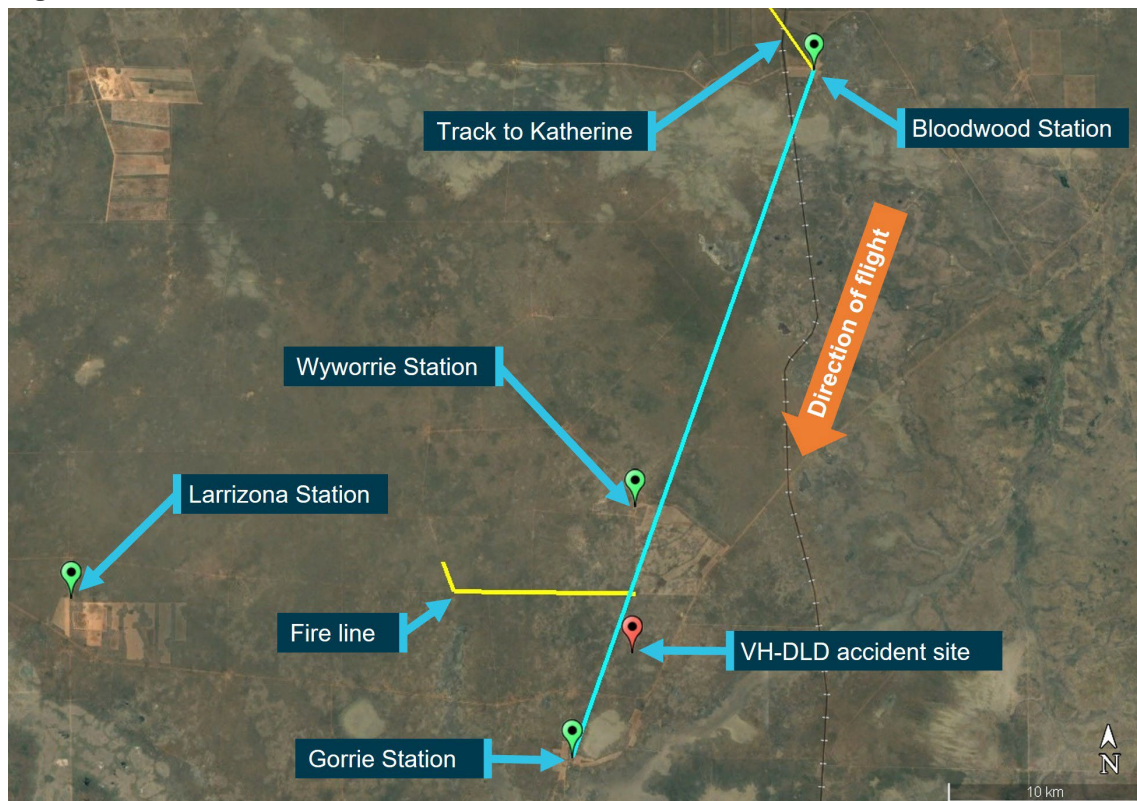
Figure 1: Direct track from Bloodwood Station to Gorrie Station

The track line from Bloodwood Station to Gorrie Station is representative of a direct track and not the actual flightpath. The position of the fire line was based on a hand drawing by the pilot's relative based at Wyworrie Station.
 Source: Google Earth, annotated by ATSB

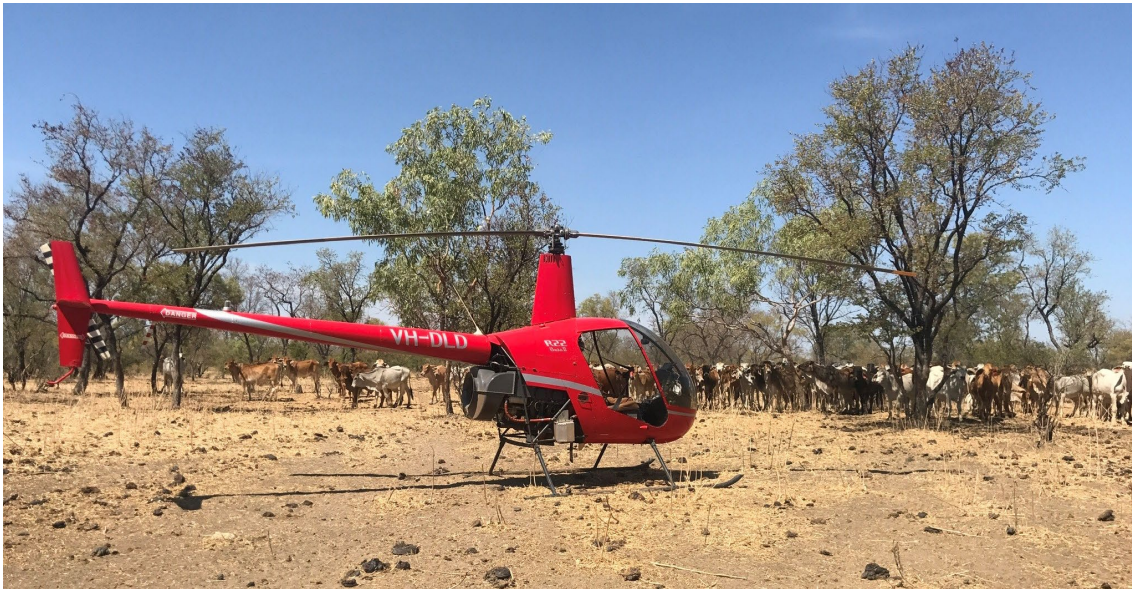
Figure 2: VH-DLD

The helicopter, registered VH-DLD, was a 2-seat Robinson Helicopter Company R22 Beta 2 helicopter, serial number 3675, powered by a Textron Lycoming O-360-J2A 4-cylinder piston engine (Figure 2). The helicopter was manufactured in the United States in 2004, first registered in Australia on 31 August 2004, and issued with a Certificate of Airworthiness on 7 October 2004.
