Technical assistance to the New South Wales Police in the examination of components from amateur-built gyroplane G-2468

Collision with terrain near Allworth, New South Wales, 12 August 2023

ATSB Transport Safety Report

AE-2023-005

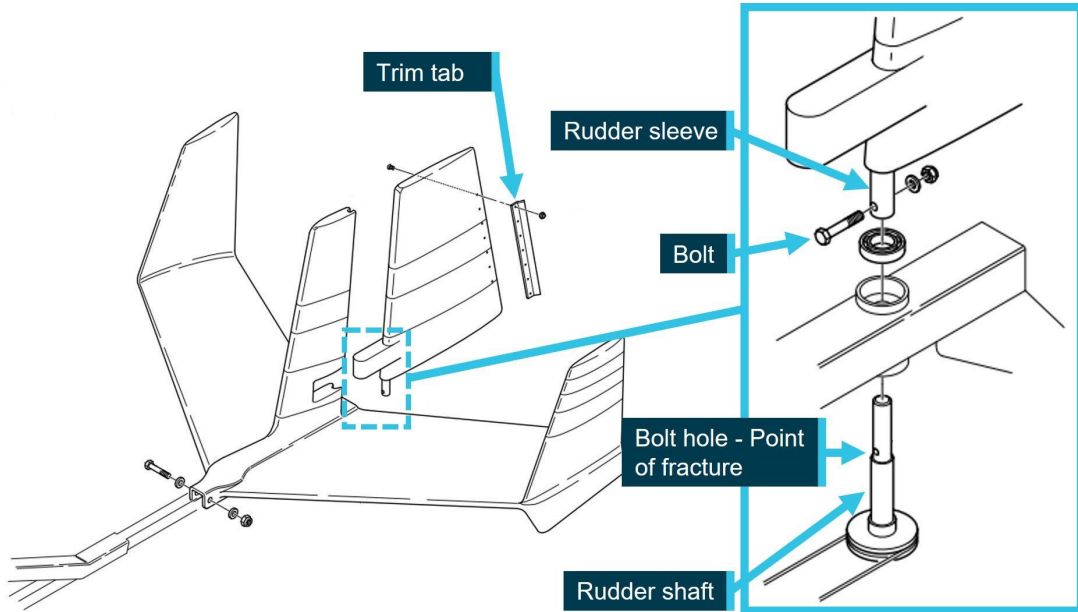
Figure 2: Magni Gyro tail assembly

Gyroplane G-2468 was fitted with a tail assembly from a factory-built Magni Gyro M22. In the factory installation, the tail assembly was mounted on an aluminium box section in line with the rest of the keel (Figure 1). The rudder mechanism employed a pulley below the keel that turned a rudder shaft, which passed through the box section and was then bolted longitudinally to a tube fixed within the rudder (Figure 2).

The rudder shaft was fractured at the point coincident with the bolt hole for attachment to the outer rudder sleeve (Figure 2, 4). The fracture surface exhibited extensive 'beach mark' features consistent with high cycle fatigue¹ crack progression (Figure 5). ATSB examination using optical and scanning electron microscopy identified that cracks had originated at all 4 corners of the bolt hole and progressed across approximately 98% of the cross-sectional area before final fracture.

Compared to the original design in Figure 1, the rudder sleeve had been shortened and the bolt hole had been changed from the original longitudinal (fore-aft) orientation to a lateral (left-right) orientation. The original M5 (nominal 5 mm diameter) rudder attachment bolt (Figure 2) had been replaced with a 6.25 mm (1/4 inch) bolt, meaning the bolt hole in the rudder shaft and sleeve were
