# Collision with terrain involving Air Tractor AT-400, VH-ACQ

75 km west-south-west of Moree, New South Wales, on 4 December 2021

## **ATSB Transport Safety Report**

AO-2021-052

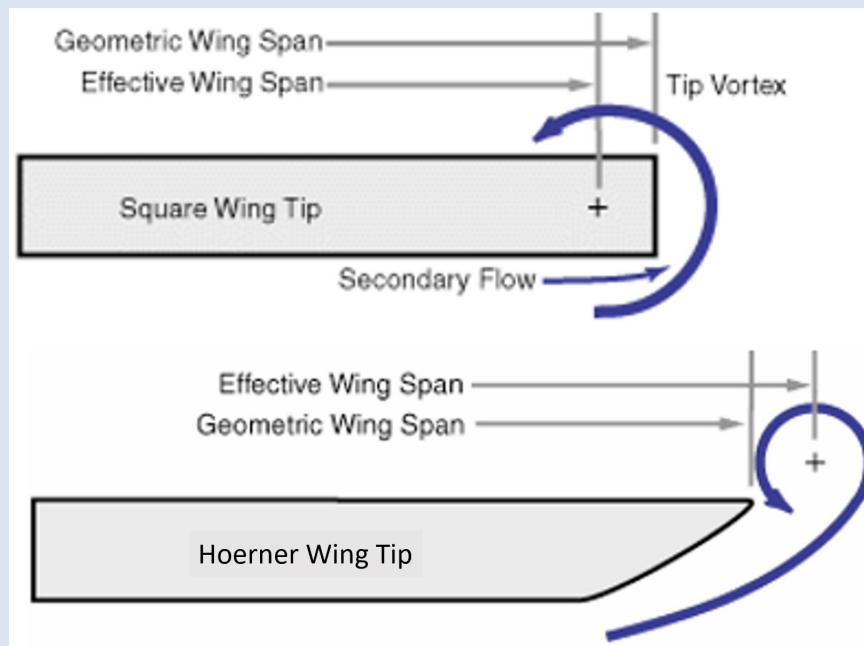
### Hoerner wing tips

Hoerner wing tips were designed to increase wing efficiency, by increasing the effective wing span beyond the actual length of the wing. Effects of this include reduced stalling speed and improved take-off performance.

Hoerner wing tips were not an option for AT-400 aircraft, however, in subsequent Air Tractor models, they were either factory-fitted or offered as a post-factory modification. From Air Tractor regarding the AT-402B: 'We designed a long, high-aspect ratio wing with Hoerner wing tips to increase wing efficiency, reduce drag and to lower stick and rudder forces so the controls are light and responsive, greatly reducing pilot fatigue.'
