Collision with terrain involving Bell Helicopter 206B, VH-PHP

6.5 km east-north-east of Maitland Airport, New South Wales, on 6 October 2022

Aviation Occurrence Investigation (Short)

AO-2022-048

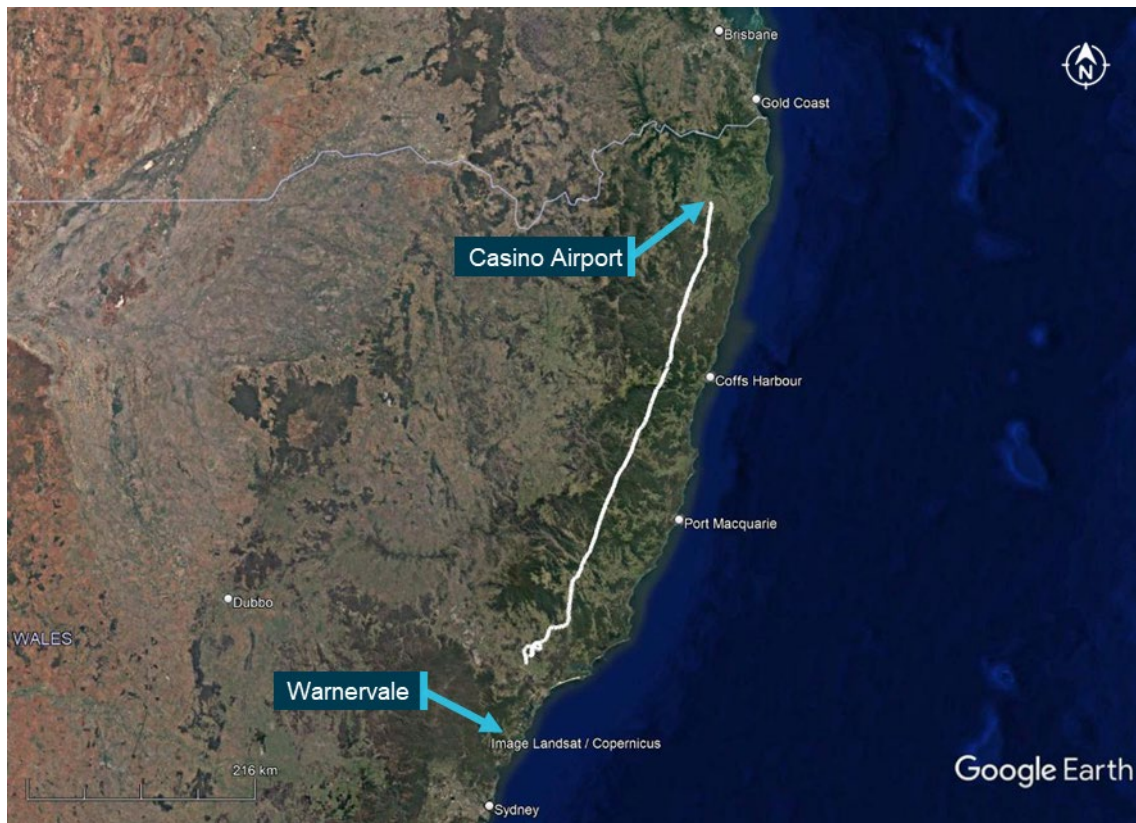
Figure 1: VH-PHP flight track

The helicopter tracked south-south-west, about 30–60 km inland of the coast (Figure 1).

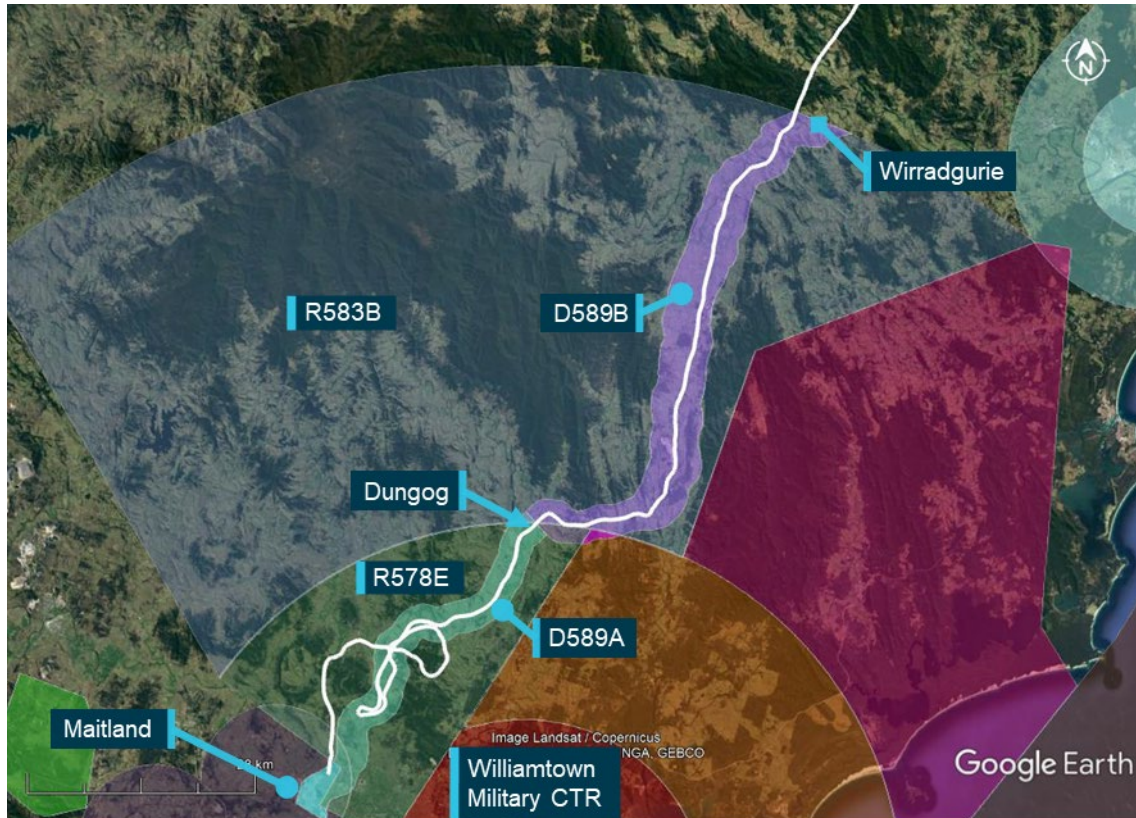
Figure 2: VH-PHP flight track (in white) through the Williamtown inland VFR route D589

Recorded data indicated that at tracking point Wirradgurie, the pilot followed the inland visual flight rules (VFR)¹ route,² D589B and D589A (shaded in purple and green respectively on Figure 2), north of the Williamstown military control area (CTR) through restricted areas R583B and R578E.³

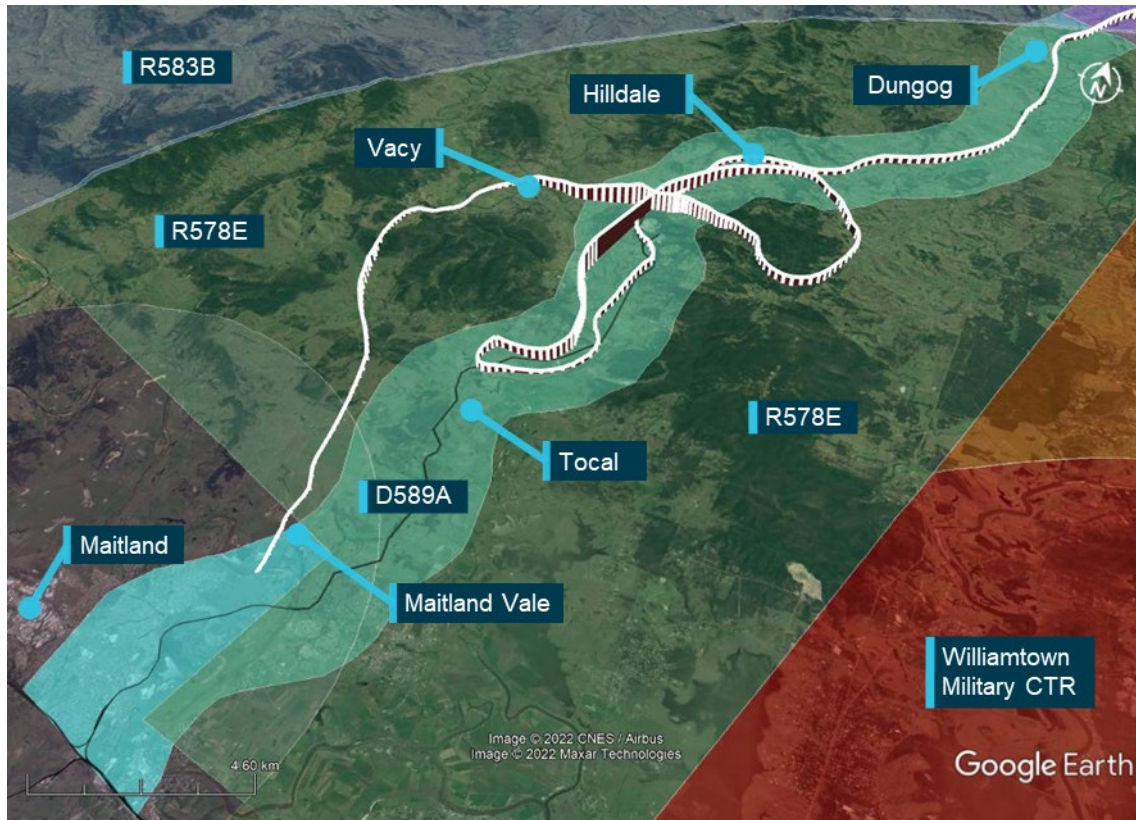
Figure 3: VH-PHP flight track (in white) through the Williamtown VFR route D589A

At about 1556, when approaching Tocal (Figure 3), about 4 NM (7 km) from the end of the lane, the helicopter started to climb and then conducted a right 180° turn to track northbound. After about 2 minutes, the helicopter transitioned through the upper limit of the VFR lane (1,600 ft) and continued climbing to 3,100 ft. The helicopter then descended to 1,100 ft, back into D589A and continued to follow the lane northbound until Hilldale when the pilot again made a right turn. This time the pilot flew the helicopter outside the lateral bounds of the lane by conducting a gradual climbing orbit around a hill before crossing from the east to the west of the lane, reaching 2,900 ft during the transition.

helicopter then descended to low levels travelling parallel to, but just outside, the VFR lane western boundary until it exited the southern border of R578E at Maitland Vale.

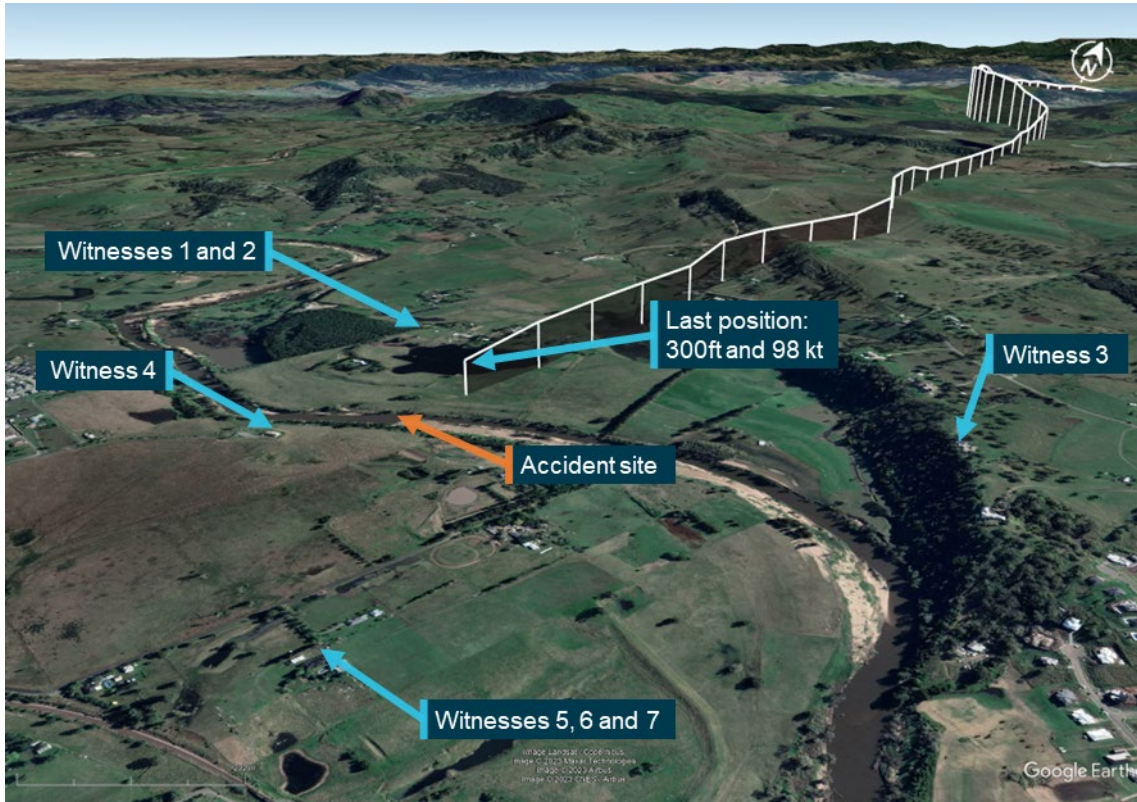
Figure 4: VH-PHP final flight track

At about 1616, the helicopter cleared a ridge by about 200 ft and descended gradually toward the Hunter River. At the last recorded data position, the helicopter was at 300 ft and 98 kt (Figure 4).⁵

The wreckage trail was about 45° to the right of the last track direction recorded by the pilot's OzRunways application (Figure 4). Examination of the accident site showed the wreckage trail (Figure 5) had started at a tree and extended along the riverbank for a distance of 33 m on a heading of 210° (magnetic). Figure 5 also shows the location of key components including the main rotor hub and blades, right horizontal stabiliser, right cockpit door, tail rotor blades, tail gearbox, left skid, and the fuselage.
