Loss of control and collision with terrain involving Pitts Model 12, VH-JDZ

8 km south-west of Maitland Airport, New South Wales, 8 July 2015

ATSB Transport Safety Report
Aviation Occurrence Investigation
AO-2015-074
Final – 29 July 2016

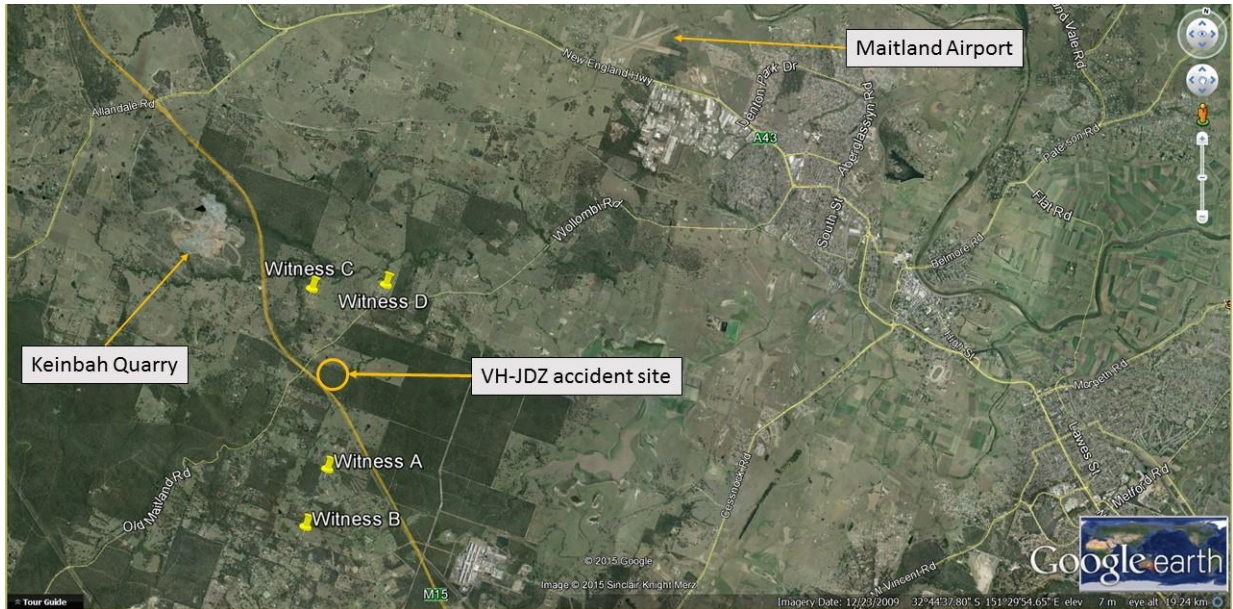
Figure 2 shows the location of each witness with respect to the accident site. Of the witnesses, witness D had flying experience.

Witness	Distance from the accident site	Witness-specific observations
A	1.75 km south	Aircraft 'swooped side to side' as it slid backwards, before entering an inverted flat spin.
B	2.9 km south	Observed in a nose-down attitude before sight was lost.
C	1.5 km north-west	Heard a loud bang after sight was lost.
D	1.75 km north-north-east	Reported that the engine sounded normal. The witness did not recall hearing the engine cut out or stall. After sight was lost, the witness heard a loud explosion, followed a few minutes later by a second explosion.

Figure 2: Witness location with reference to the accident site
