# Loss of control and collision with terrain involving Cessna 206 floatplane, VH-NTK

6 km SE of Southport Airport, Queensland, on 5 June 2016

**ATSB Transport Safety Report**  
Aviation Occurrence Investigation  
AO-2016-055  
Final – 25 August 2016

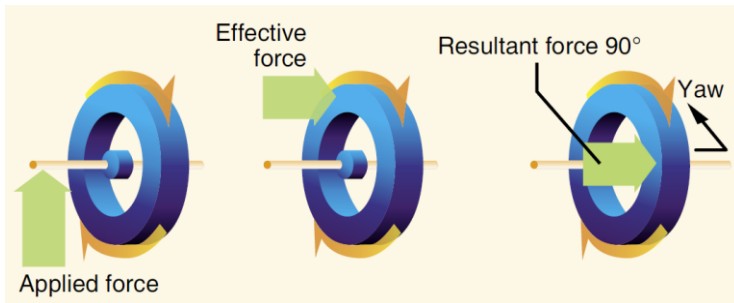
**Figure 4: Gyroscopic effect**

- Gyroscopic effect: The rotating propeller behaves like a gyroscope. As such, any time a force is applied to deflect the propeller from its plane of rotation, the resultant force is 90° ahead in the direction of rotation, and in the direction of the effective force (Figure 4). As such, the gyroscopic effect results in a yawing motion to the left when the aircraft is pitched forward from the plow position to the step position.

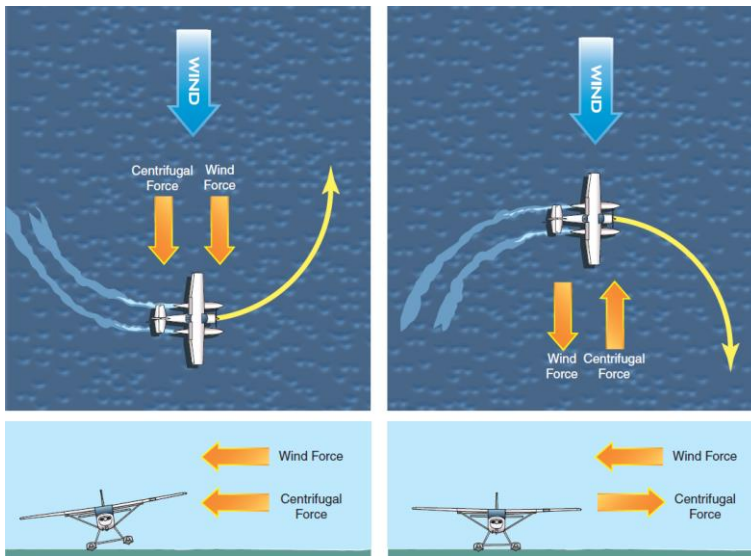
**Figure 5: Effect of wind force and centrifugal force**

According to the FAA [Seaplane operations handbook](#), crosswinds can present special difficulties for floatplane pilots. If the aircraft turns towards the wind during a crosswind take-off, then centrifugal force will combine with the wind force to produce a rolling moment in the opposite direction to the turn (Figure 5). If strong enough, the combination of wind and centrifugal force may lift the upwind wing and submerge the downwind float, rolling the aircraft until the downwind wingtip strikes the water. This is known as a water-loop (Figure 6).

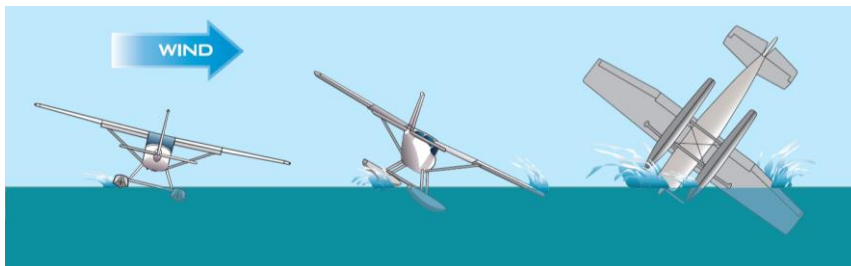
**Figure 6: Water-loop**

This accident highlights the risk of a water-loop event during a crosswind take-off in a floatplane. The combined forces acting on a floatplane have the potential to significantly reduce the margin of control available to the pilot. The FAA *Seaplane operations handbook* provides several recommended crosswind take-off techniques, including the considerations associated with arcing manoeuvres during take-off. If an arcing manoeuvre is to be attempted then the FAA handbook recommends placing the centrifugal force and wind force on opposite sides, and reducing the radius of the arc as the floatplane speed increases.

Refer to the FAA *Seaplane operations handbook* for a detailed explanation of the recommended crosswind take-off techniques.

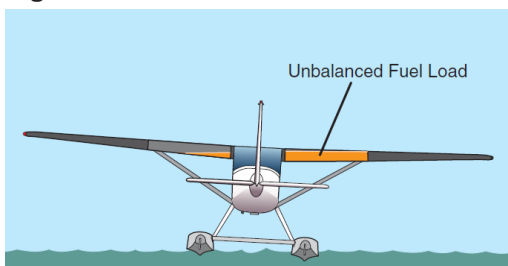
**Figure 7: Effect of fuel imbalance on centre of gravity**

Centre of gravity<sup>8</sup> location also affects the floatplane's handling characteristics on the water. If the centre of gravity is located to one side of the centre-line, such as a fuel imbalance between the tanks, one float must support more weight and therefore displace more water than the other float, resulting in more water drag on that side (Figure 7).
