# Engine shut down involving Boeing 787, VH-VKK

370 km north of Guam, 6 August 2016

**ATSB Transport Safety Report**  
Aviation Occurrence Investigation  
AO-2016-095  
Final – 14 December 2016

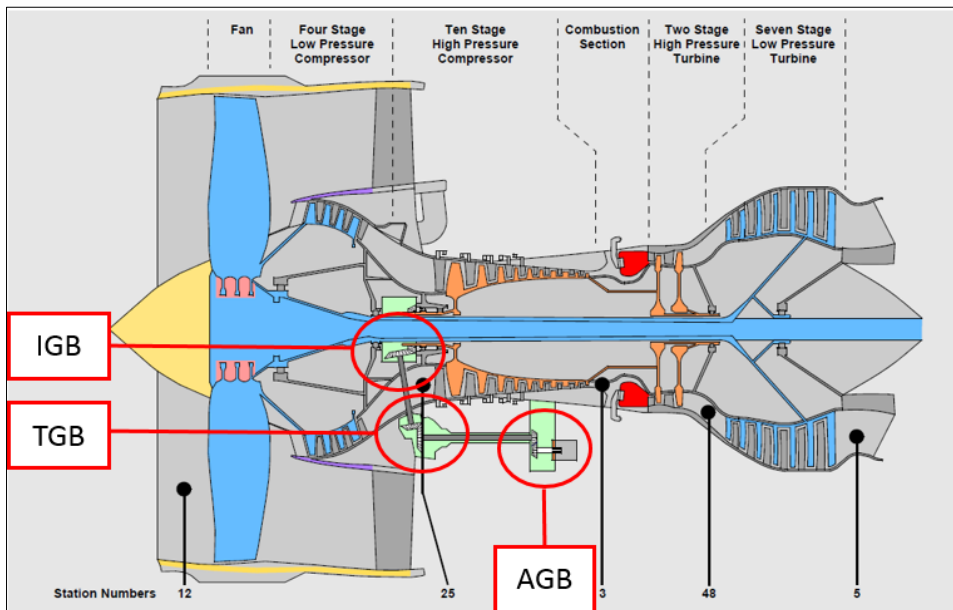
**Figure 1: Engine driven gearboxes**

Engine rotation is transmitted to an inlet gearbox (IGB) with a radial driveshaft, which connects to a transfer gearbox (TGB). The TGB transmits the engine speed to the AGB via a horizontal driveshaft (Figure 1). The AGB drives the accessories necessary for engine operation and other aircraft services, such as the generators for the aircraft electrical system. The engine oil system provides lubrication, cooling and removes debris from the gearboxes.

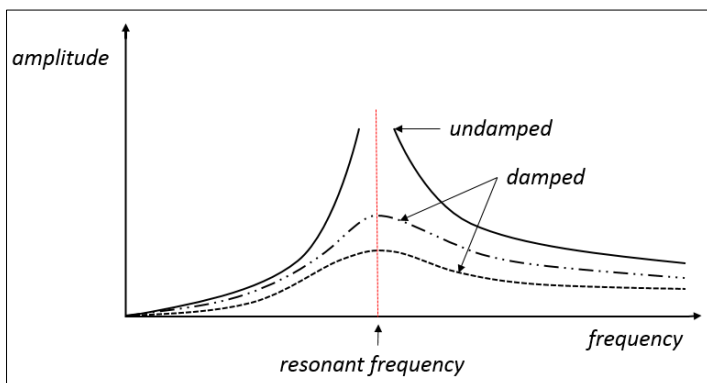
**Figure 4: Resonant frequency for damped and undamped vibration**

All machinery have a natural frequency of vibration. If a particular abnormality in the machinery generates a forced vibration, which vibrates in-phase and at the same frequency as the natural frequency of vibration, then the energy will magnify. The frequency at which this occurs is known as the resonant frequency (Figure 4). If there is insufficient damping present at the resonant frequency, then the amplitude of the vibrations will increase with each cycle. Excessive movement of components with high energy can cause a catastrophic failure of the machinery.
