# Take-offs without runway lighting involving Embraer ERJ-135 VH-JTG

Tamworth Airport, New South Wales, 19 and 28 August 2016

**ATSB Transport Safety Report**  
Aviation Occurrence Investigation  
AO-2016-108  
Final – 17 January 2017

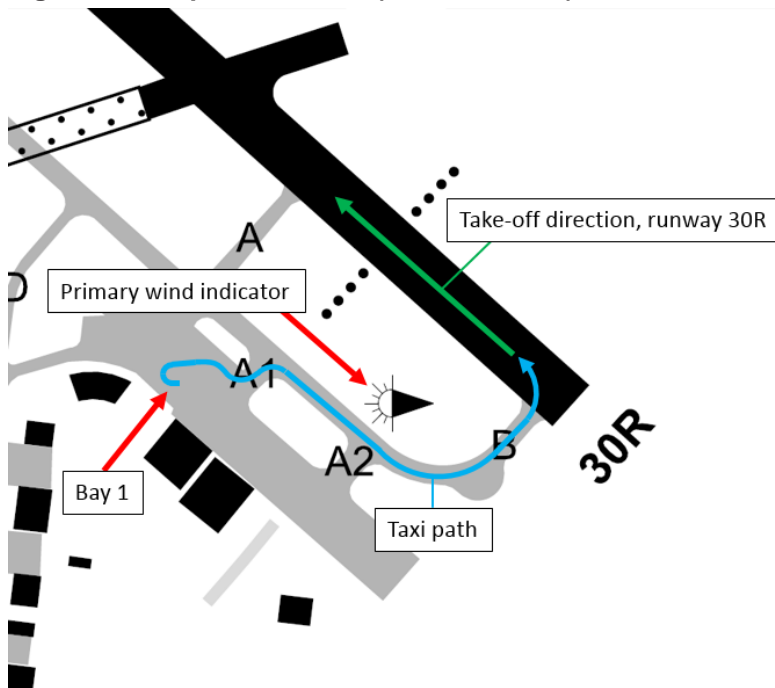
Figure 1: Taxi path overview (both incidents)

On 19 August 2016, a JetGo Australia Embraer EMB-135LR, registered VH-JTG (JTG), operated scheduled passenger flight JG65 from Tamworth, New South Wales (NSW), to Brisbane, Queensland (Qld). At 2104 Eastern Standard Time (EST), the aircraft began to taxi from parking bay 1 to runway 30 right (30R) with the taxiway and runway lights not activated (Figure 1). At 2107, the captain taxied the aircraft onto the runway and immediately began the take-off run. During the take-off run, at a speed of about 70 knots, the first officer detected the runway lights were not illuminated and activated them using the pilot activated lighting (PAL) (Figure 2). The flight crew continued the take-off.
