# Collision with terrain involving Cessna 172S, VH-CPQ

3.5 km west of Camden Airport, New South Wales on 24 January 2024

AO-2024-002

Final – 23 July 2024

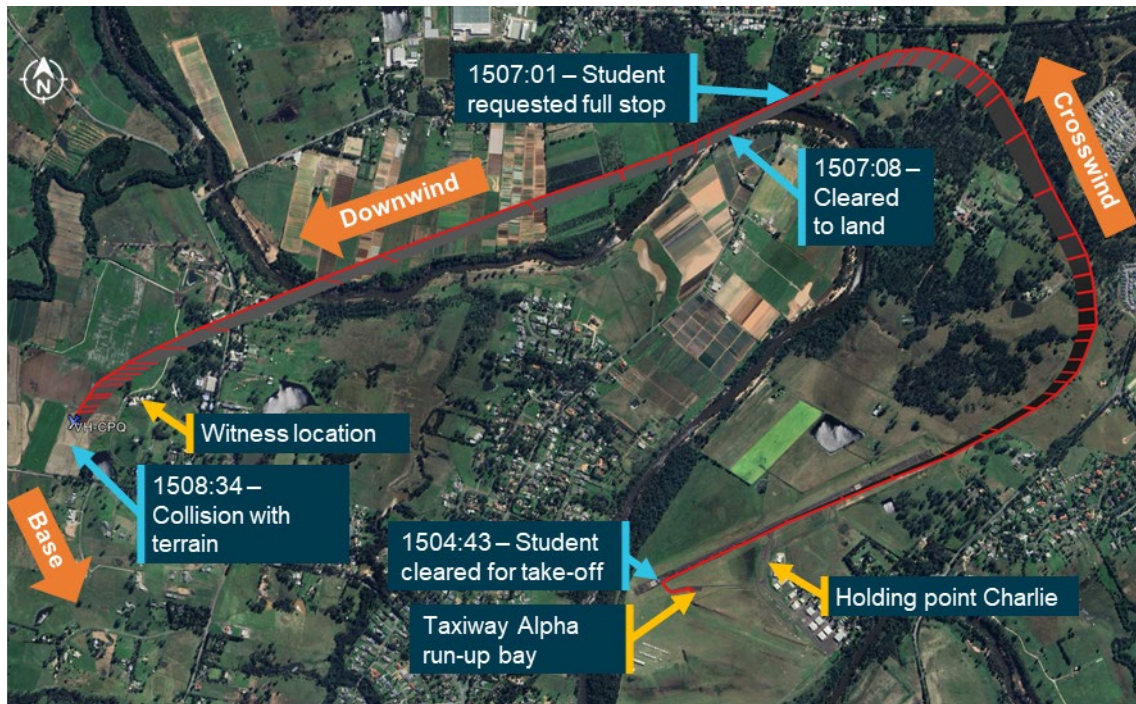
**Figure 1: Flight path overview**

The student landed the aircraft and taxied clear of the runway to the run-up bay just prior to holding point Alpha (Figure 1). The instructor selected the ALT mode on the transponder to allow a viewing of the flightpath of the aircraft online and then exited the aircraft. The instructor informed the student they should complete the take-off checklist again and do everything required to feel comfortable to go solo.

The instructor recalled watching the student take off, turn onto the crosswind leg of the circuit and then onto the downwind leg (Figure 1). The instructor walked towards holding point Charlie which was the preferred viewpoint for the entire circuit. The student made a radio call stating 'Charlie Papa Quebec downwind full stop' and the instructor recalled hearing this before losing sight of the aircraft behind an obstruction. The pilot sounded normal during all recorded radio transmissions.

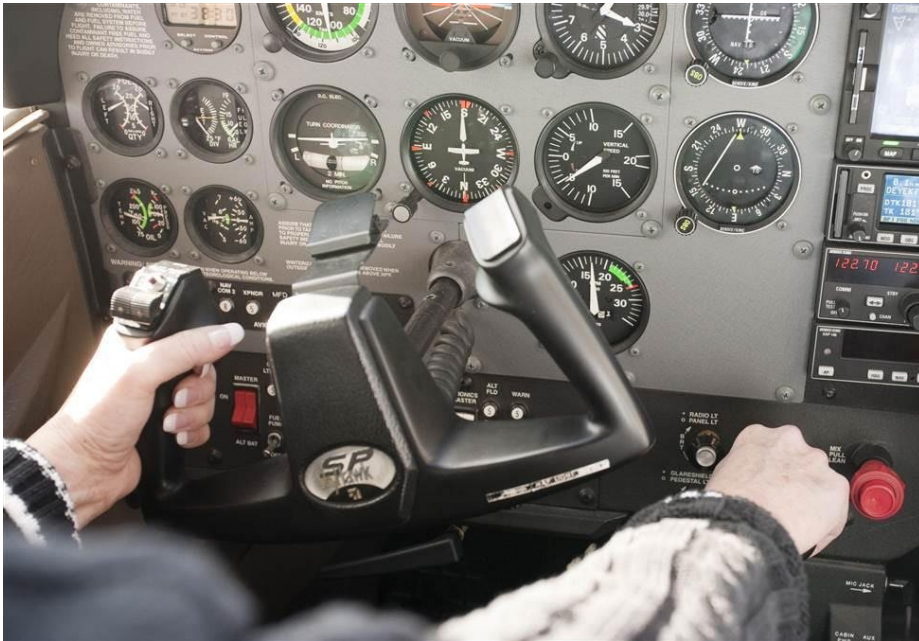
**Figure 2: Cessna 172 control yoke**

Although extremely rare, a sudden unexplained medical event can never be completely excluded. However, given the relative positions between the pilot and control yoke, the horizontal movement of the control yoke required to initiate and maintain a nose-down control input (as shown in Figure 2), and the pilot's use of the shoulder harness, the ATSB considered it very unlikely that a significant forward pressure on the control yoke would result from such an event. Rather, an incapacitation would more likely result in a significant roll input which did not occur. A pilot who 'froze' at the controls would not be likely to maintain a significant forward yoke pressure.

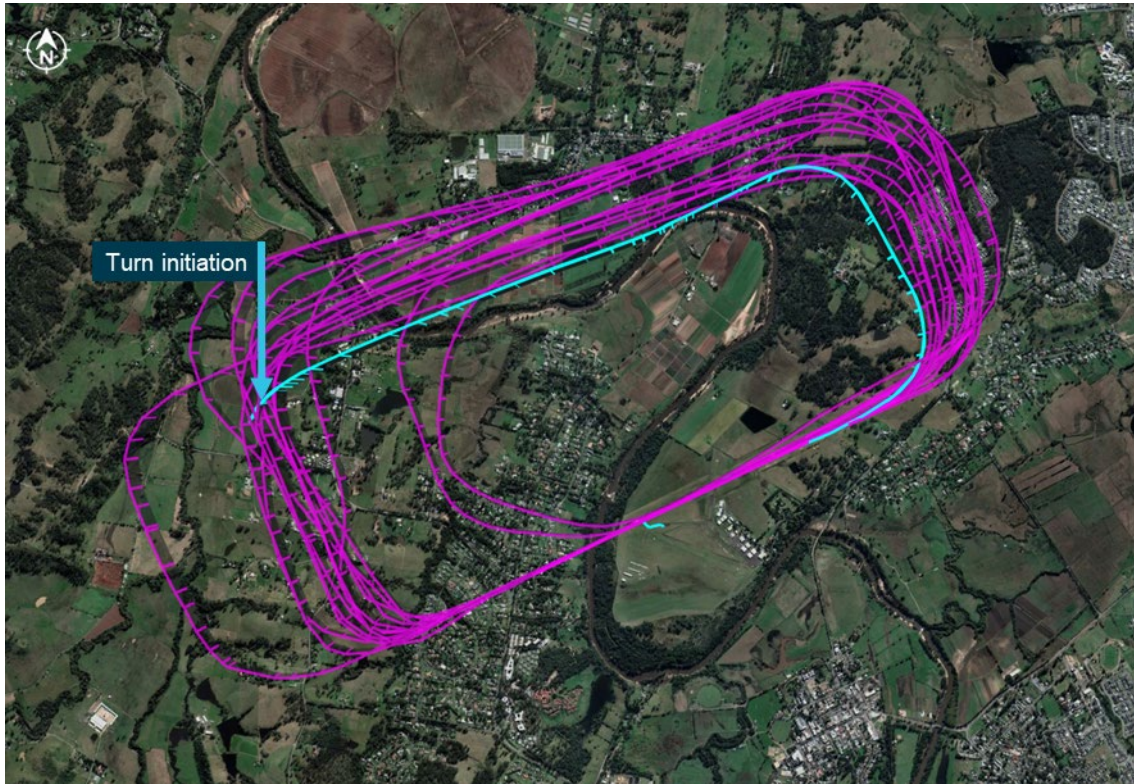
**Figure 5: Previous circuit flights flown by the accident pilot**

Recordings of previous flights the pilot had conducted were also collected from ADS-B Exchange<sup>13</sup> (Figure 5). When comparing the occurrence flight to previous circuits, the location of the accident was in a similar location to the start of the turn onto base with the aircraft at a similar initial height and speed.

*Training flights are indicated in pink. Occurrence flight is indicated in blue.*  
Source: Google Earth, annotated by the ATSB

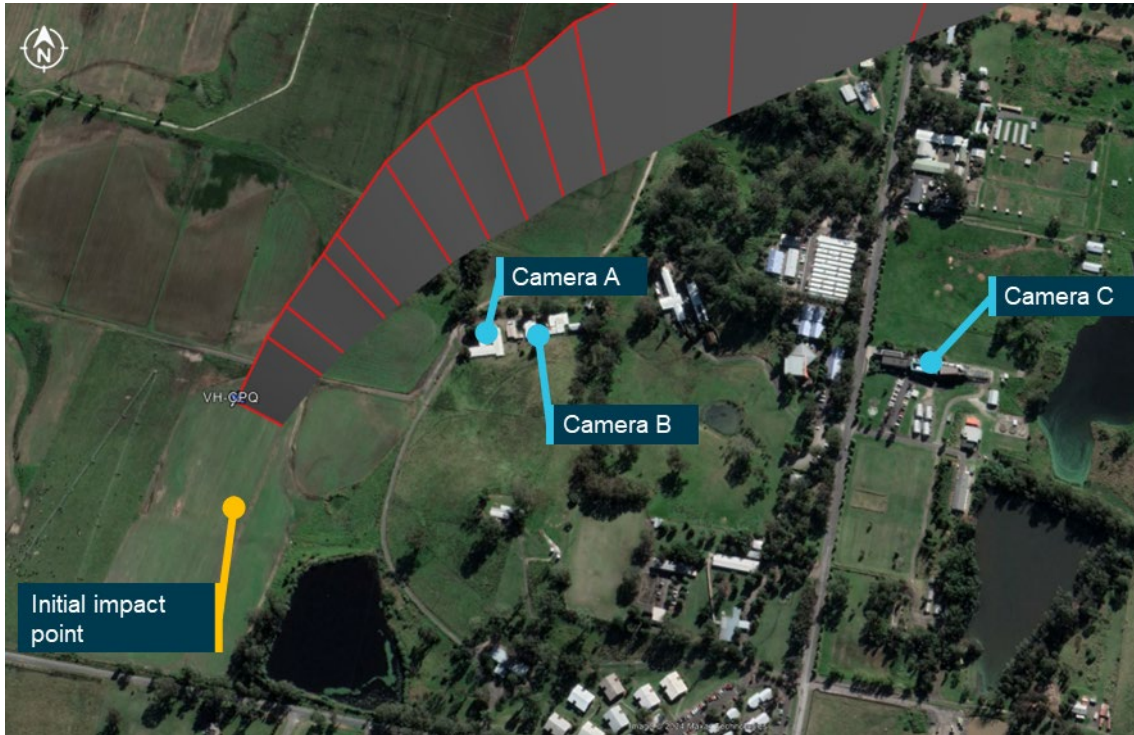
**Figure 6: CCTV locations**

The ATSB obtained recordings from 3 CCTV cameras in the local area that had the potential to capture part of the accident flight (Figure 6). Cameras A and B were located on a building 340 m from the accident site. Both cameras recorded in 25 frames per second and captured the aircraft at various stages in its descent to impact.

Camera A faced southwest and captured the collision with terrain in a small part of the background. The footage indicated the aircraft was in a steep, nose-down descent on impact.
