Collision with terrain involving Air Tractor AT-502, VH-AQW

17 km north-west of Bourke Airport, New South Wales on 10 February 2024

ATSB Transport Safety Report
Aviation Occurrence Investigation
AO-2024-005
Preliminary – 17 July 2024

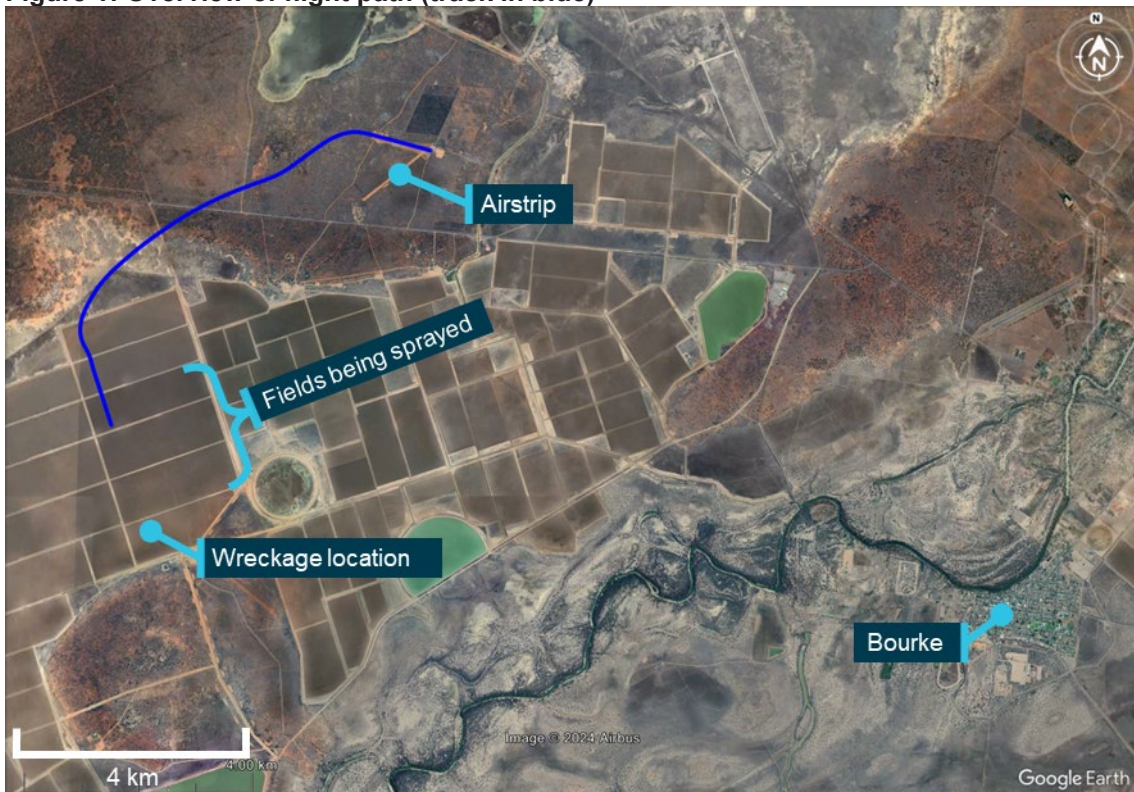
Figure 1: Overview of flight path (track in blue)

At 0629 local time, AQW departed a private airstrip on the property in a southerly direction with the first load of herbicide (Figure 1). Another pilot also departed around this time to conduct spraying in a different area of the same property. At 0632, recorded data showed that AQW had commenced spraying a field. The recording ended 12 seconds later. The final point recorded AQW’s ground speed of about 114 kt and travelling in a south-easterly direction.
