Near grounding of *Rosco Poplar*

Bond Reef, Hydrographers Passage, Queensland on 4 May 2022

ATSB Transport Safety Report

MO-2022-005

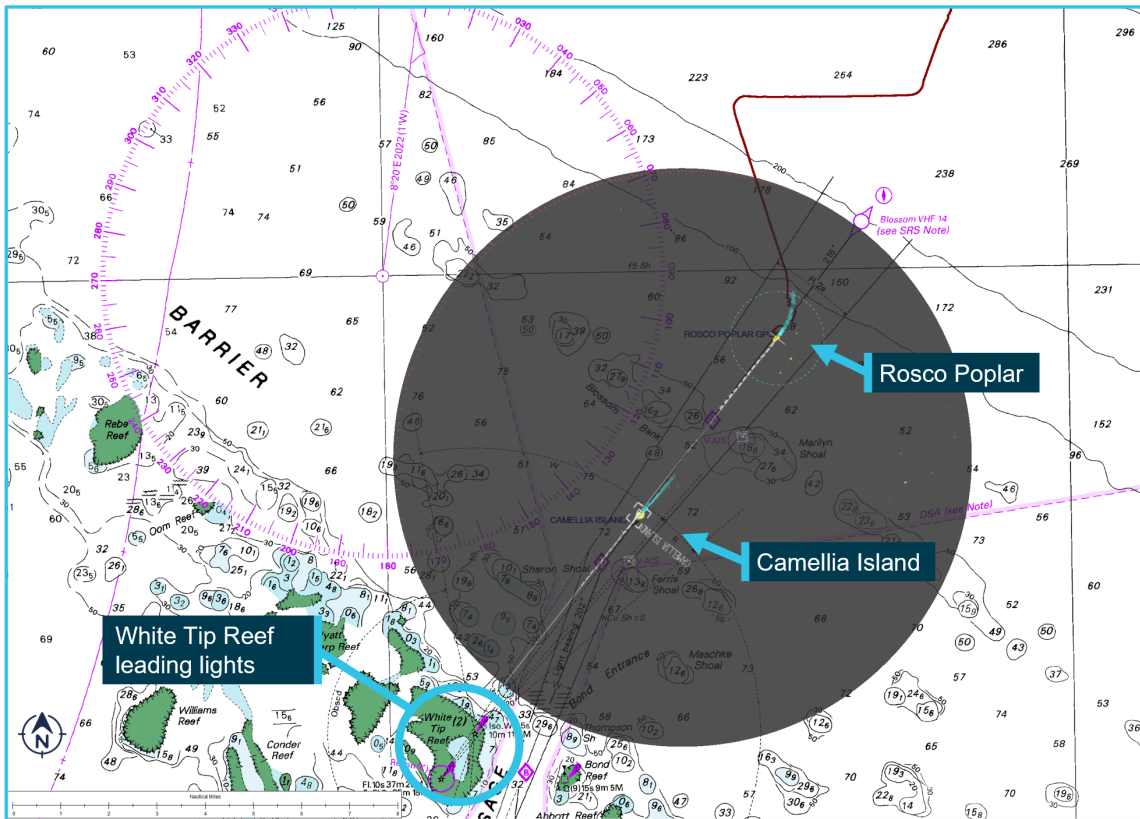
Figure 3: Navigational chart with *Rosco Poplar's* radar display overlaid (grey) at 0217

At 0215, the second mate informed the pilot that the waypoints had been input into the s-band radar. Shortly after, as the ship approached the compulsory pilotage limit near Blossom Bank, the pilot ordered a heading⁵ of 218° to line up the ship along the 218° (T) leading line indicated by the White Tip Reef lights ahead (Figure 3). At 0218, the pilot made a 'pilot commencing duties' report to the coastal vessel traffic service (REEFVTS) via VHF radio and advised the master that he was taking over the conduct of the ship.

At about the same time, the second mate moved to the x-band radar to input waypoints. The pilot reported that at this time, he was monitoring the ship's progress visually and on the 2 ECDIS displays, which the pilot compared to the position displayed on the PPU. At 0234, the second mate completed the waypoint input for the x-band radar and returned it to operational mode.

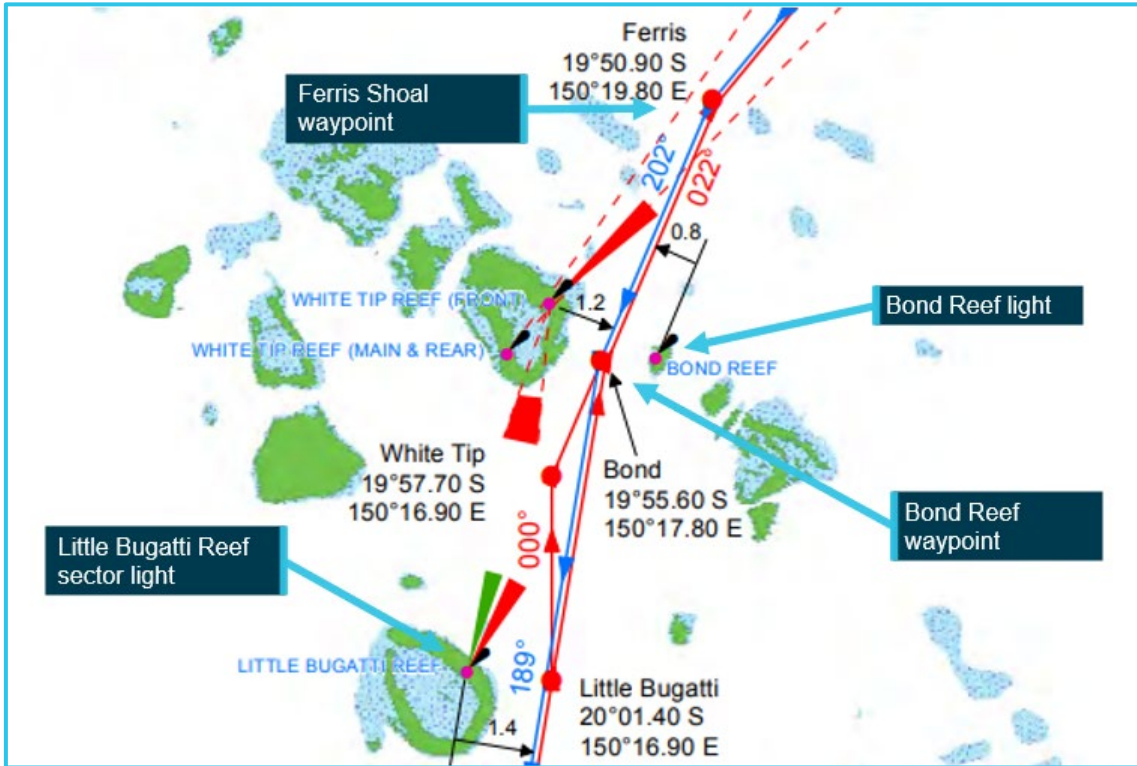
Figure 4: Standard planned routes near Bond Entrance (inbound tracks are blue)

As the ship passed the Ferris Shoal waypoint at 0246, the pilot ordered a 202° heading towards the next waypoint to track the ship 0.8 miles to the west of Bond Reef light beacon (Figure 4). According to the pilot, he saw that Little Bugatti Reef sector light was white at the time (the white and red sectors indicate safe and unsafe waters, respectively).

About 2 minutes later, the pilot ordered a heading of 195° and over the following 20 minutes, continued to give heading orders ranging from 193° to 202°. Meanwhile, at 0301, the second mate carried out a position crosscheck by using the line of position (LOP) function on the ship's ECDIS, using the range and bearing of Little Bugatti Reef sector light directly from the ECDIS, which indicated the ship was on the planned track. During this period, the master observed that the flashing white light fine on the port bow had closed until it was almost directly ahead of the ship. The master did not query the pilot to identify the light and assumed it was not Bond Reef beacon but some other light.

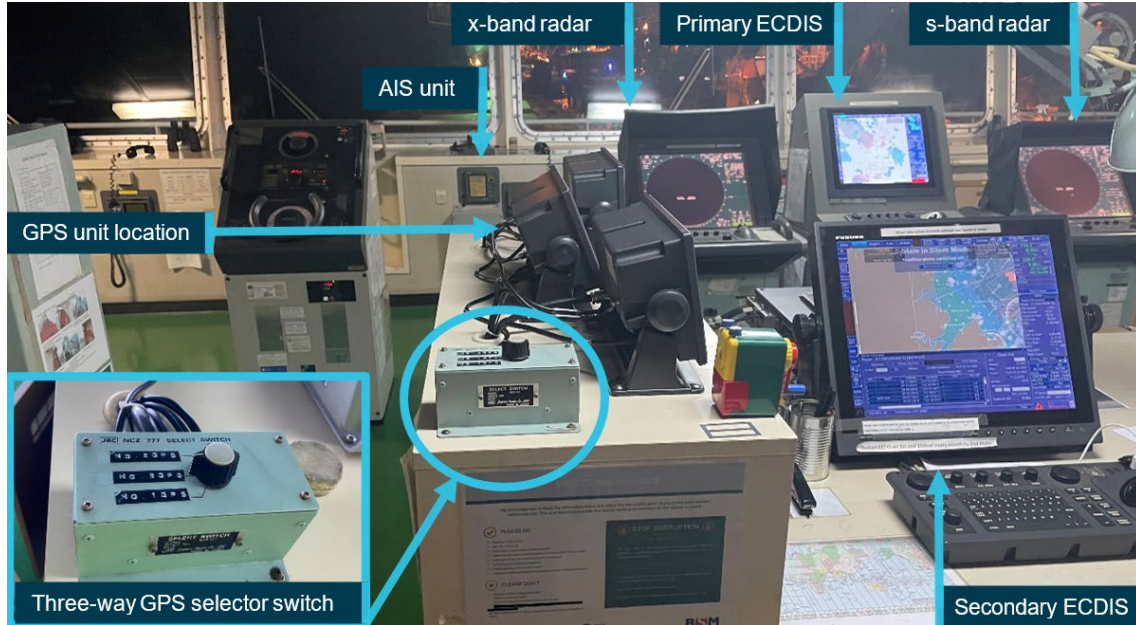
Figure 7: Rosco Poplar's navigational equipment

Rosco Poplar was equipped with 2 Furuno EC3000 electronic chart display and information system (ECDIS) units. The primary unit was situated on the starboard side of the bridge, between the s-band and x-band radar units (Figure 7). The secondary ECDIS unit was fitted on the chart table behind the primary unit and radars. The automatic identification system (AIS) unit was located beneath the bridge window panels, forward of the primary ECDIS unit.

At the time of the occurrence, 2 Japan Radio Company (JRC) differential⁸ GPS units and a Furuno GPS unit were installed on the chart table near the secondary ECDIS unit. The data output feed from each GPS unit was connected to a 3-way selector switch, adjacent to the units (Figure 7 and Figure 8). A single output feed from the selector switch was connected via a JRC data buffer to a secondary buffer which distributed the data to the navigational equipment, including both ECDIS units, both radars, AIS unit and the voyage data recorder (VDR). The JRC JCY 1800 type VDR recorded bridge and communication audio, radar images and various other navigational data.

While in Australia, the ship's bridge navigational system was updated by shore technicians with new GPS units and a reconfigured wiring system to interconnect the electronic navigational aids. The update facilitated multiple GPS inputs for the different aids, providing greater redundancy in the event of single GPS unit failures.
