# Collision between banking locomotives and grain train 5446

Near Werris Creek, New South Wales, on 6 January 2022

**ATSB Transport Safety Report**  
Rail Occurrence Investigation (Defined)  
RO-2022-001  
Final – 20 August 2024

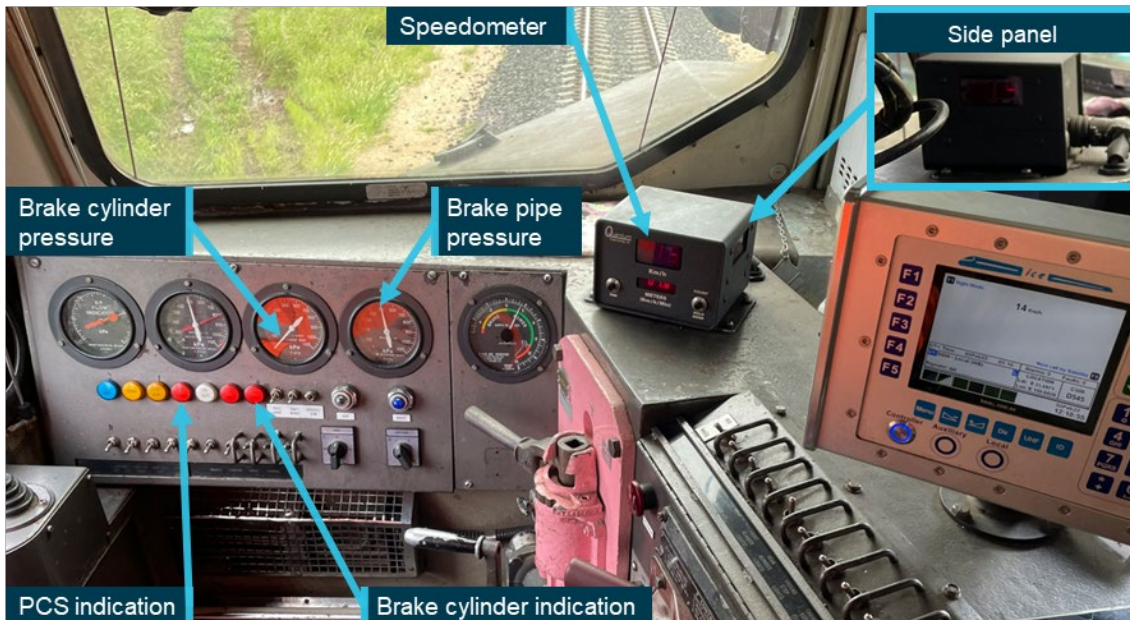
**Figure 3: Locomotive C506 control indications**

At the driver controls was the trainee driver, who could observe several warning light indications and pressure gauges to monitor the train consist. These included pressure changes in the train's brake pipe and C506's brake cylinders, and warning lights associated with C506's PCS function and brake cylinder pressure (Figure 3).

Control indications on C506 as applied during banking operations.  
Source: OTSI

The mentor driver, who was seated in the observer's seat, had access to basic functions such as the locomotive horn and light switches. Although the speedometer had a side panel to enable speed monitoring by the mentor driver (Figure 3), they relied on the trainee driver to advise them of gauge and warning light indications.

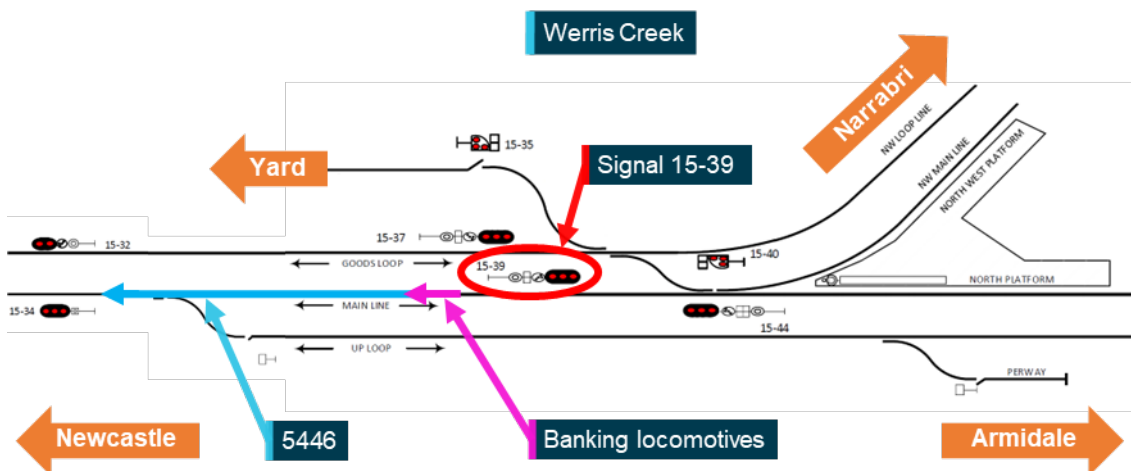
Figure 5: Banking locomotives' attachment location

The distance between signals 15-34 and 15-39 was 1,012 m, with the length of 5446 (including the attached banking locomotives) being about 944 m. When interviewed, the mentor driver described this as problematic. At least a 'couple of times' stretch tests were unable to be performed due to the proximity of the banking locomotives to signal 15-39 in the rear, after the grain train had stopped a greater distance than usual from signal 15-34 on arrival (Figure 5). This was not a factor on the day of the accident.

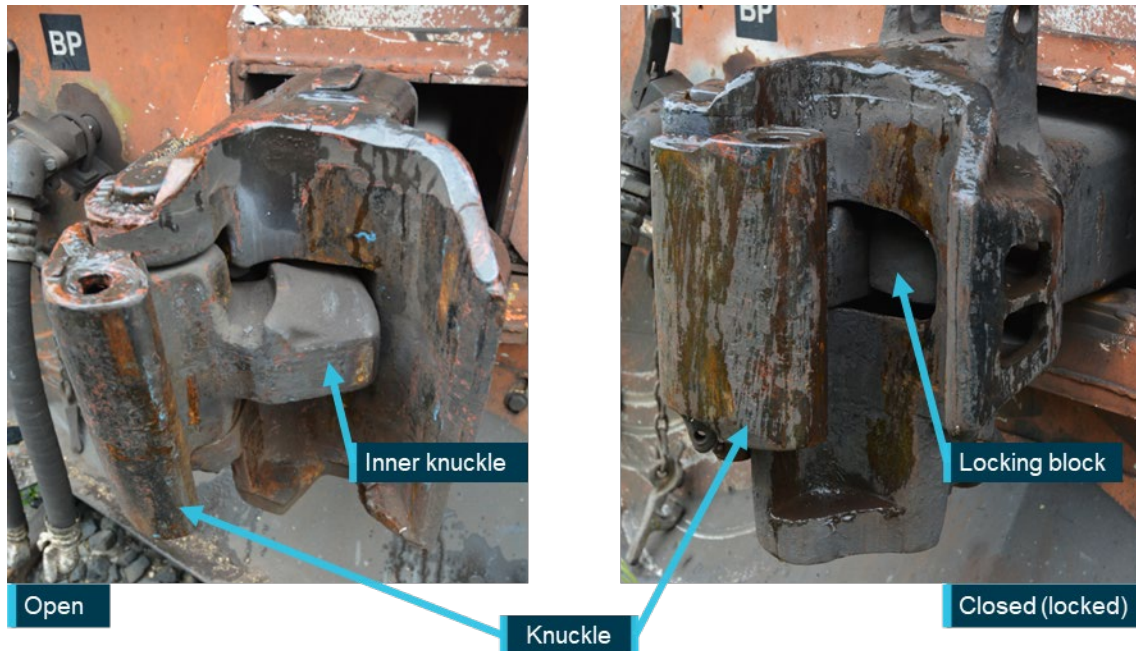
**Figure 8: Open and closed automatic coupler**

*An open knuckle (left image) and a closed and locked knuckle (right image). The locking block keeps the knuckle from opening once closed. If adjacent rolling is coupled, the pairing knuckle of the adjacent rolling stock would lock in behind the pictured knuckle.*  
 Source: OTSI

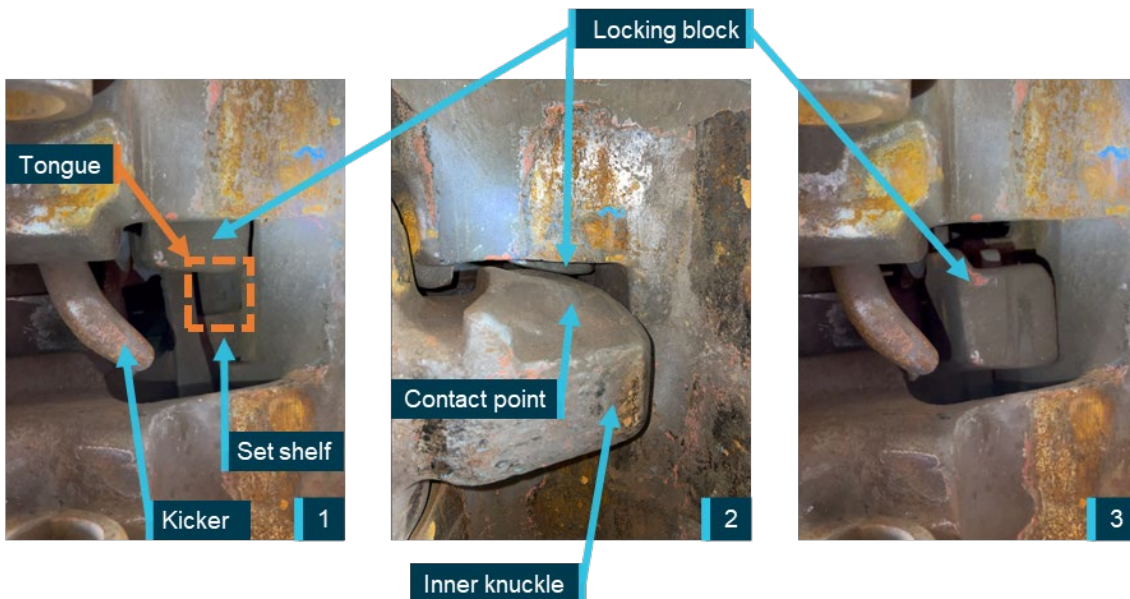
**Figure 11: Internal coupler mechanisms**

Figure 11 illustrates the sequence of mechanical events internal to the coupler body when performing coupling operations, as follows:

- Image 1: As the locking block moves upward during unlocking, it contacts with and thereby engages the kicker, which assists in pushing open the unlocked knuckle. In addition, the tongue of the locking block (see also Figure 10), rests on the set shelf within the coupler, keeping the locking block raised and the knuckle in an unlocked state. This allows the shunting personnel to release the control rod without the knuckle immediately re-locking. The purpose of this safety design feature is to allow shunting personnel to:

- Image 3: Once the locking block drops in front of the inner knuckle, it locks it in place, preventing it from reopening (see also right-hand image in Figure 8).

*This image shows operation of the internal mechanisms within the coupler body. Image numbers 1 and 3 have had the knuckle physically removed to allow visibility of the locking block.*  
Source: OTSI

Importantly, once the locking block tongue has come to rest on the set shelf, the knuckle must be fully opened to dislodge the tongue from the set shelf, thereby enabling the knuckle to be relocked. If the knuckle remains closed but unlocked, it will not lock again regardless of how much inwards pressure is exerted, as the locking block tongue will not dislodge from the set shelf. So, if both automatic couplers on adjacent rolling stock are unlocked for coupling, but only one knuckle is fully opened, only the fully opened knuckle will lock when the rolling stock are pushed together regardless of the buff (compressive) force applied. This will result in the closed but unlocked knuckle remaining in an unlocked state after coupling, and a train separation when the train is next moved with a draft (stretched) force.

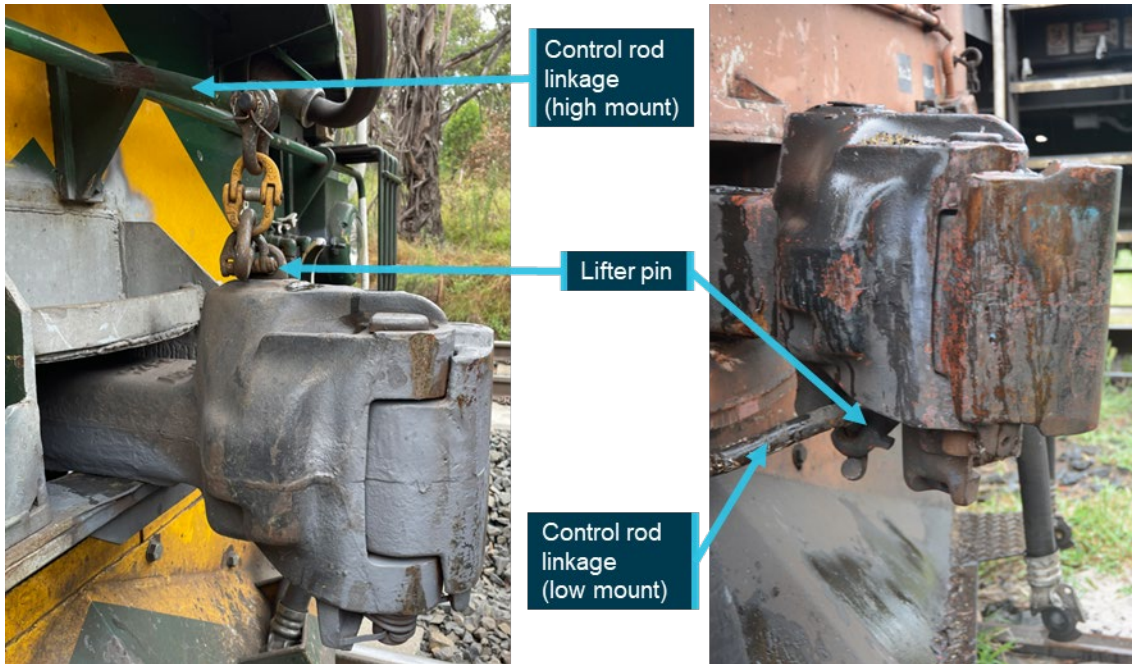
**Figure 12: Comparison of top lifter (left) versus bottom lifter (right) automatic couplers**

While the operation of the automatic coupler remains the same, there is a subtle design difference in the way the locking block is lifted for a top versus a bottom lifter operation. The top lifter pulls up the locking block when operating the control rod, whereas bottom lifter pushes up the locking block. While top lifter operation is more common, the bottom lifter design allows for a lower control rod and lifter position, providing clearance from pipework (on locomotives) and reduced obstruction during loading (container wagons) (Figure 12).

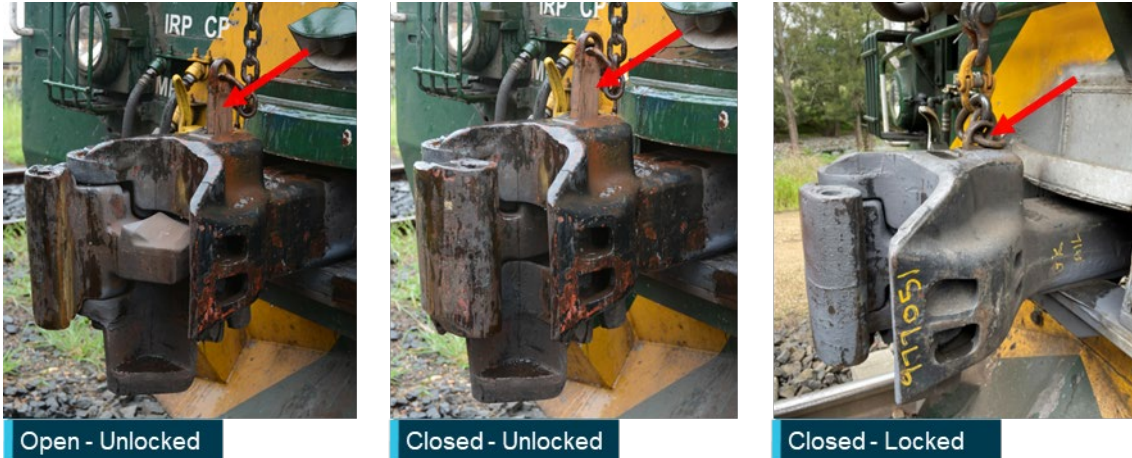
**Figure 13: Top lifter operated automatic coupler**

For top lifter operation, the lifter and control rod linkage are mounted on the top of the automatic coupler body. As shown in Figure 13, the lifter gives a clear and reliable visual indication of the position of the locking block. Unless the locking block has fully engaged in the locked position in front of the inner knuckle, the lifter will appear in a raised position.

Visual appearance of the lifter in various operational knuckle states for a top lifter operated automatic coupler.  
Source: OTSI
