Loss of separation involving a Cessna 310, VH-XXT and a Cessna 210, VH-RQD

Darwin Airport, 17 February 2012

ATSB Transport Safety Report

AO-2012-030

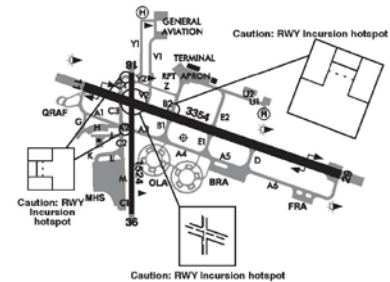
Figure 1: Darwin Airport

RQD vacated runway 18 to the left via taxiway Alpha and held short of runway 29 at holding point Charlie 3 (C3) (Figure 1), in accordance with instructions issued by the surface movement controller (SMC). At the same time, a Cessna 310, registered VH-XXT (XXT), was holding at taxiway Echo 2 (E2) for an intersection departure from runway 29.
