Loss of performance involving DH-82A (Tiger Moth), VH-DDA

Luskintyre Airport, NSW, 15 December 2012

ATSB Transport Safety Report
Aviation Occurrence Investigation
AO-2012-169
Final – 23 April 2013

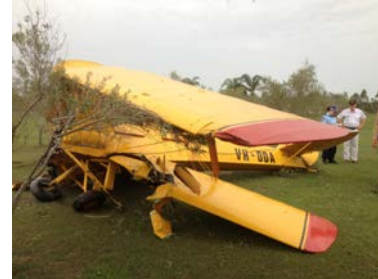
A small fire caused by a fractured fuel line was quickly extinguished by ground crew and the aircraft sustained substantial damage.

Figure 1: Damage to left wing following impact with a tree
