Instrument failure and control issues involving Raytheon Aircraft Company C90A, VH-JEO

170 km north-east of Kalgoorlie-Boulder Airport, Western Australia on
25 January 2024

ATSB Transport Safety Report

AO-2024-003

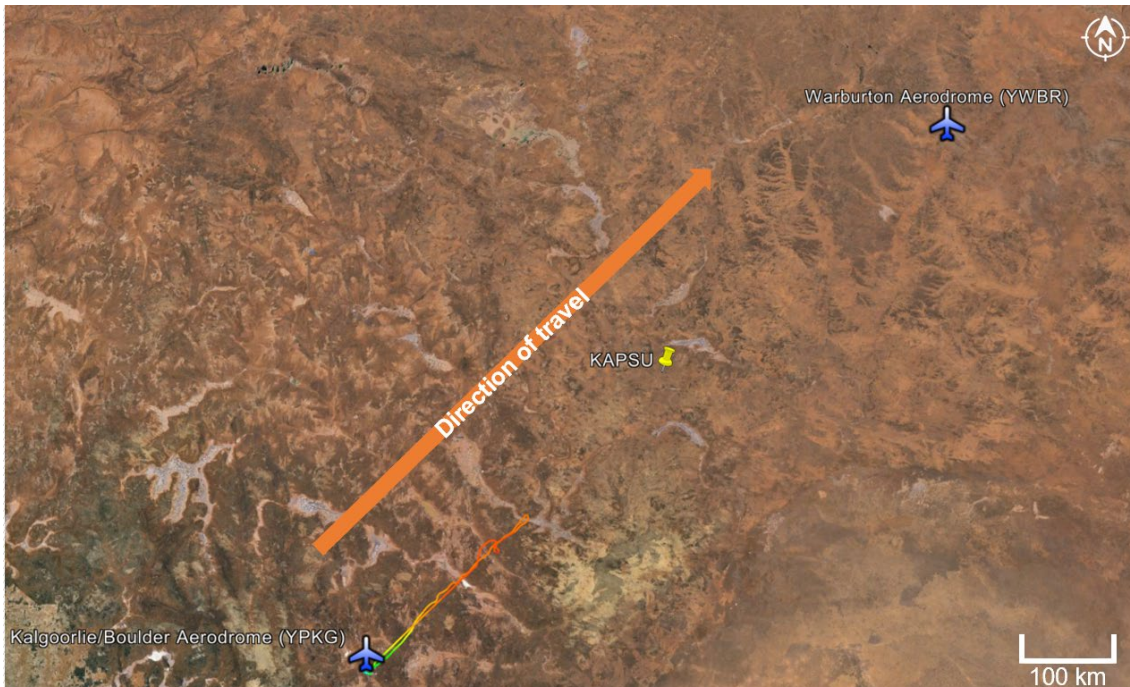
Figure 1: Flight track from Kalgoorlie to Warburton

At 0640 local time on 25 January 2024, a Raytheon Aircraft Company C90A aircraft, registered VH-JEO and operated by Goldfields Air Services, departed Kalgoorlie-Boulder Airport (Kalgoorlie), Western Australia (WA) on a commercial passenger transport flight to Warburton Airport, WA (Figure 1). On board were the pilot and 2 passengers.
