# Flight below minimum altitude involving Boeing 737-800, PK-LDK

19 km south of Canberra Airport, Australian Capital Territory on 14 June 2024

**ATSB Transport Safety Report**  
Aviation Occurrence Investigation  
AO-2024-035  
Preliminary – 4 September 2024

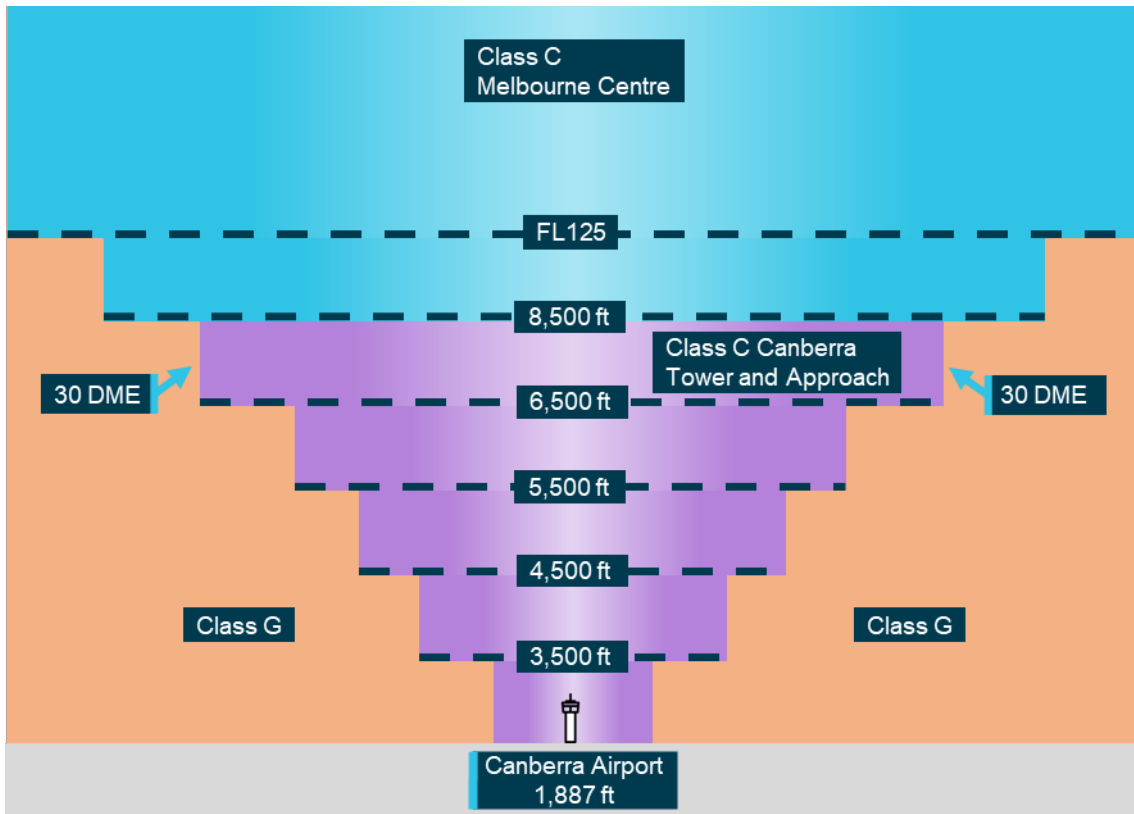
**Figure 4: Canberra airspace when tower and approach were operating**

On the day of the incident, the operating hours of Canberra Tower and Approach controlled airspace were 0600 to 2300. During these hours, Canberra Airport was within class C airspace, with airspace bases that increased as the airspace fanned out at increasing distances from the airport (Figure 4). The Canberra Tower and Approach air traffic control (ATC) services controlled the class C airspace within 30 DME of Canberra and below 8,500 ft above mean sea level (AMSL). Control services for the airspace above 8,500 ft AMSL were provided by a Melbourne Centre controller at all times during the flight's descent and approach.

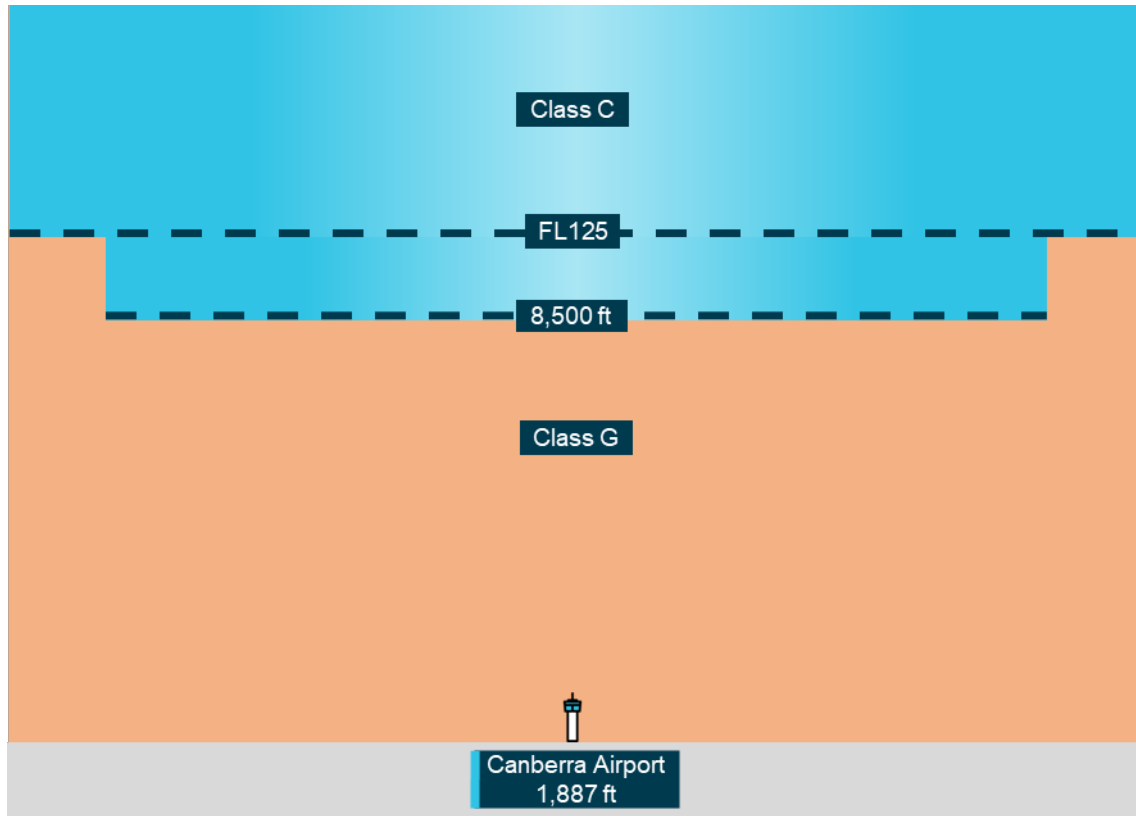
**Figure 5: Canberra airspace when tower and approach were not operating**

Outside of the Canberra Tower and Approach operating hours, the base of the Class C airspace was 8,500 ft AMSL. Below this was class G, non-controlled airspace (Figure 5). Within class G airspace, aircraft crews could manoeuvre as required to position for an approach and were responsible for maintaining adequate terrain clearance. ATC was unable to issue STARs or approach clearances for the class G airspace.

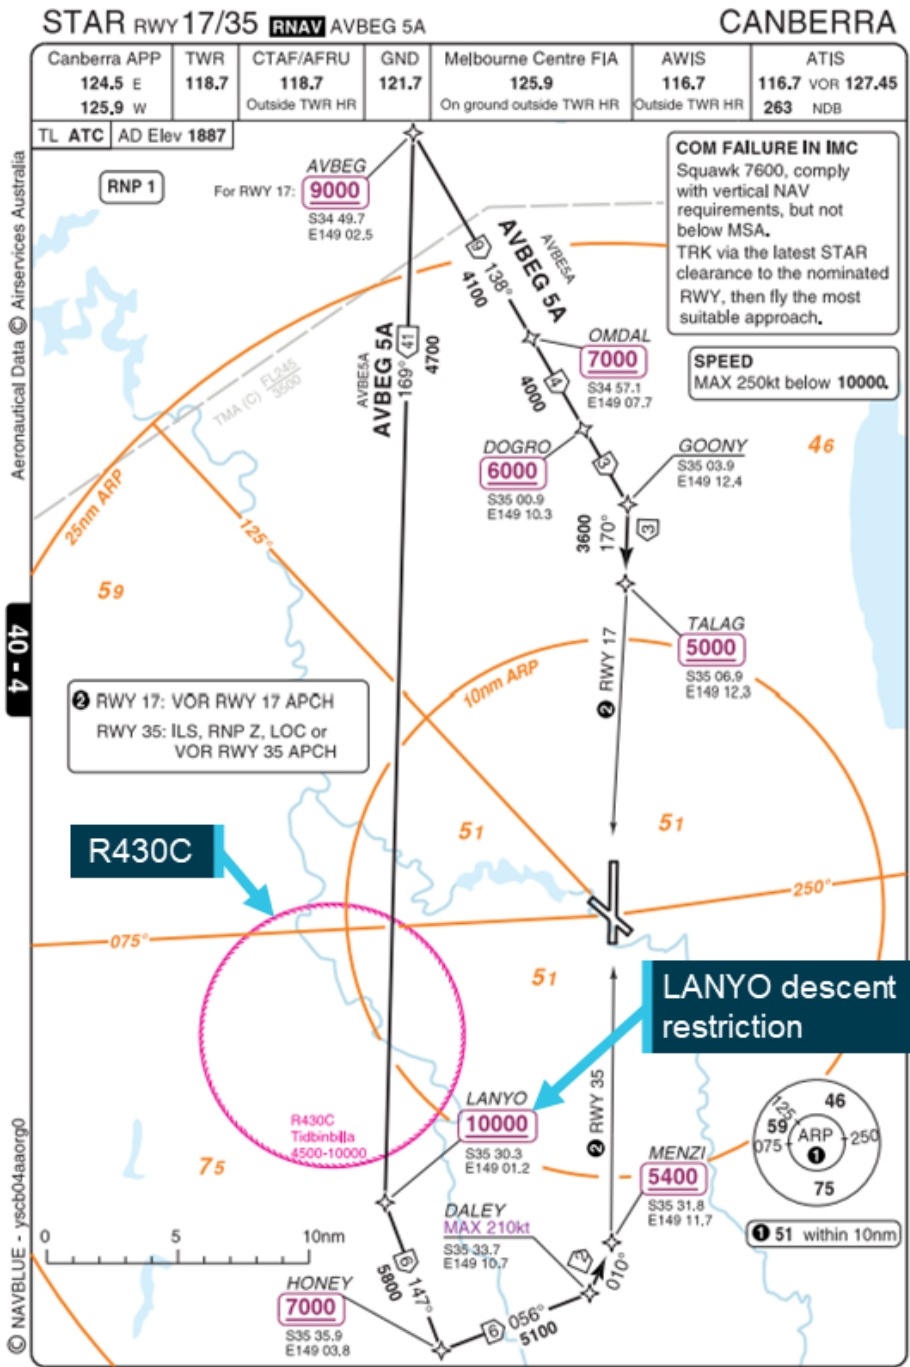
Figure 6: AVBEG 5A standard arrival route

South-west of Canberra Airport, restricted areas of airspace (R430 A-C) encompassed the Canberra Deep Space Communications Complex at Tidbinbilla. The uppermost of these restricted areas (R430C) had a radius of 10 NM and a ceiling of 10,000 ft AMSL. The AVBEG 5A STAR (Figure 6) passed over this restricted area and had a 10,000 ft AMSL descent restriction at the waypoint LANYO which prevented aircraft descending via the STAR from entering that area.

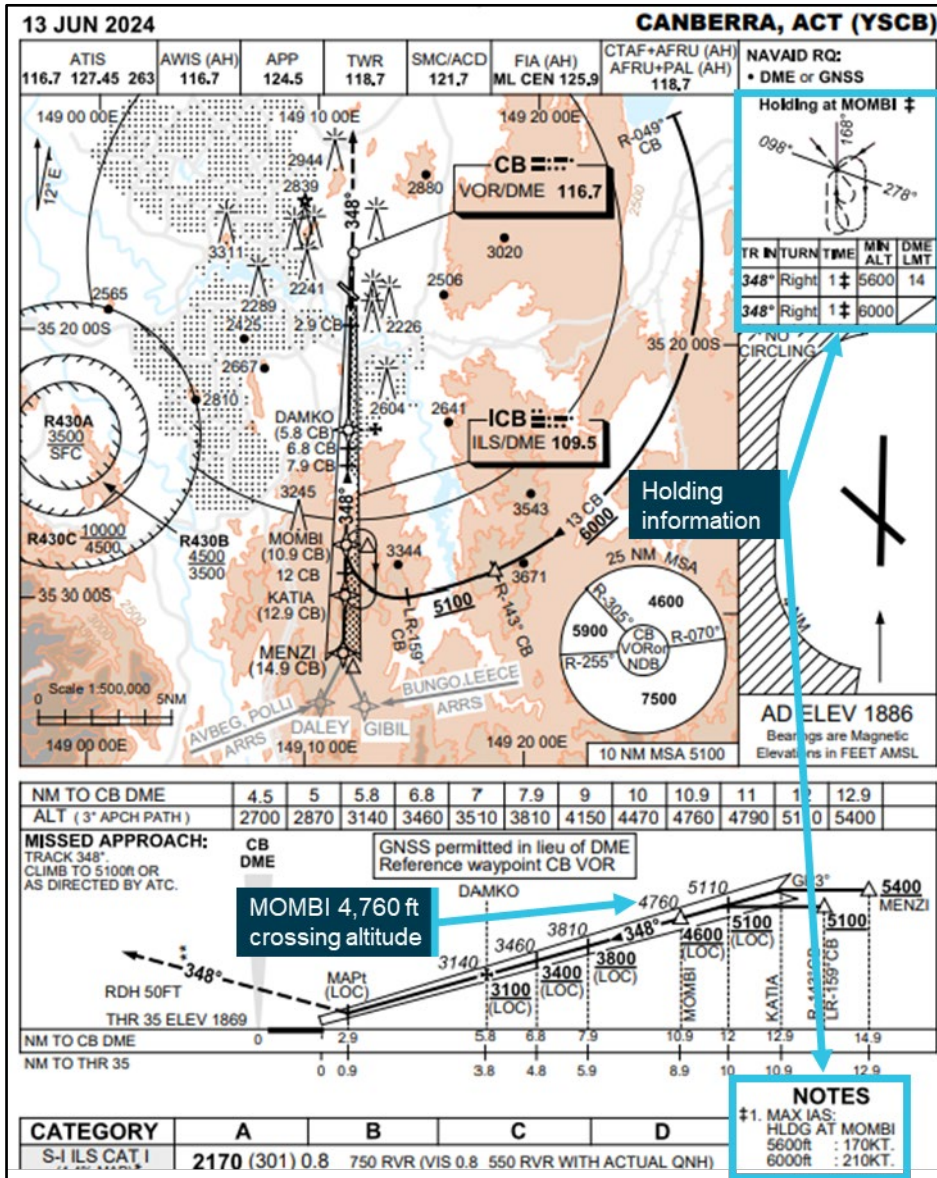
Figure 7: Canberra runway 35 instrument landing system approach

The approach included a right turn, 1 minute holding pattern at the approach waypoint MOMBI (Figure 7). The minimum holding altitude at MOMBI was 5,600 ft AMSL. To use that minimum altitude, the crew was required to adhere to a maximum speed of 170 kt and a 14 DME limit from the Canberra DME for commencing the inbound turn back to MOMBI. A higher minimum holding altitude of 6,000 ft AMSL could also be used which allowed for a higher maximum speed of 210 kt with no DME limit.
