In-flight break-up involving Cessna 210N, VH-TFT

237 km east-north-east of Katherine, Northern Territory on 24 December 2022

ATSB Transport Safety Report

AO-2022-067

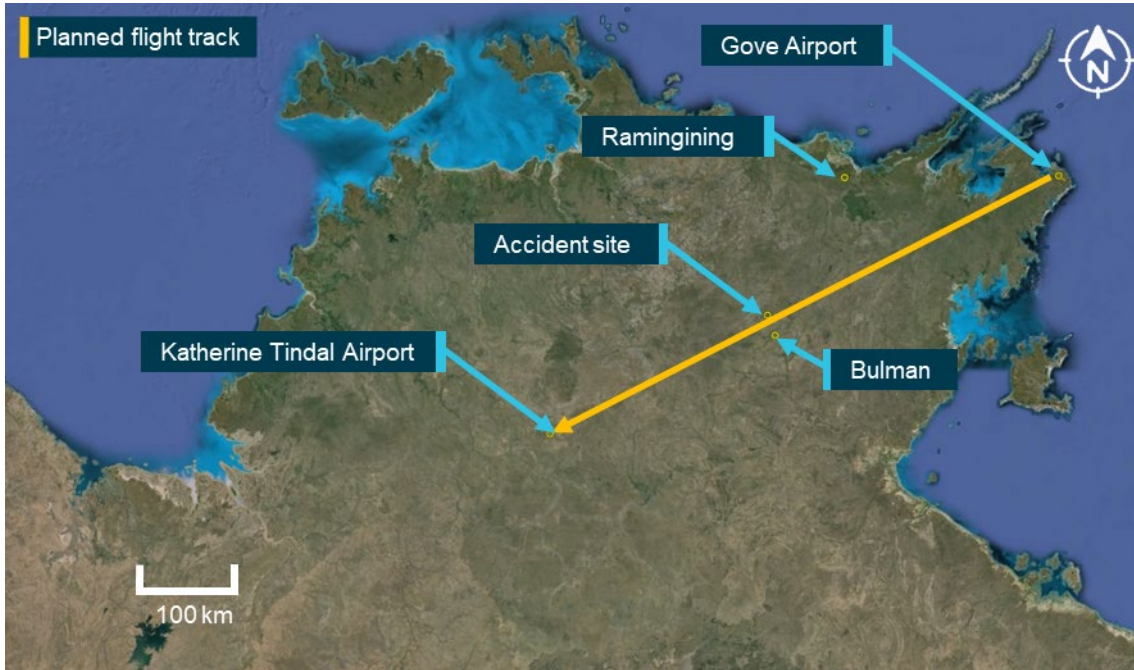
Figure 1: Satellite view showing the planned direct track, the location of the accident site and its proximity to Bulman

A search and rescue response was commenced by the Australian Maritime Safety Authority's Joint Rescue Coordination Centre (JRCC), with an airborne search commencing at 1344. The JRCC requested mobile phone tracing records that enabled the search to be refined around the Bulman area (Figure 1). The JRCC advised there was no signal received from the aircraft's emergency locator transmitter to assist with locating the aircraft.

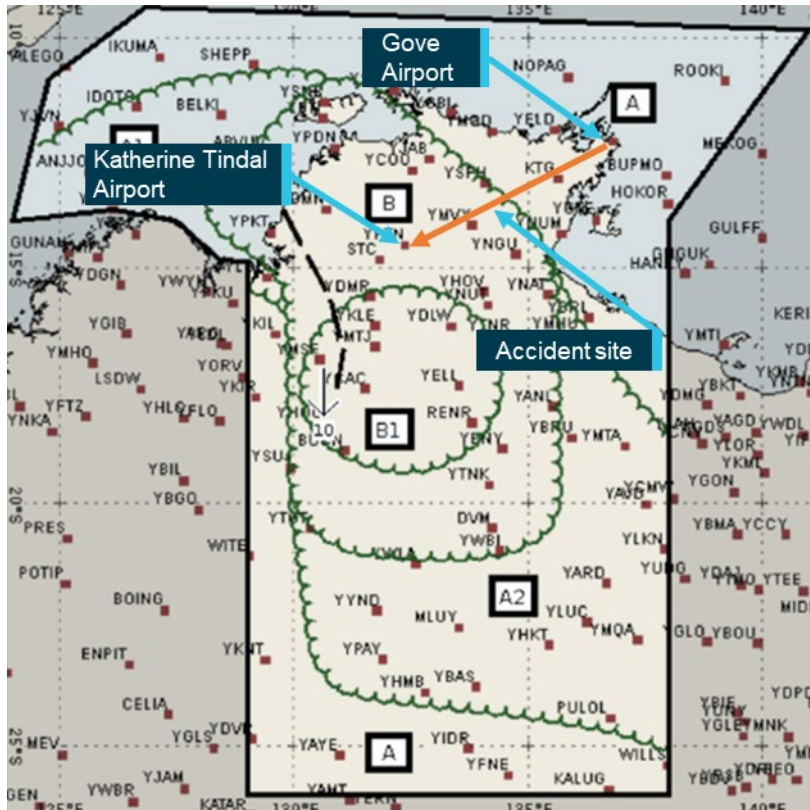
Figure 2: GAF for the Northern Territory with the track from Gove to Katherine Tindal Airport highlighted (upper image) and accompanying weather features (lower table)

The GAF for the Northern Territory issued at 0135 on 24 December 2022, valid from 0830 to 1430, divided the territory into several areas (Figure 2). Gove was in area A, Katherine in area B and the accident occurred about 25–35 km into area B.

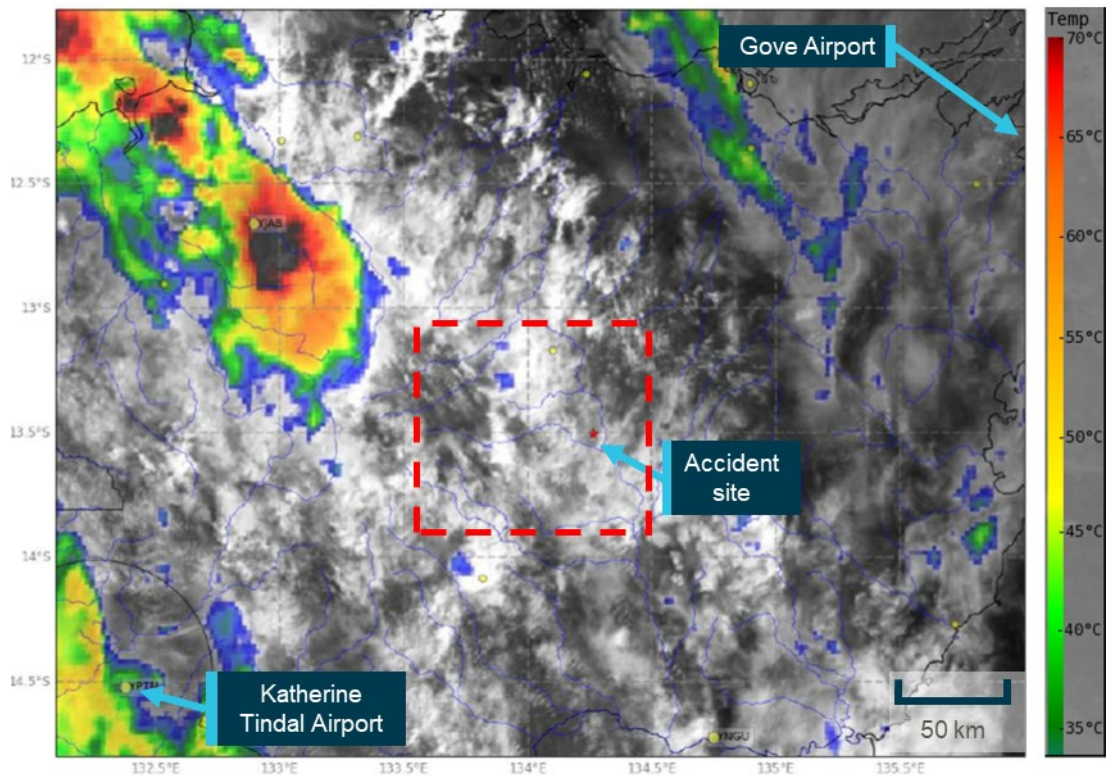
Figure 3: Weather satellite imagery showing cloud and convective cloud activity relative to the accident site at 0900 on 24 December 2022

Analysis of satellite imagery⁶, conducted by the BoM, indicated that from 0900 convective cloud developed to the west of the accident site. The cloud developed into thunderstorms with the first observations of lightning recorded between 0940 and 0950. The satellite imagery in the vicinity of the accident site is shown in Figure 3 and the montage in Figure 4. The imagery shows the development of the weather system near the accident location from 0900 to 1000. The system persisted for several hours after 1000. The BoM estimated that the cloud tops in the vicinity of the accident site were between 38,000 ft and 46,000 ft AMSL.

The white areas are scattered to broken clouds, and the colours provide an indication of the vertical development of the cloud with temperatures ranging between -35 to -70 °C. The colours provide an indication of the vertical development of the cloud and in general terms, the colder the cloud top temperature, the higher the top of the cloud.
 Source: Bureau of Meteorology, annotated by the ATSB

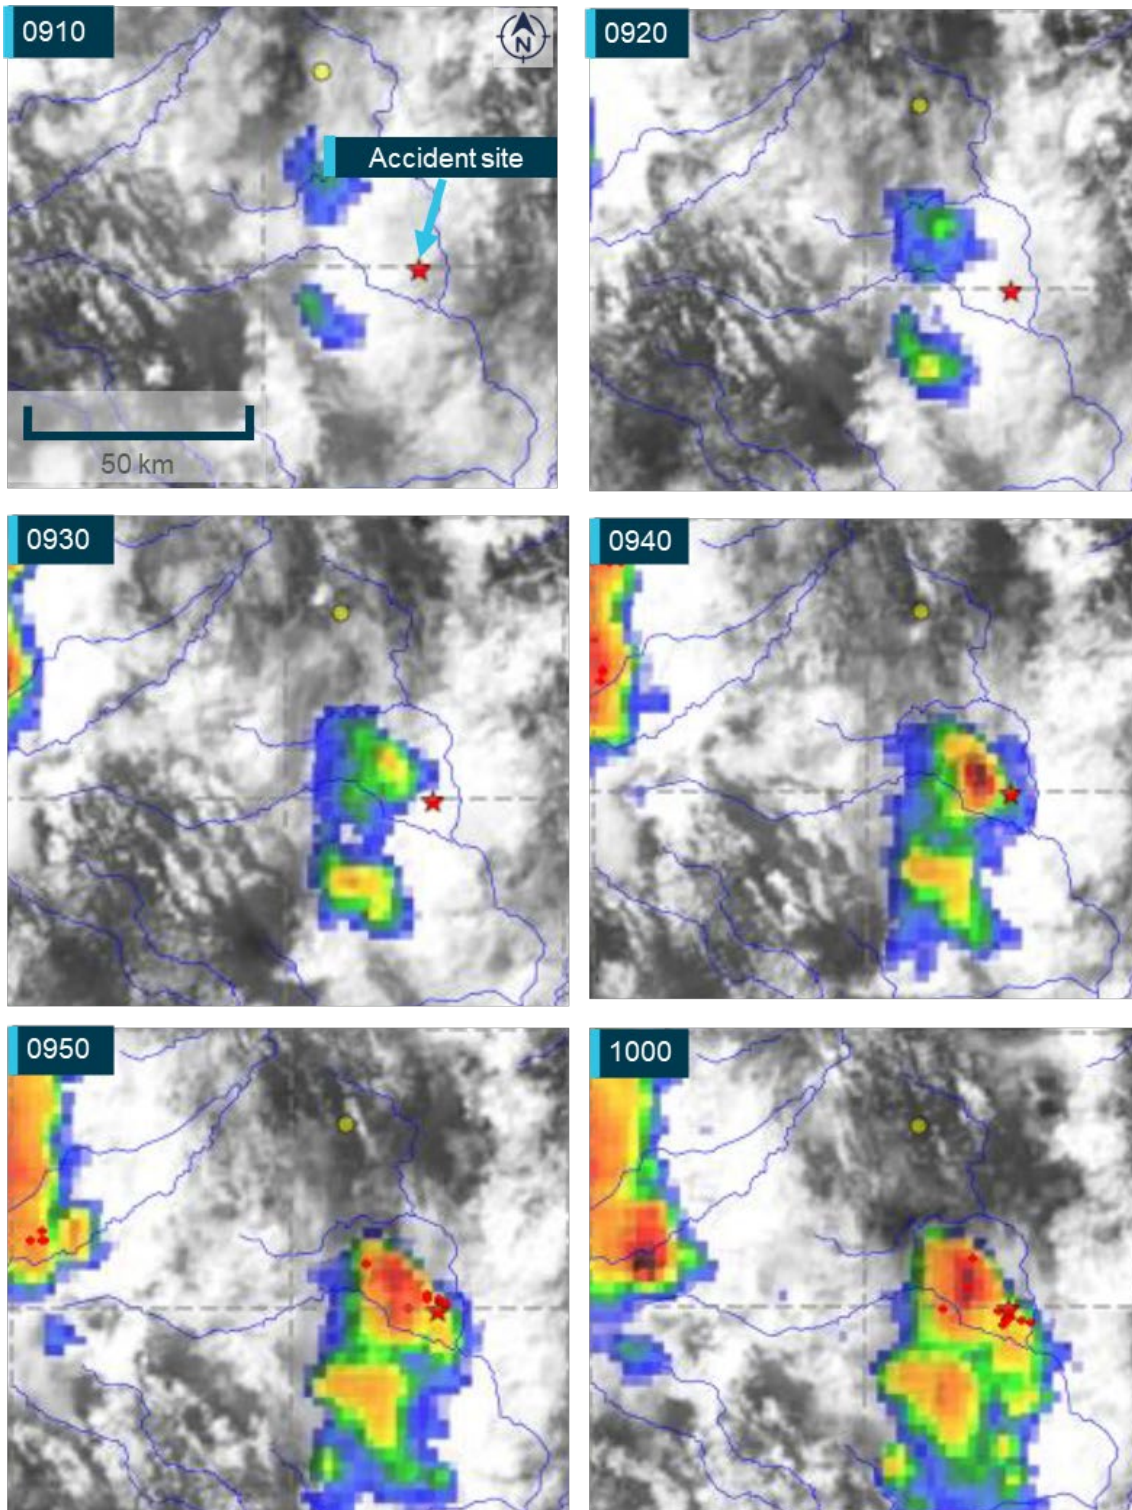
Figure 4: Montage of satellite imagery showing the rapid build-up of convective activity near the accident site from 0910 to 1000 on 24 December 2022

Red dots in the above images at 0940, 0950 and 1000 are recorded lightning strikes.

The accident site is represented by a red star.

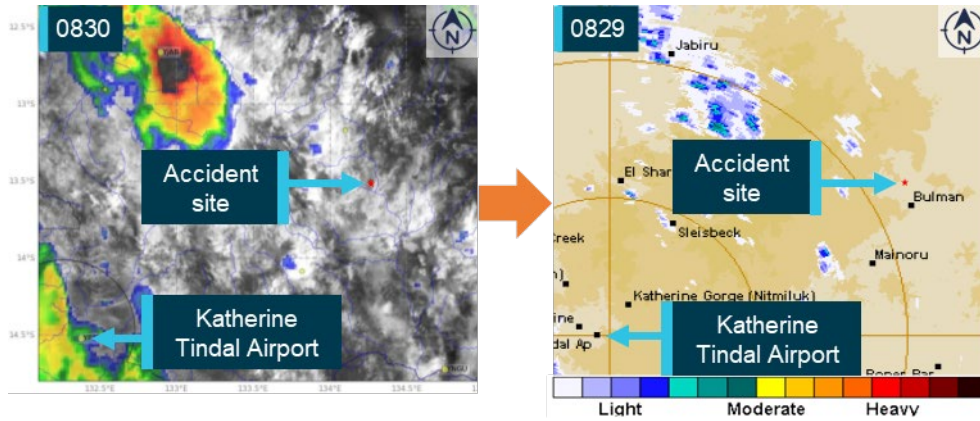
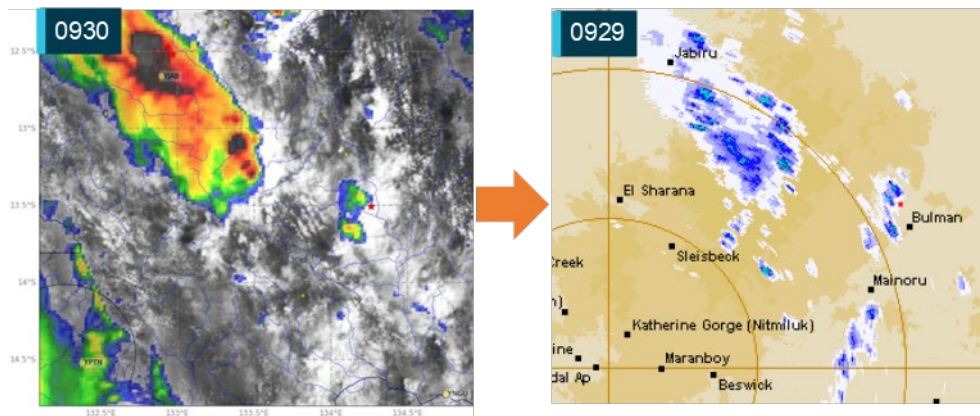
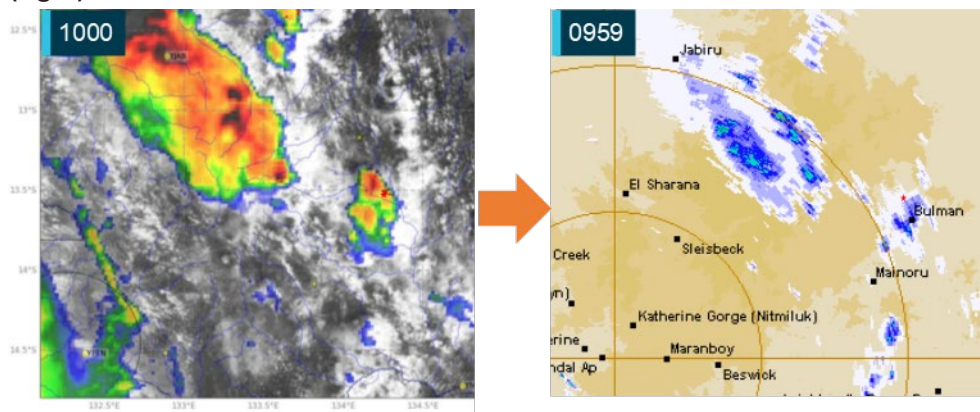
A comparison of the overhead satellite imagery and the Katherine–Tindal weather radar is also shown at Figure 5 to Figure 7. After the flight had departed Gove, the data at 0830 that morning identified that while significant thermal activity had developed to the north-west of the planned route, the immediate area along the planned track near to Bulman was clear of rain. At 0930 to 1000, the weather radar identified light to moderate rain, along with increased convective activity, signalling the development of a thunderstorm. The BoM identified that limitations exist to the accuracy of weather radar information, particularly as distances increase from the radar head. As the flight progressed toward Bulman, it remains possible that the weather radar did not completely display the extent of the weather system to the pilot. Optimal coverage of weather radar information is described by the BoM:

It was not possible to determine whether the pilot accessed the weather radar information prior to, or during the accident flight. Furthermore, the location of the accident site surrounding Bulman was beyond the optimal coverage range of the BoM radar. Therefore, as discussed above, even if this information was accessed by the pilot, the rain intensity detected by the BoM weather radar on approach to Bulman may not have accurately represented the conditions at the time.
