# Loss of control and collision with water involving Bell Helicopter Company 204B, VH-EQW

Tarome, Queensland, on 20 September 2023

Aviation Occurrence Investigation (Short)

AO-2023-044

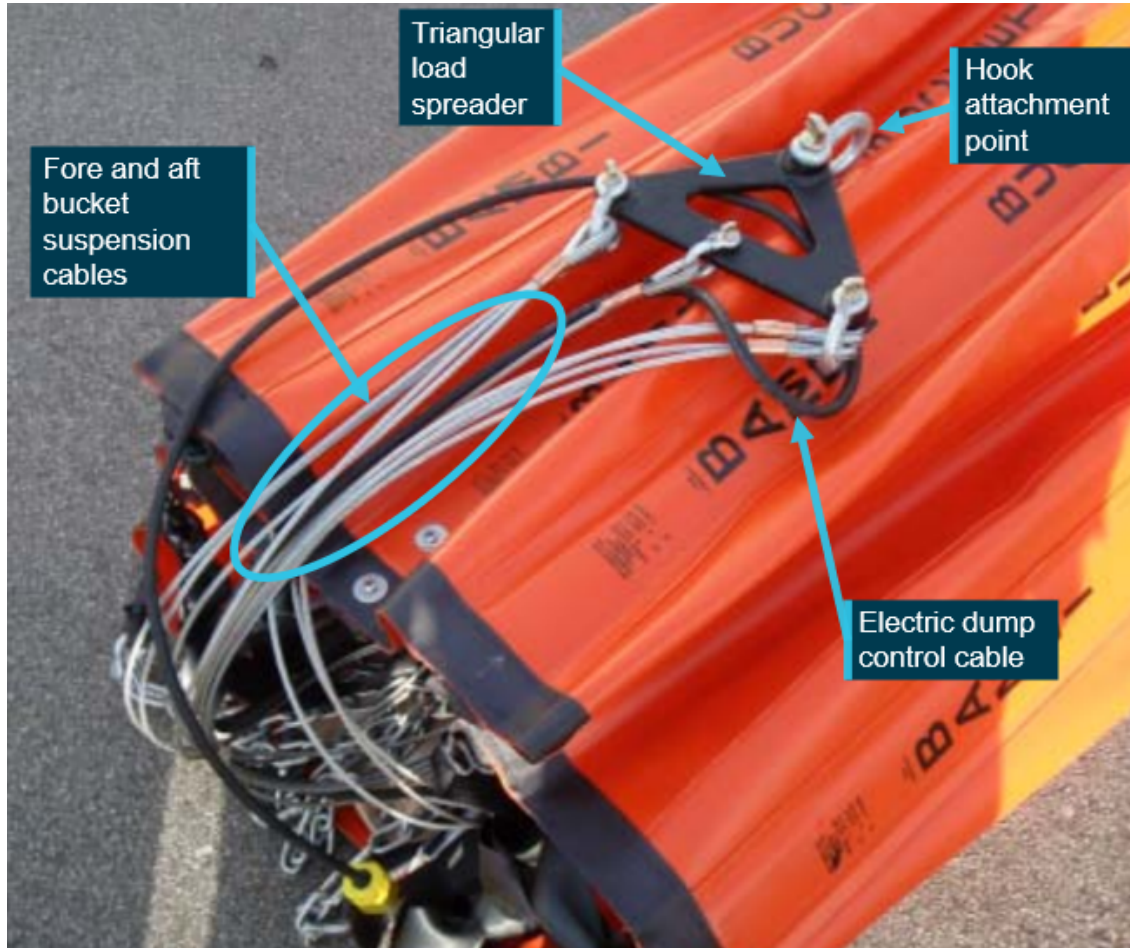
**Figure 4: Photo of exemplar Bambi Max bucket in the stored configuration showing the triangular spreader bar and suspension cables**

The Bambi Max water bucket fitted to VH-EQW was manufactured by SEI industries and weighed 67 kg empty and 1,300 kg when full, with a capacity of 1,230 L. The bucket was connected to the helicopter's external load hook by several stainless steel suspension cables, separated fore and aft by a triangular spreader bar (Figure 4). A dump switch on the collective<sup>2</sup> was connected through a black electrical cable to control the dump valve located in the base of the bucket. The

suspension cables used on the day had a length of 5.05 m and the total length including the bucket was 6.27 m.

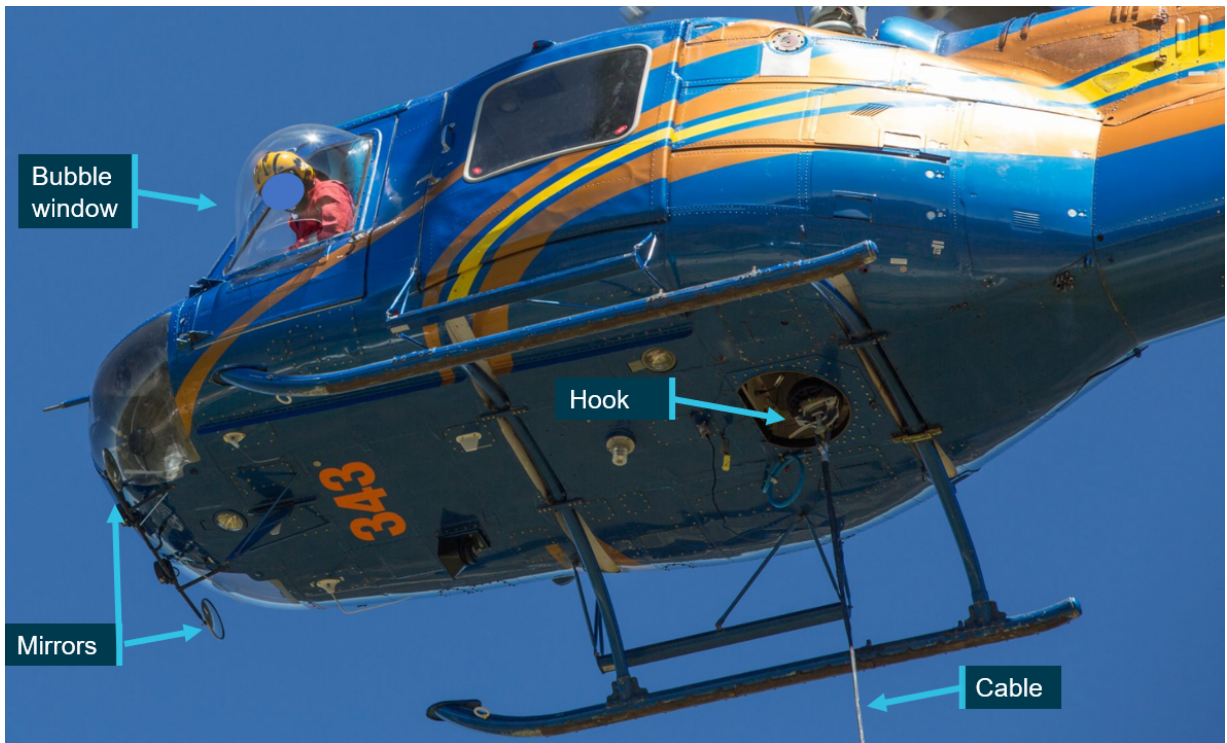
Figure 5: Bell 204 showing mirrors and bubble window

The helicopter was fitted with 2 rear vision mirrors that were located under each of the Perspex chin bubbles to provide visibility of the external hook, suspension cables and bucket. The bubble window fitted to the pilot's left door also allowed for better visibility downwards and, to a limited extent, the rear of the helicopter (Figure 5). In response to this draft report, the pilot reported that the mirrors provided a full and clear view of the external hook and bucket.

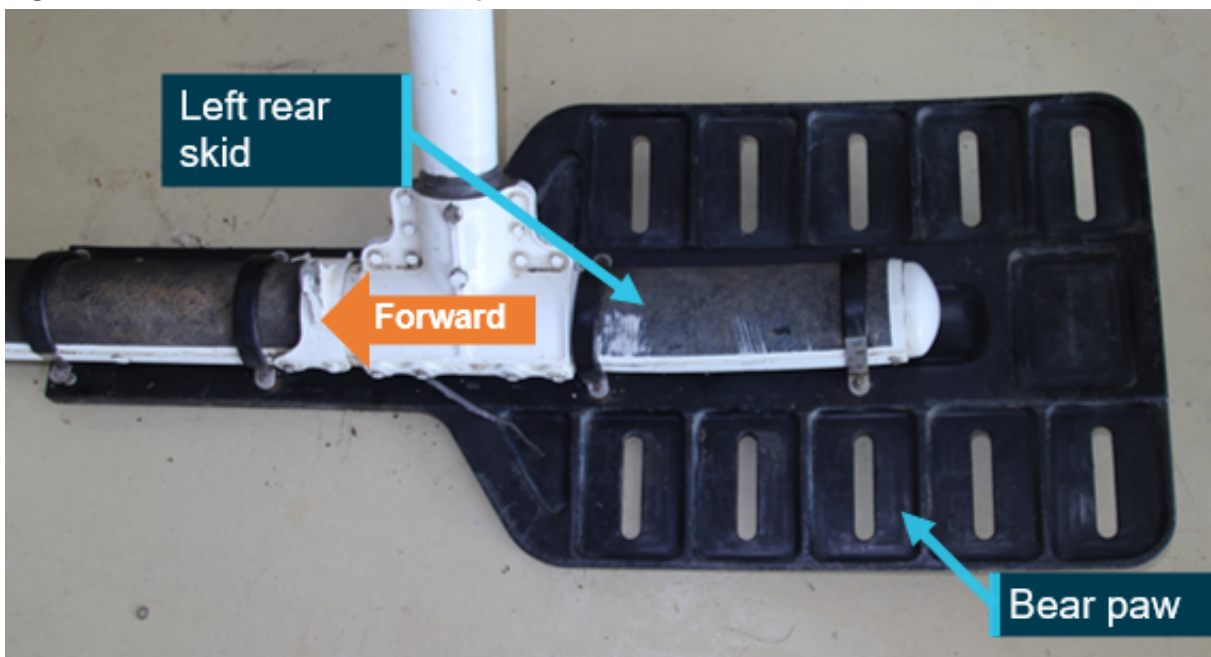
Figure 6: VH-EQW left skid with bear paw fitted

The helicopter had a pad like modification to the skids called ‘bear paws’, which are supplied as a kit of 2. The pads fit under and to the rear of each of the skids and are designed for landings off airport, on uneven or unstable terrain, helping with overall landing stability and to prevent the rear of the skids from sinking into soft surfaces. The bear paws are made from a polymer plastic and feature high impact resistance, durability and flexibility. They are secured to the skid utilising 4 metal clamps (Figure 6).
