VFR into IMC, loss of control and collision with terrain involving SOCATA-Groupe Aerospatiale TB-20, VH-JTY

65 km west of Mackay Airport, Queensland, on 28 October 2023

ATSB Transport Safety Report

AO-2023-052

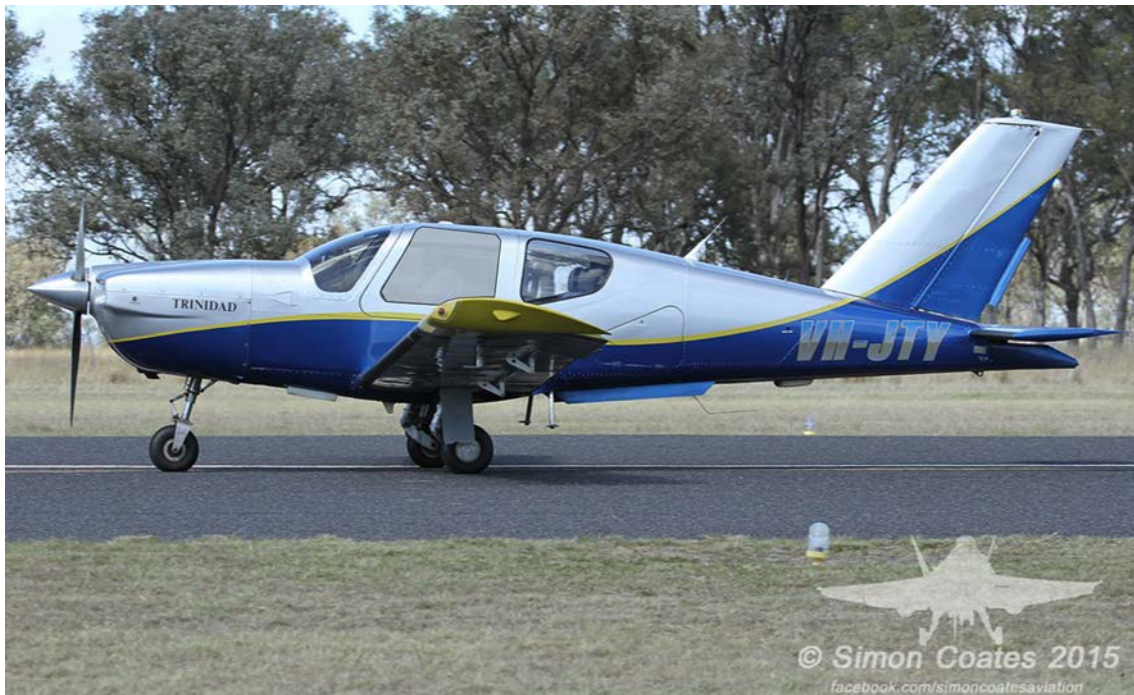
Figure 4: VH-JTY

VH-JTY as it appeared in 2015. The yellow lines and wingtips were later painted dark red.
Source: Simon Coates, modified by the ATSB

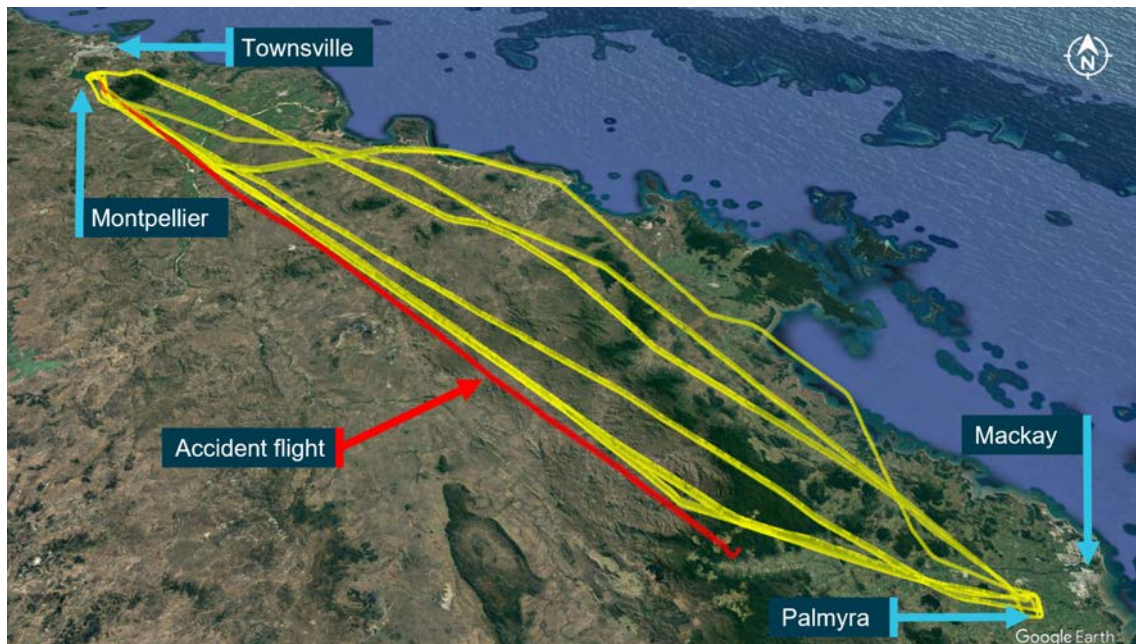
Figure 7: Previous flight data

Data obtained for the previous 3 months showed a number of previous flights between the two locations consistent with logged flight records (Figure 7). Each flight took about 1.2 hrs depending on the route taken.

Flights would often depart Palmyra, tracking inland towards Townsville where they would descend outside the Townsville control zone steps and land at Montpelier Airfield. On return to Palmyra, the pilot routinely flew inland past Collinsville and would descend down the [Pioneer Valley](#) approaching Palmyra from the west below the Mackay control zone steps.

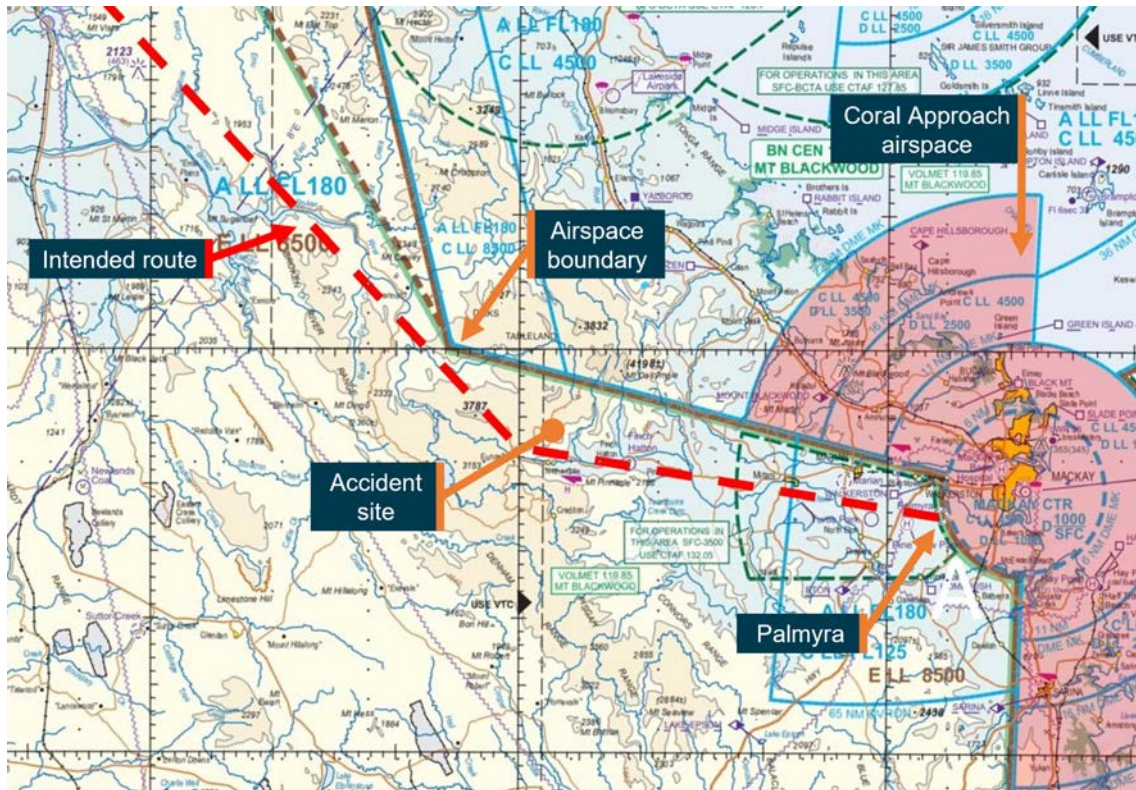
Figure 8: Intended flight path

The pilot was known to plan routes that were outside controlled airspace (Figure 8). Witnesses interviewed advised this was common practice among local pilots due to the potential of encountering delays in access to controlled airspace in that region.

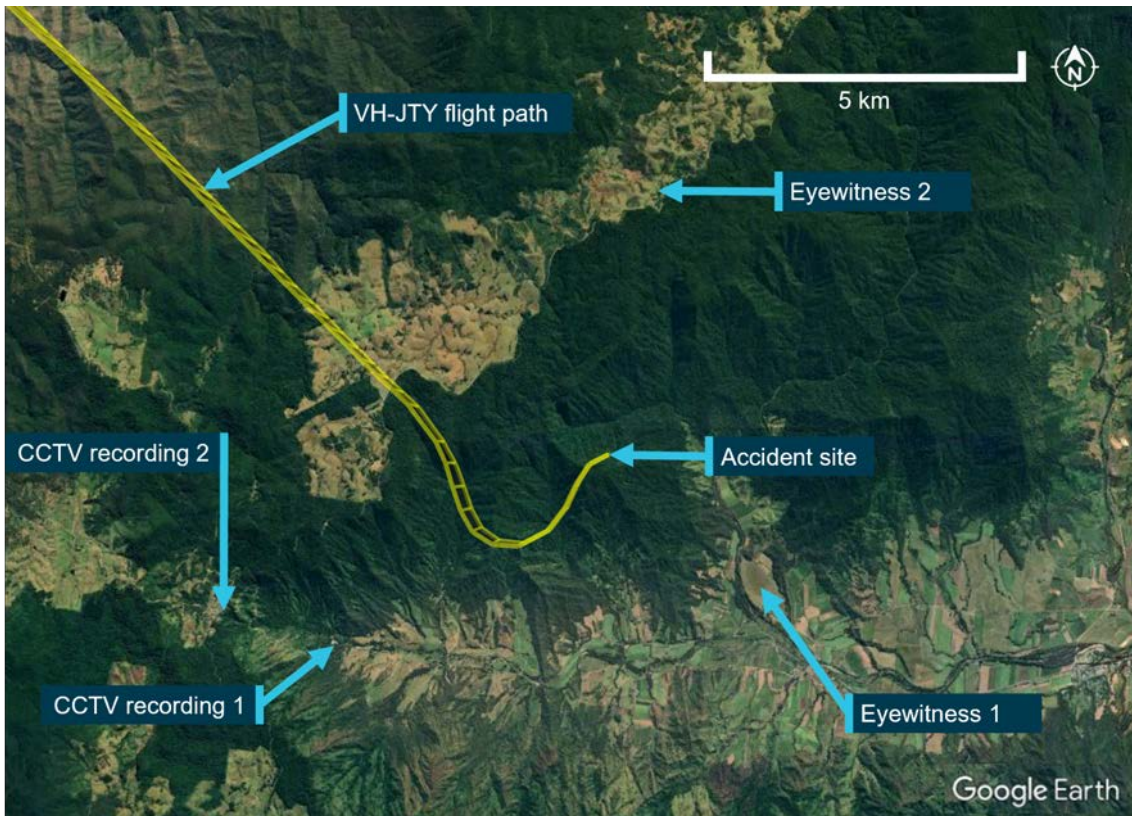
Figure 11: Witness locations

Figure 11 shows the location of witnesses and CCTV recorded at the time of the accident.

- Eyewitness 2 described the cloud as being very thick that morning from when they woke at 0500. The cloud started to rise around 0800 but still produced limited visibility of their paddock until around 1000. They also described a 'good breeze' on the ground during the morning with occasional gusts but did not recall strong winds on the day. CCTV footage from that location showed low cloud close to where the pilot commenced their descent (Figure 12).
