Australian Government
Australian Transport Safety Bureau

Collision between a passenger train and a motor vehicle

near West Dapto Road level crossing, Kembla Grange, New South Wales on
20 October 2021

ATSB Transport Safety Report
Rail Occurrence Investigation (Defined)
RO-2021-012
Final – 25 October 2024

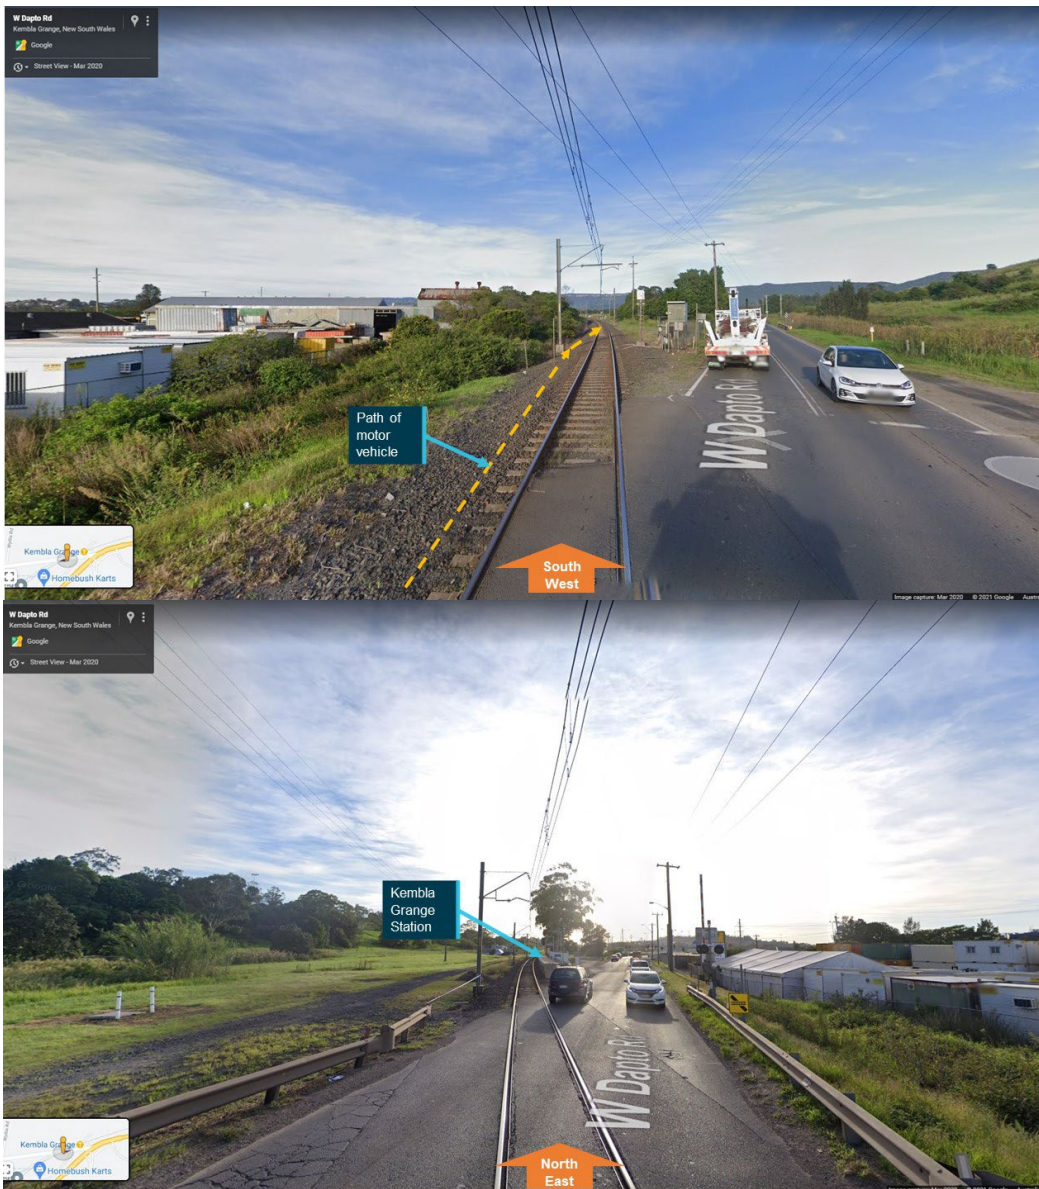
Figure 6: West Dapto Road Level Crossing

Figure 6 shows the level crossing and how its design affords access into the rail corridor. The individual likely accessed the rail corridor in their motor vehicle from the southwest entry on the downside (left side) of the railway line.

The individual likely drove the motor vehicle along the side of the track until they reached the high voltage stanchion. They then attempted to drive the motor vehicle over the rail track onto the upside (right side). This is when the motor vehicle got stuck on the rail line.

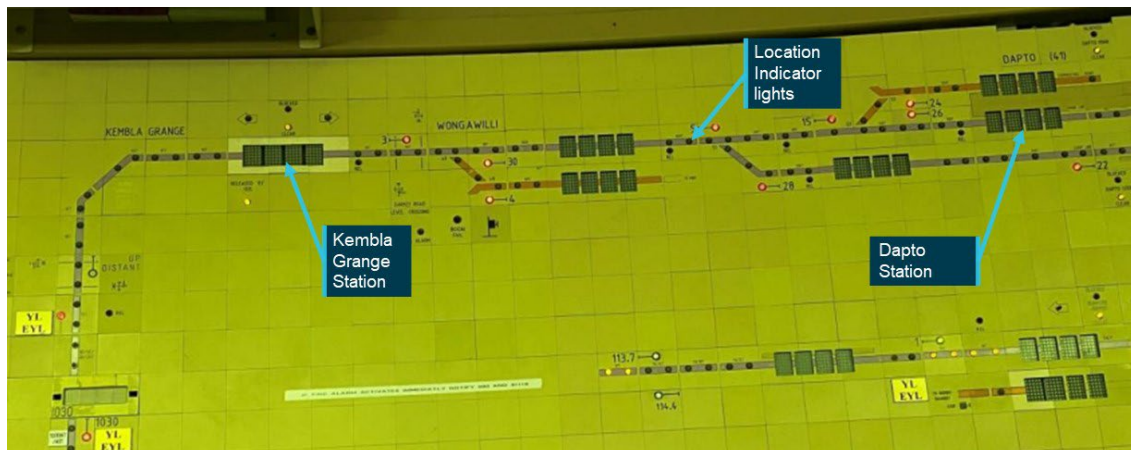
Figure 11: Train location board – Wollongong Signalling Complex

As a train traverses a track circuited area, it disrupts the electrical currents flowing through the rails which can then be used to indicate the position of the train. Lights are illuminated on a train location board (see Figure 11) to allow the network controller to get an indication of the location of the train.

This was evidenced in this incident when the WCP signaller was aware C012 was in the track section between Dapto and Kembla Grange and was able to respond to the TSDM by saying they would make direct contact with C012, when the TSDM said to stop all services.
