Controlled flight into terrain involving Boeing 737-3H4 Fireliner, N619SW

Fitzgerald River National Park, Western Australia on 6 February 2023

ATSB Transport Safety Report

AO-2023-008

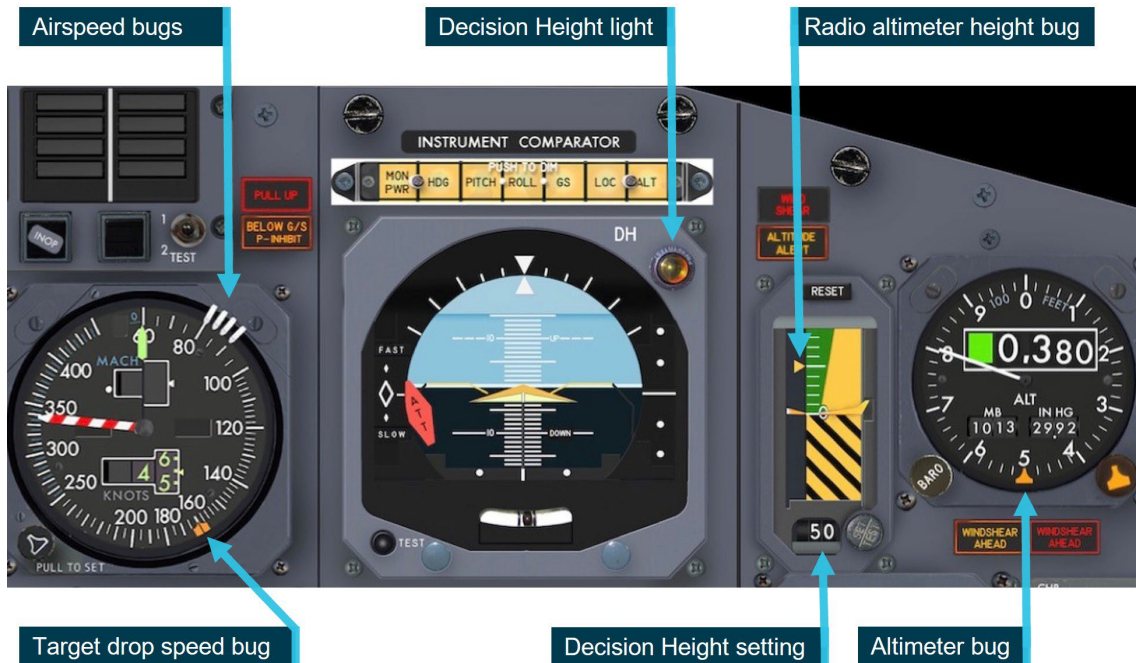
Figure 4: Co-pilot’s partial instrument panel

The altimeters and airspeed indicators incorporated bugs that could be set to reference altitudes and airspeeds. The operator reported that the orange airspeed bug was used for the target drop speed. The altimeter bug was not used because the retardant drop was conducted at a height above terrain and not at an altitude. Figure 4 illustrates the co-pilot's instrument panel with the radio altimeter DH set at 50 ft.

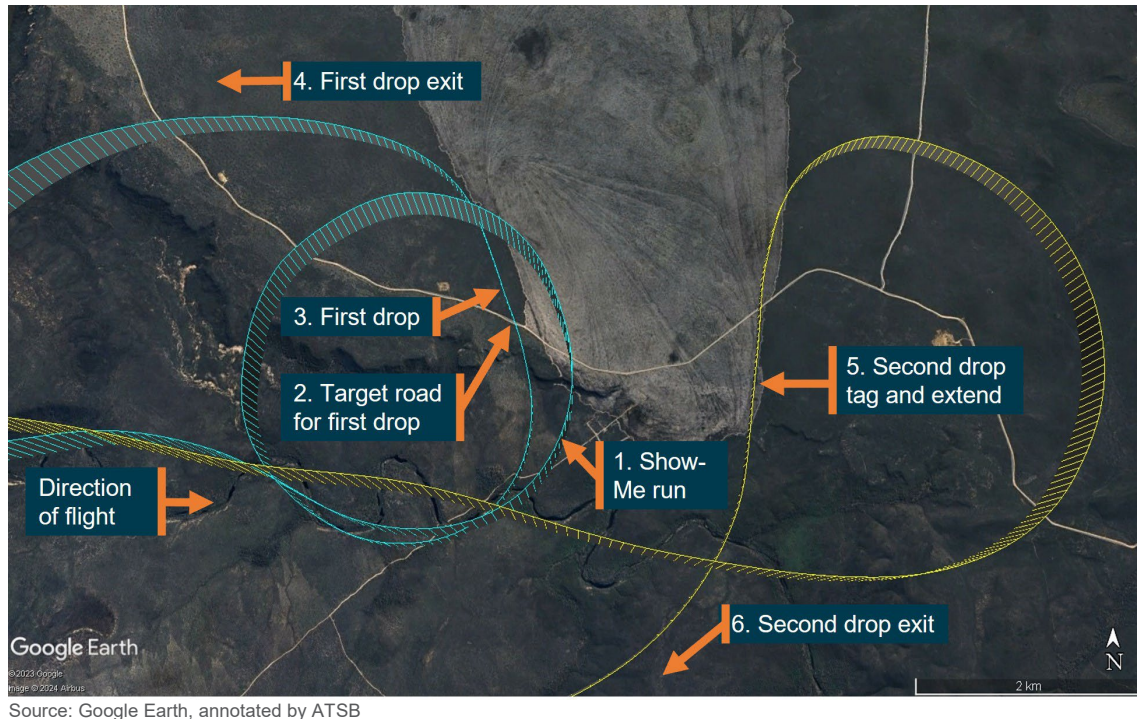
Figure 11: First and second drop flight profiles on 6 February 2023

over 15 seconds but without a Show-Me profile. Figure 11 depicts the flight profiles and Figure 12 shows imagery of the first drop, which started at the same road as the accident flight, and the second drop tag and extend an existing line of retardant.

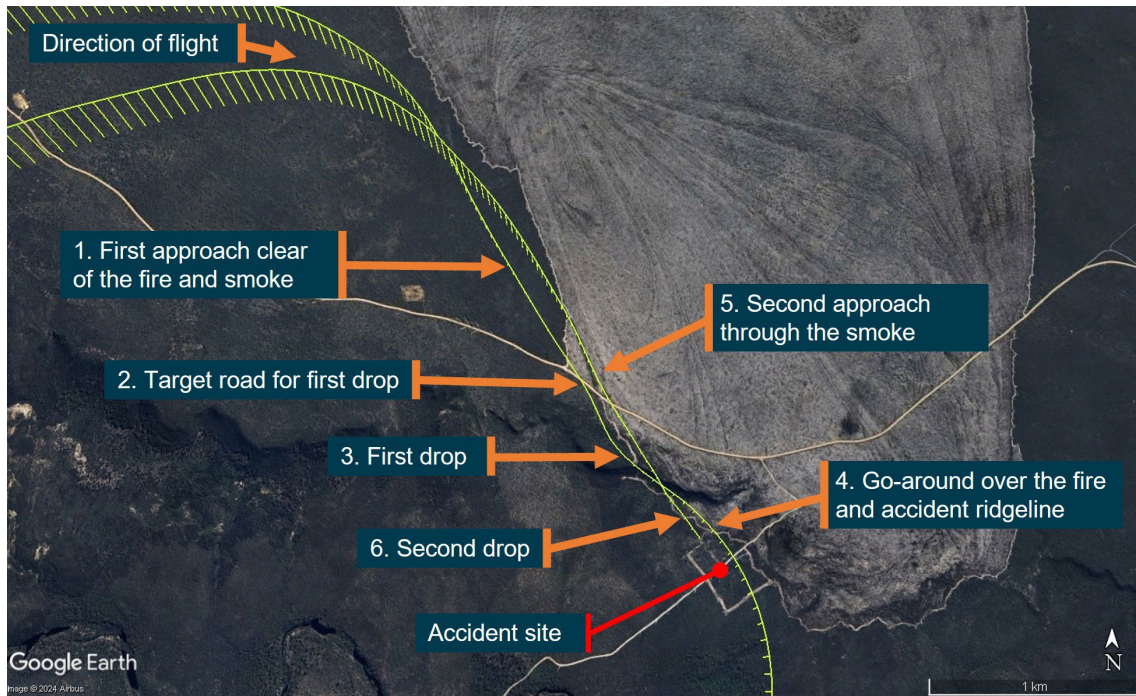
Figure 13: Accident flight first and second drops

On the first drop of the accident flight the captain reported the large circuit was due to the manoeuvring required to join up with BD123. The captain recalled that this resulted in a very wide base but final was flown clear of the smoke on the right side of the fire-line and at a normal angle of approach (Figure 13).

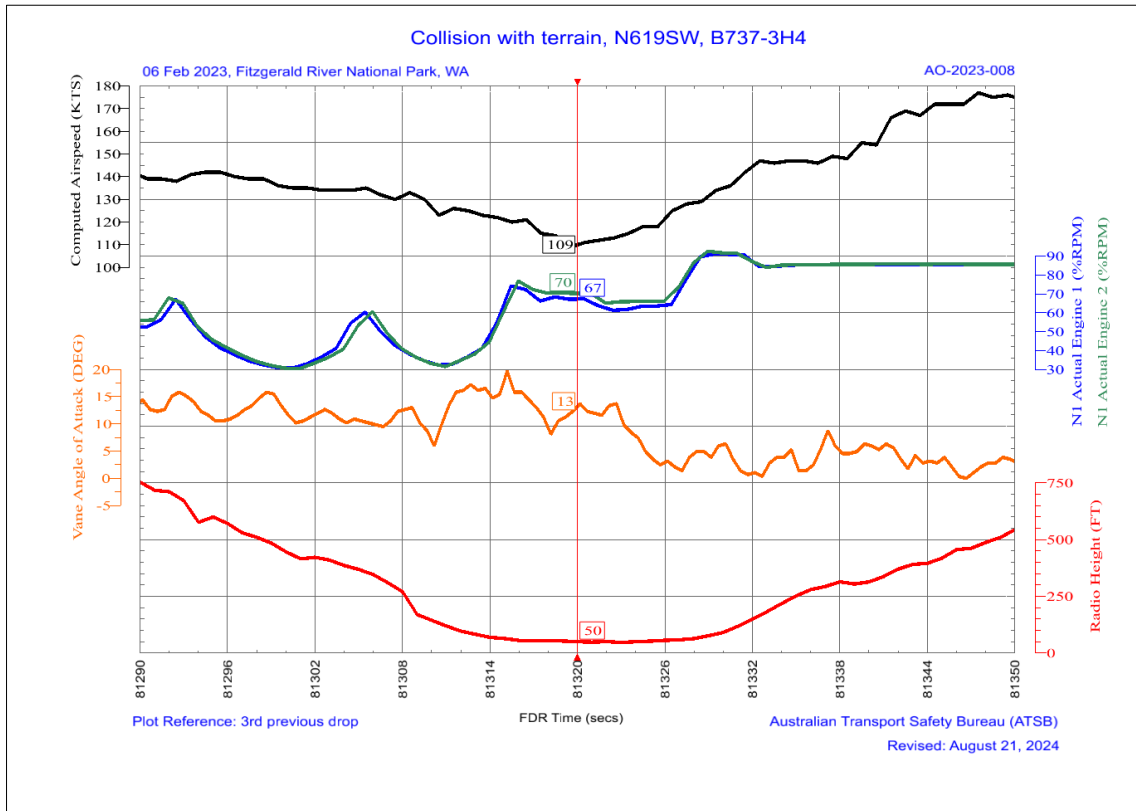
Figure 14: FDR plot of first drop with minimum airspeed reference

- On the first drop, Bomber 139 reached a minimum height of 46 ft with 120 ft/min rate of descent at 113 kt and 61–66% N1. Minimum airspeed was 109 kt at 50 ft and maximum angle of attack was 19.7° at 64 ft.²⁸ On reaching the go-around thrust lever setting, the height was 64 ft with 360 ft/min rate of climb at 128 kt and 77–86% N1. Idle thrust was employed intermittently near the start of the drop, which resulted in a V-shaped airspeed trace during the drop (Figure 14) and in BD125 closing on Bomber 139 during the drop (Figure 15).

²⁸ Using similar weights to the accident flight of 125,000 lb at the start of the drop and 90,000 lb at the end of the drop, Vs would have reduced from 107 kt at the start of a drop to 88 kt at the end of the drop. There was no stick shaker activation recorded during this drop as neither of the angle of attack sensors reached 20°.

The effects of the FAA-specific excess power equation were evident in the 4 retardant drops on the day of the accident. The high engine thrust (N1) and large weight reduction on the first 3 drops resulted in a positive reversal of the vertical speed and airspeed at the end of those drops. However, the idle thrust and smaller weight reduction on the accident drop resulted in the

airspeed and height decaying at the end of the drop as the captain arrested the aircraft’s significantly higher rate of descent.

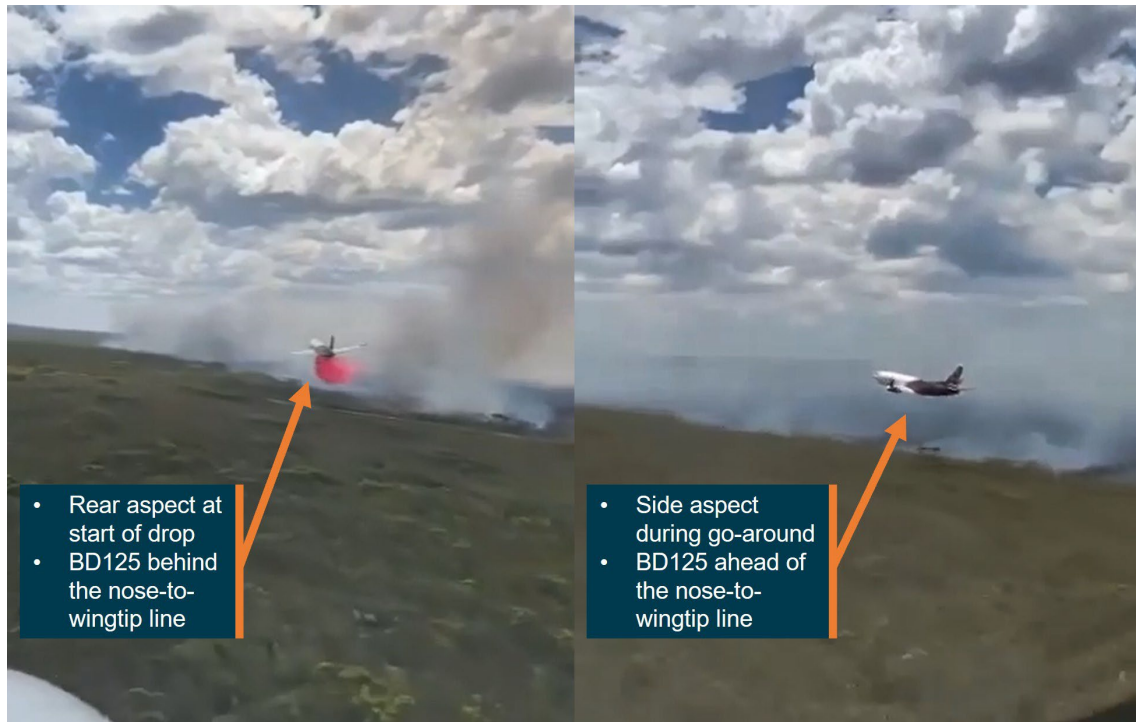
Figure 15: Aspect change of Bomber 139 from start of first drop (left) to go-around (right)

Birddog 125 closing on Bomber 139 during the first drop.
 Source: Department of Fire and Emergency Services, annotated by ATSB

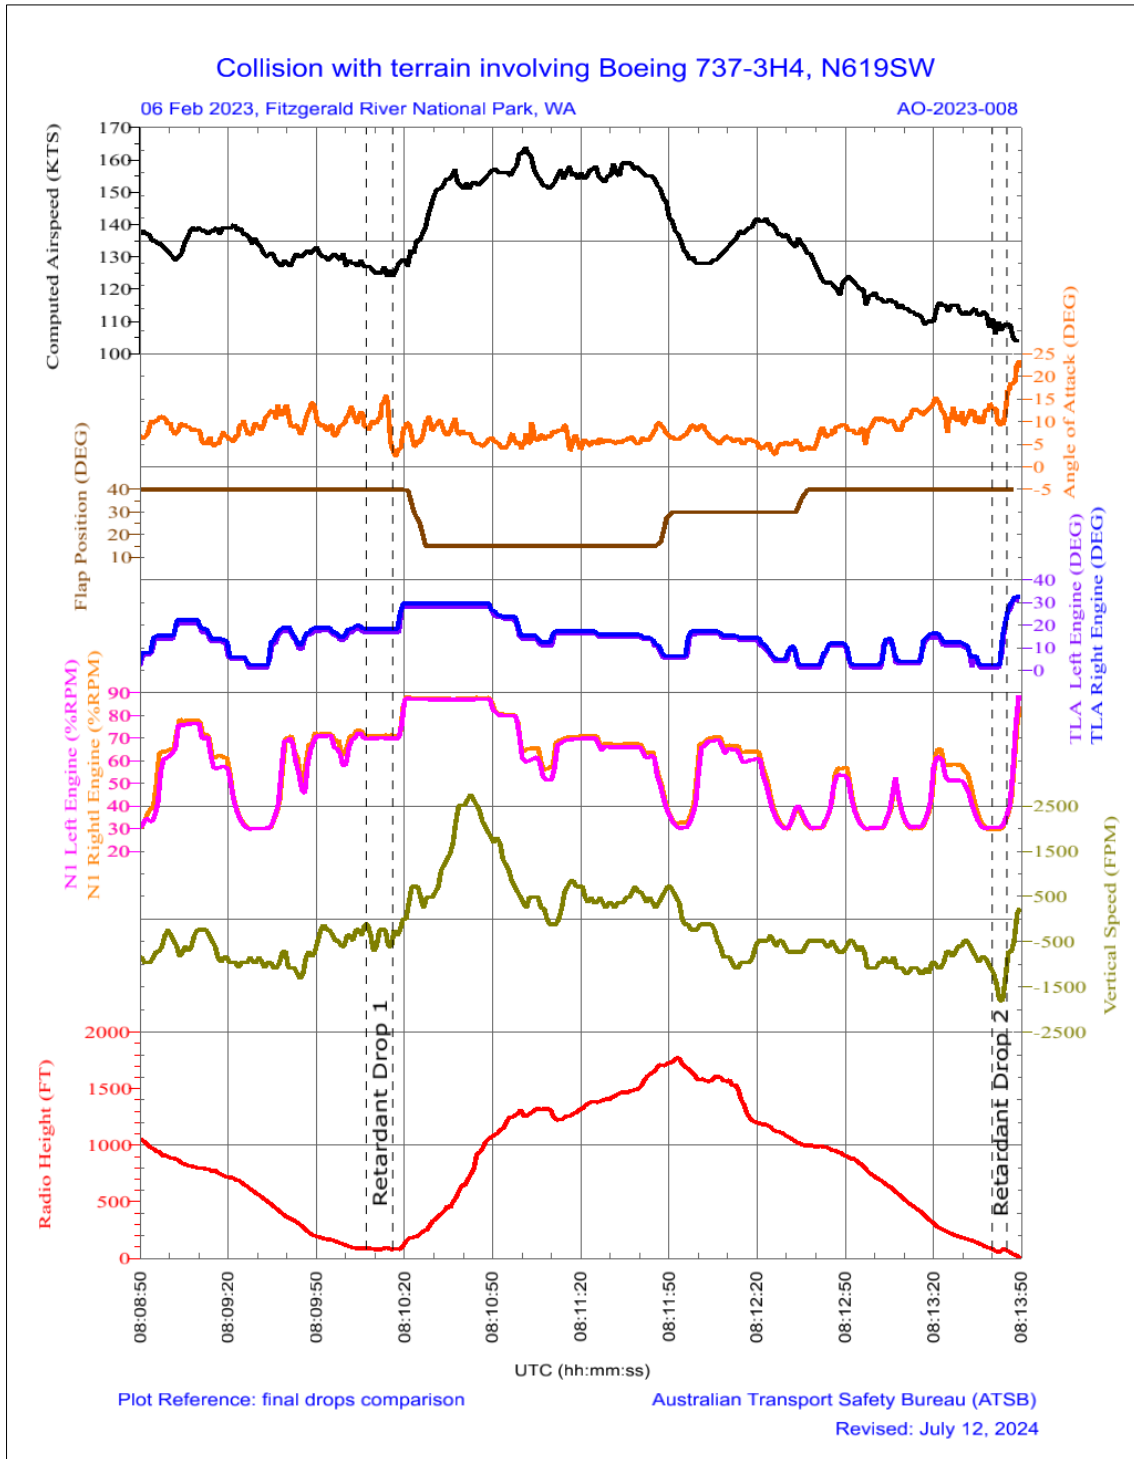
Figure 19: FDR plot of last 5 minutes of the accident flight with the last 2 drops

Bomber 139 descended to a minimum height¹¹ of 78 ft and completed a 9-second partial drop¹² of three-quarters of their tank at about 70% N1¹³ with a minimum computed airspeed¹⁴ of 124 kt before the captain stopped the drop because their retardant line was starting to enter area that was already burnt. The captain reported the partial drop to BD123, and another Lead profile was set up to tag and extend the first drop with the remaining retardant, with the captain remarking to the crew of BD123 '...and head down off the hill'.

The engines did not immediately respond to the movement of the thrust levers and the captain started to pitch the nose up, which resulted in a reversal of the rate of descent and a decay of the airspeed. The captain then announced 'fly airplane' followed immediately, at about 1614,¹⁶ by the activation of the stick shaker¹⁷ and an abrupt vertical acceleration associated with the aircraft impacting a ridgeline at an elevation of about 222 ft at 104 kt with the engines at 85–89% N1.
