# Fuel exhaustion involving Aero Commander 500-S, VH-MEH

6 km east of Bathurst Airport, New South Wales on 8 March 2024

## **ATSB Transport Safety Report**

AO-2024-008

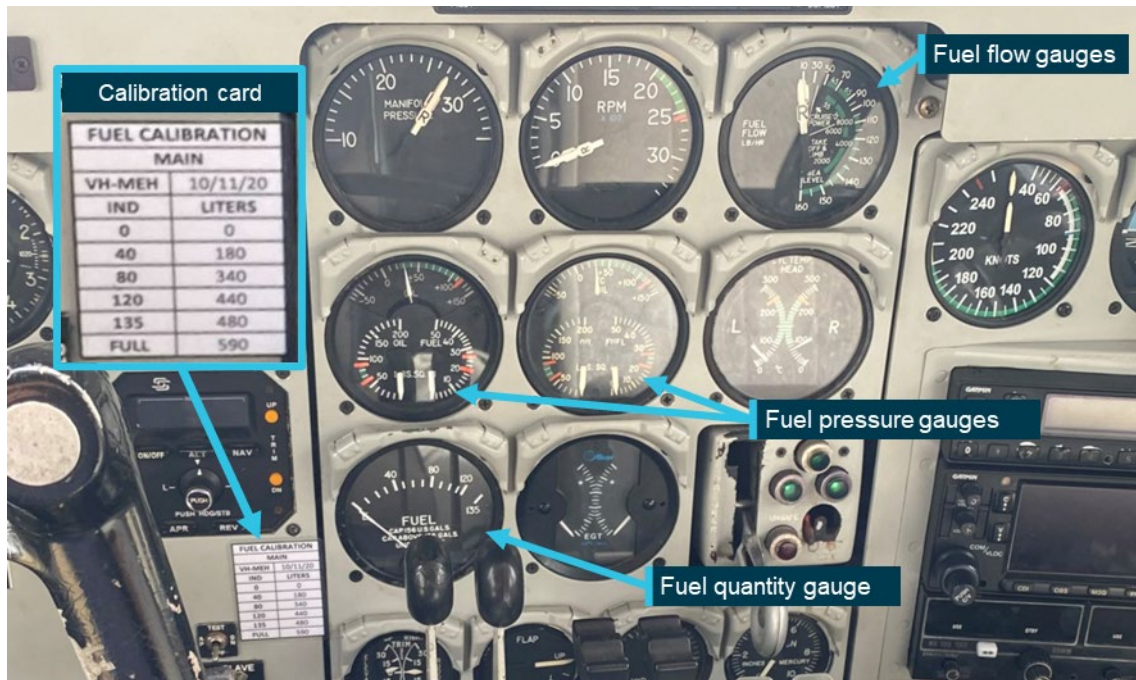
Figure 3: Cockpit fuel system indicators

The aircraft had fuel quantity, fuel pressure and fuel flow gauges in the cockpit (Figure 3). A printed calibration card that provided the conversion of fuel gauge readings in US gallons (USG) to usable fuel in litres was affixed adjacent to the fuel quantity gauge. Although full fuel was 159 USG (590 L), the gauge could not indicate a quantity of fuel above 135 USG (480 L). Therefore, prior to commencing the flight, the pilot was unable to confirm the fuel level using the gauge. Because of this gauge limitation, the operator required pilots to begin flights with a fuel quantity that had been visually confirmed.

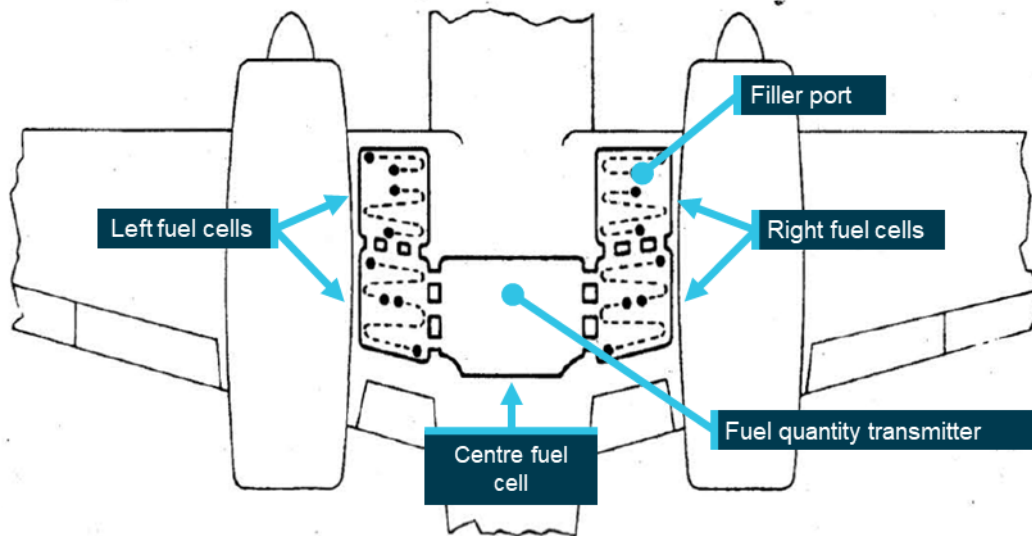
**Figure 5: Fuel tank internal layout**

The maintenance engineer inspected the fuel cap and found that the chain securing the fuel cap to the inside of the filler neck had disconnected from its attachment point and lodged under the anti-siphon valve, holding it slightly open. This also prevented the fuel cap locking mechanism from engaging. The engineer removed the chain from its lodged position, re-attached it to the filler neck, and successfully closed and locked the fuel cap. They also observed minor blue fuel dye

The aircraft's fuel tank consisted of 5 interconnected synthetic rubber cells installed in the inboard and centre wing sections (Figure 5). A single fuel quantity transmitter was installed in the centre fuel cell and electrically connected to the fuel quantity gauge. Both the operator and the aircraft manufacturer reported that the distribution of the fuel throughout interconnected fuel cells made physical determination of the fuel level using a dipstick impractical. Therefore, the only way to confirm the fuel level was to observe the fuel at a level full or close to full. Additionally, during refuelling, the fuel could take time to settle and allow a reliable visual determination of the fuel level. A placard advising of this was placed adjacent to the filling point on the operator's Aero Commander aircraft (Figure 2).

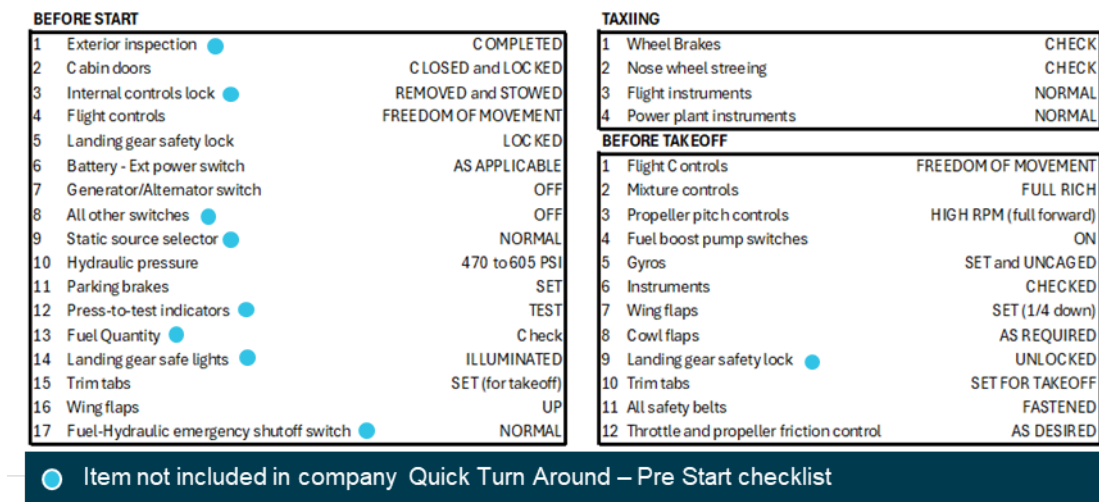
Figure 10: AFM checklists

The ATSB also found that GAM Air's Quick Turn Around – Pre-Start checklist did not include a fuel quantity check before start, contrary to the aircraft flight manual's before-start checklist.

The ATSB compared the operator’s checklists with equivalent checklists in the manufacturer’s aircraft flight manual (AFM) (Figure 10). While standard checklists closely followed the checks included in the AFM, several checks were excluded when a pilot conducted the operator’s QTA Checklist.
