Wheels-up landing involving Beechcraft King Air B200, VH-XDV

Williamtown Airport, New South Wales on 13 May 2024

Aviation Occurrence Investigation (Short)

AO-2024-031

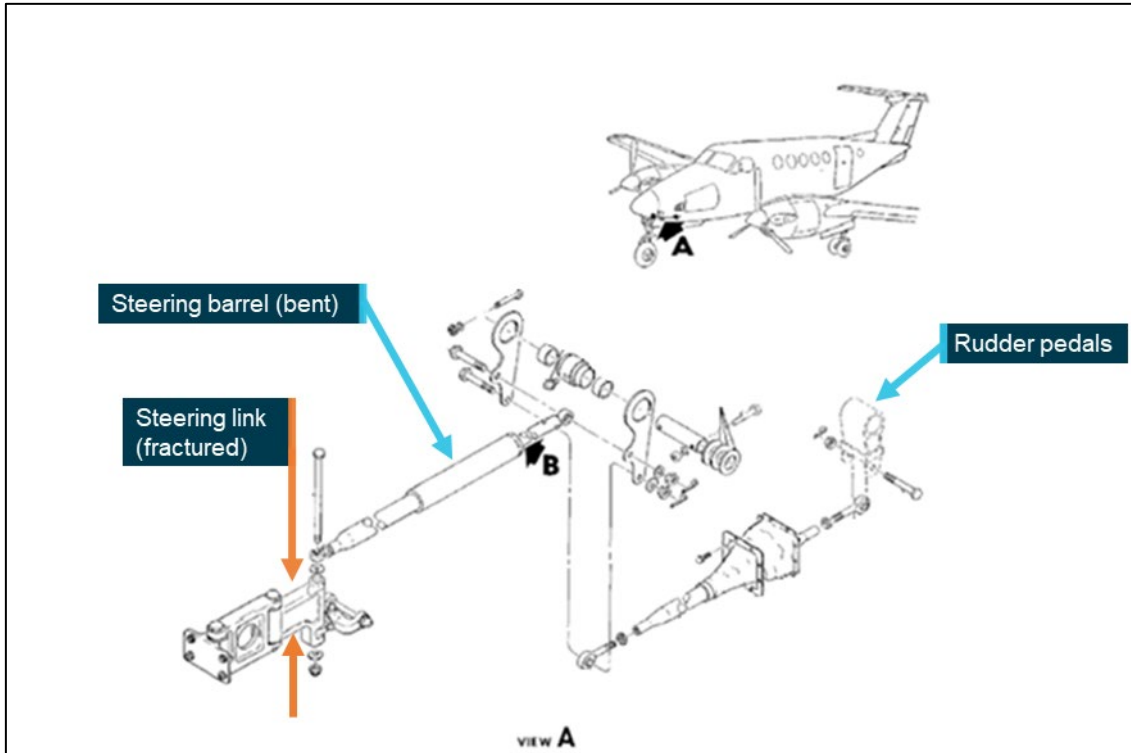
Figure 5: King Air B200 nose steering system schematic

The ATSB identified that during either the take-off roll or landing gear retraction sequence the steering link fractured from a pre-existing fatigue crack, resulting in a mechanical disconnect within the nose landing gear steering system.

When the landing gear retracted, the fractured steering link allowed the nose gear shimmy damper to contact the side of the wheel well and jam the nose landing gear in a partially retracted position. This prevented extension of the landing gear using the published emergency procedure, necessitating a wheels-up landing.

Nose wheel steering is through direct mechanical actuation of the linkages in the system from the rudder pedals that connect to an arm near the top of the nose gear shock strut (Figure 5). A spring mechanism in the steering barrel dampens the transmission of excessive shock loads to the rudder pedals. A strut-mounted roller engages with a centring ramp to automatically centre the nose wheel during retraction of the gear.
