# Grounding of *Hagen Oldendorff*

Port Hedland, Western Australia on 9 April 2022

## **ATSB Transport Safety Report**

MO-2022-007

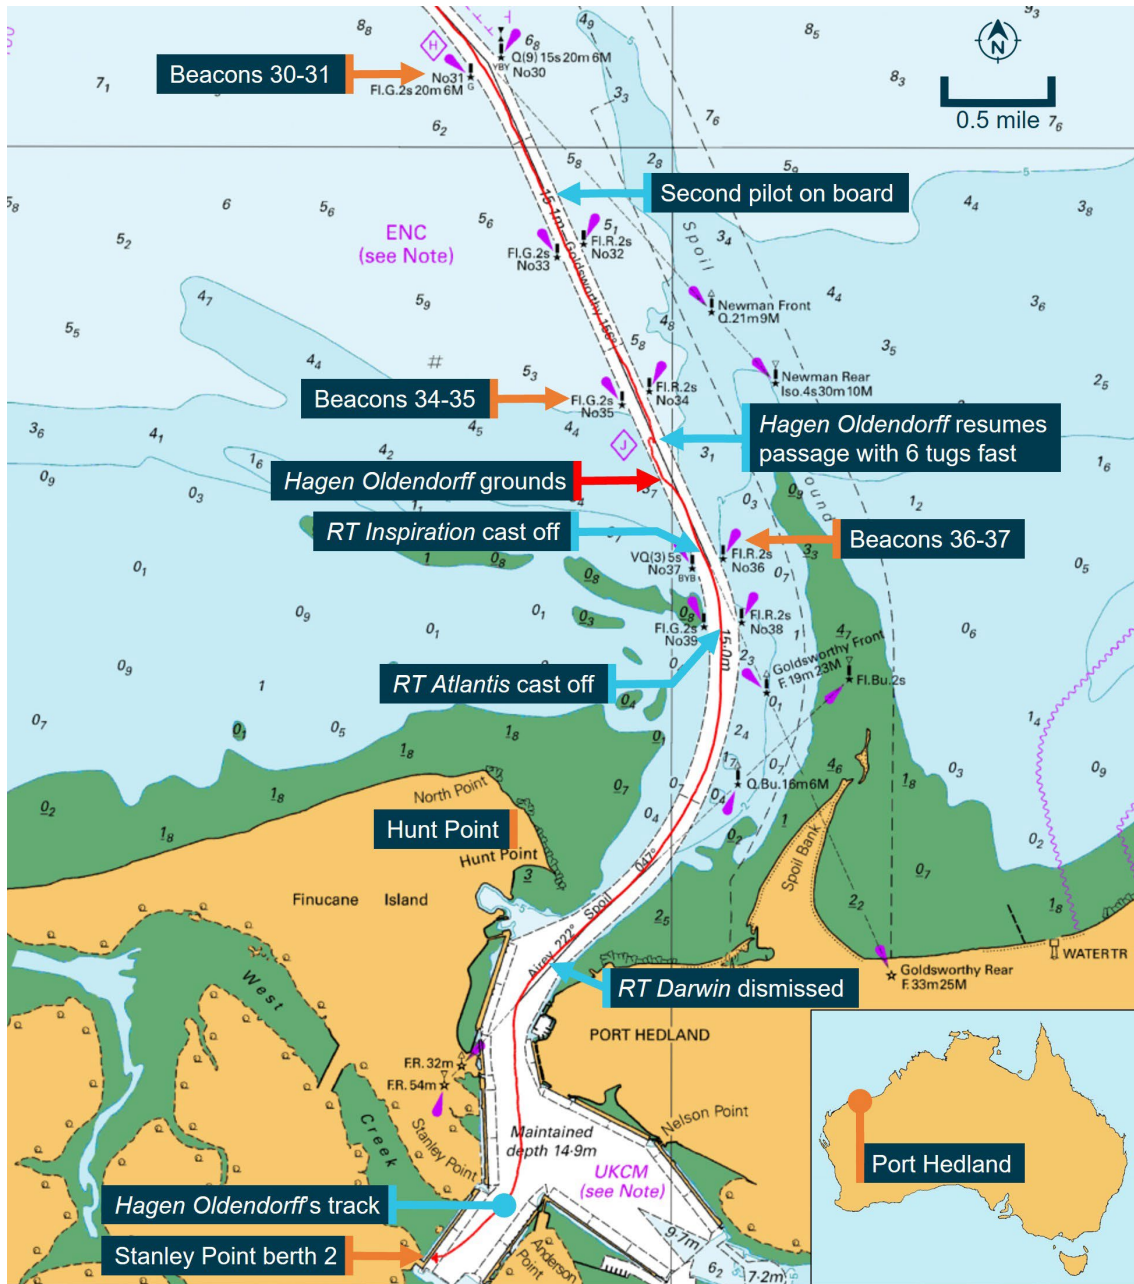
Figure 2: Section of navigational chart Aus 53 showing location of key events

At about 0118, when *Hagen Oldendorff* was about 3.5 cables<sup>5</sup> (648 m) south of Hunt Point (Figure 2), *RT Darwin* was cast off and dismissed. The ship proceeded north-east along the channel. The pilot then offered *RT Clerke's* master a training opportunity in helping turn the ship into the Goldsworthy channel using 'indirect towing'<sup>6</sup> (a routine practice in the port to train, and maintain the skills of, tug masters). *RT Clerke's* tug master accepted the pilot's offer.

At about 0133, the pilot ordered the release of the tug *RT Atlantis* on the starboard shoulder and by 0135, the crew of *RT Atlantis* had recovered the tug's towline (Figure 2). *RT Atlantis* continued to maintain station off the ship's starboard shoulder as a 'passive escort'.<sup>9</sup> Shortly after, the pilot ordered the release of the tug *RT Inspiration* on the port shoulder as *Hagen Oldendorff* approached beacons 36-37 in the Goldsworthy channel (Figure 2). Recorded data from the ship's voyage data recorder (VDR)<sup>10</sup> showed that, at the time, the ship was turning to port at a rate of turn (RoT)<sup>11</sup> of about 9° per minute and its speed was 6.7 knots, with the main engine set to manoeuvring full ahead (51 RPM).

By 0148, *FMG Dusky* and *Iron Ibis* were fast on the starboard quarter and centre lead forward, respectively. By this time, *Hagen Oldendorff* was stopped and had been recovered to the middle of the channel, south of beacon 35 (Figure 2). Shortly after, the tug *Iron Whistler* was made fast on the port quarter and *RT Atlantis* was fast on the starboard shoulder.

At about 0212, when the ship was past beacons 32-33, a second pilot boarded the ship by helicopter (Figure 2). The second pilot took charge of communications with external parties while the pilot maintained conduct of the ship. Shortly after, VTS advised the pilot that sufficient tidal window remained for the ship to proceed and exit the channel at the C1 beacon.

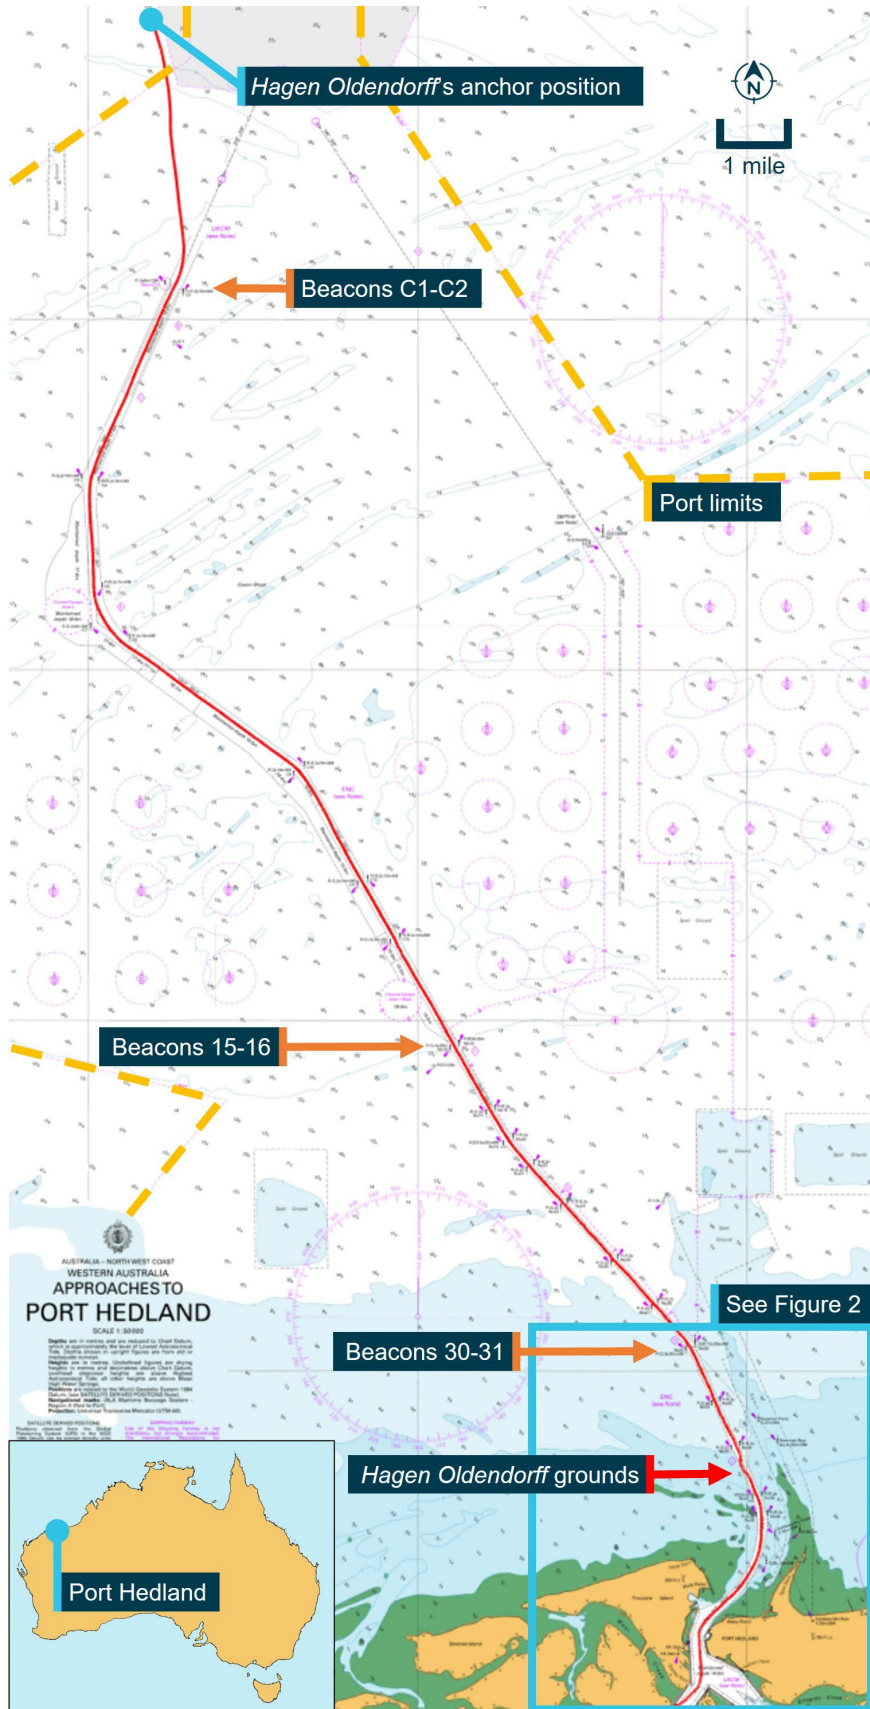
Figure 4: *Hagen Oldendorff's* track overlaid on chart of Port Hedland

Shortly after 0430, the ship cleared the channel (at beacons C1-C2) and all tugs, except *RT Clerke*, were dismissed. By 0530 on 9 April, the ship had anchored outside the port limits in a position 24 miles north-north-west of Hunt Point (Figure 4). Soon after, *RT Clerke* was dismissed, and the pilots left the ship by helicopter.

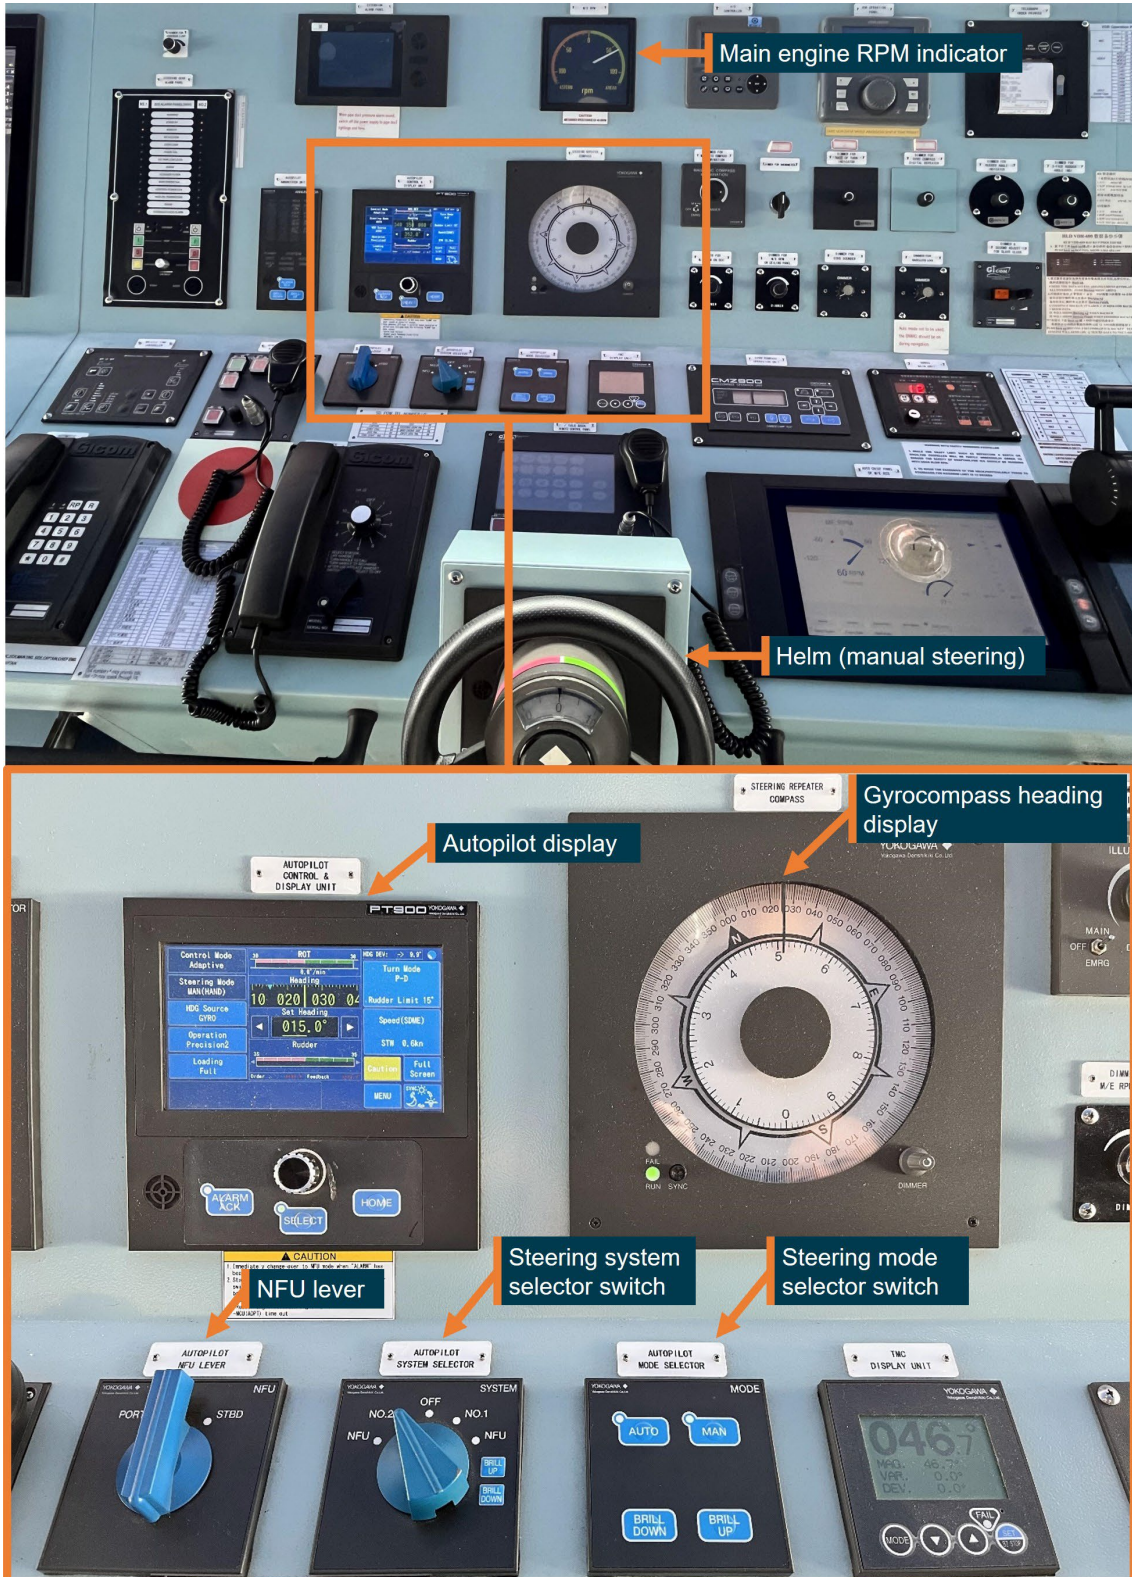
Figure 6: Hagen Oldendorff's bridge console layout showing steering mode controls

Similarly, in hand steering mode, when the helm (wheel) is moved manually (Figure 6) to port or starboard, a signal is transmitted to move the rudder. A follow-up or feedback signal is received at the bridge steering control stand and compared to the helm order to stop the rudder at the commanded angle.

In the NFU mode, when the spring-loaded lever (Figure 6) is operated in the port or starboard direction, the rudder moves in that direction until the lever is released or the mechanical rudder limit is reached. When operating in NFU mode, the helmsman depends upon the rudder angle indicator or other means of knowing what the rudder angle is so that the lever can be released when the desired rudder angle is reached.

The mode of steering operation was selected by means of push-button switches on the bridge console (Figure 6).

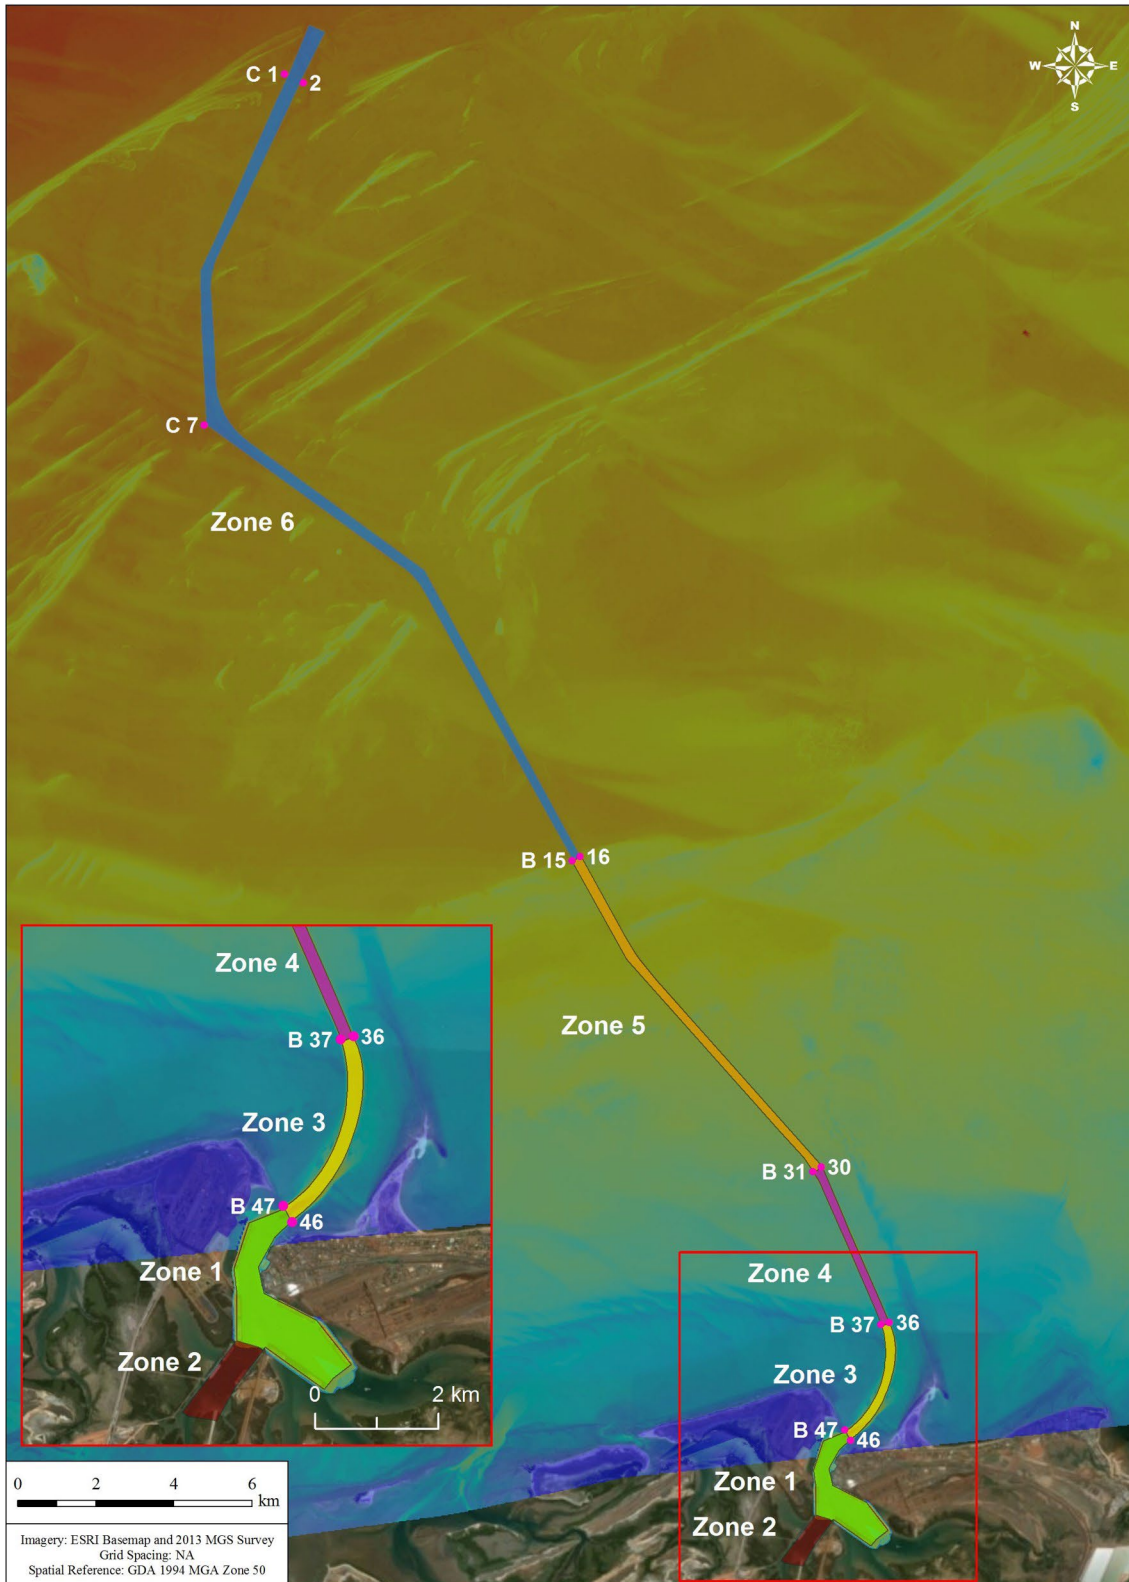
Figure 10: Port Hedland channel zones

The Port Hedland navigation channel was divided into 6 zones (Figure 10) based upon navigational or environmental characteristics that would impact the risk within that zone. These characteristics included location, channel alignment, bathymetry, channel slopes and sea conditions.

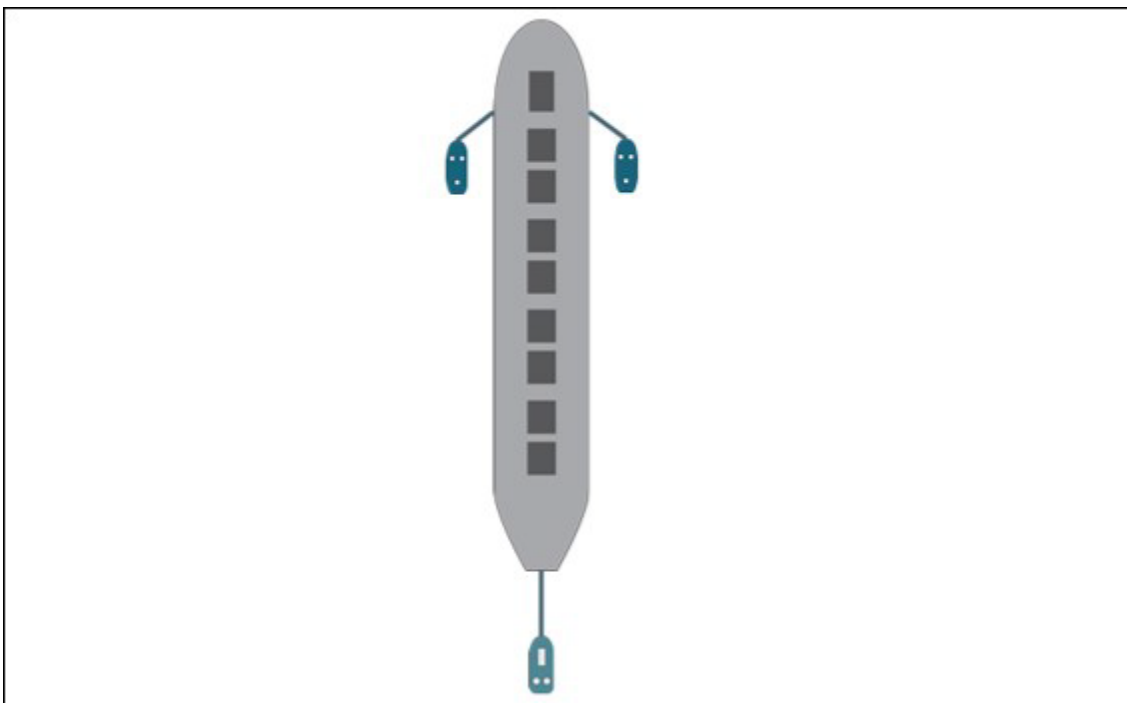
**Figure 12: Recommended tug configuration for capesize ships in zones 3 and 4**

It stated that, in zone 3, laden outbound ships would typically require 3 tugs and that the primary escort tug aft was to be the most capable tug asset available for the ship movement. It stated that the other 2 tugs should have their towlines tethered on the port and starboard shoulders of the ship prior to, and throughout zone 3, except where weather or other conditions made it unsafe to do so (Figure 12).

The towage strategy stated that the tug allocation in zone 4 was the same as zone 3 (Figure 12). Similarly, the escort towage procedure in the event of a steering incident in zone 4 was largely identical to that in zone 3, although the strategy noted that the channel was straight but narrower in zone 4 with ships generally making way at a higher speed (7–8 knots).

In all emergency scenarios in Zone 4, having the shoulder tugs with their lines tethered is preferable so that they can immediately provide braking forces and also be positioned to assist with controlling the position of the ship’s bow when the speed of the ship reduces.
